Gazetteer Penny Rigg

APPENDIX 4 – CONDITIONS SUMMARY - PENNY RIGG

Conservation Management Plan – Penny Rigg Copper Mill, Cumbria – Appendix 4: Conditions Summary

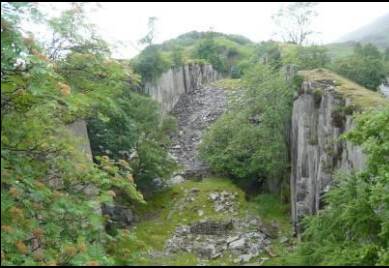
ID No	Type	NGR	Date	Source	Conditions Risks/Issues	Description	Image
2000	Slate Quarry	330537, 500853	18 th – 20 th century	Site Survey First Edition OS Cameron 1986	Good -Vegetation Cracking rock face; climbing routes drilled into face.	Large slate quarry first appearing on the 1st edition OS but dating to the early 18th or late 17th century. Known to be already producing over 600 tons by 1752. Measures approx. 220 x 20m and obviously worked in various phases progressing probably north to south with various stages of backfill evident. A number of structures and retaining walls preserved on various levels across the site.

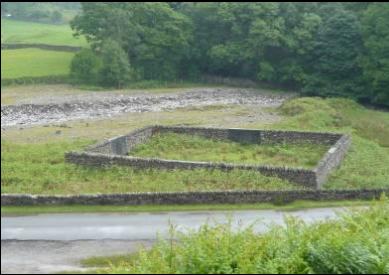
2001	Sheep enclosure	330675, 500990	18th Century	Site Survey First Edition OS	Good -Stands 1.80 high and coping stones in place (or replaced). Today part of modern sculpture.	Square sheep enclosure measuring approx. 20m across. Formerly associated with a small building or sub-enclosure in the SE corner (shown on 3rd edition map) but no longer extant. Today, forms part of a sculpture by Andrew Goldsworthy.

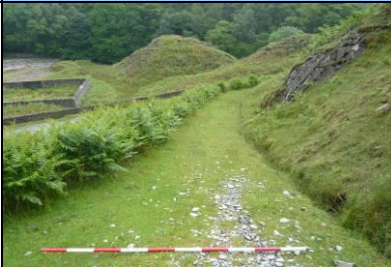
ID No	Type	NGR	Date	Source	Conditions Risks/Issues	Description	Image
2002	Quarry access track	330484, 500844. 330488 500841 330343, 500686	18th Century	Site Survey First Edition OS	Good - Stable	Access track serving main quarry. Measures 3m wide and winds round contour of hill coming up from road. Runs as a broad transport route till the Quarry Cutting and then narrows down to a track, leading to footbridge over the river.

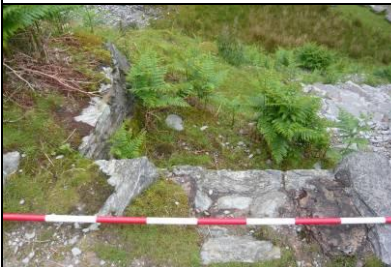
2003	Stone feature at top of steps	330632, 500960	Unknown, possibly modern	Site Survey	Good - Stable	Section of stone wall at the top of the modern access steps leading from the car park. Structure is L-shaped, measuring 2 x 2m and 0.5m deep and may be just a junction at the top of the wall, but seems unnecessary and therefore could be associated with the riving sheds further up the bank. Maybe a winch or balance pit for hauling the slate.

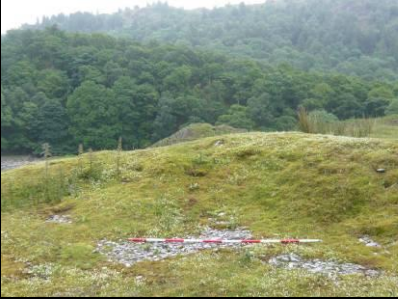
ID No	Type	NGR	Date	Source	Conditions Risks/Issues	Description	Image
2004	Rectangular depression at the top of spoil tip	330628, 500968	19th century?	Site Survey	Poor Overall site seems stable but some cracks observed on the outer edge above the car park. Cracks denote slippage of slate spoil heap which is an urgent issue.	Rectangular, flat area at the top of spoil tip, surrounded by a slight bank, measuring approx. 0.5m high. Could be evidence of a processing area or last episode of spreading/leveling the spoil

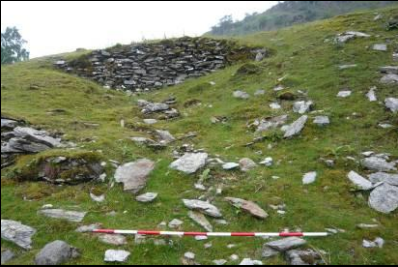
2005	Retaining wall	330599, 500962	19th Century?	Site Survey	Good - stable	Curved pack retaining wall measuring approx. 4m across and stands 2m high

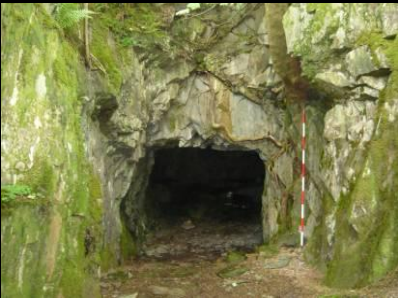
2006	Slate Closehead	330590, 500910	19th Century	Site Survey	Good Potential issue with large sycamore (trunk 30cm in diameter) growing through rock just above the head entrance could threaten long term maintenance – needs assessing.	Slate Closehead sunk to access slate from below the open quarry. Entrance measures approx. 3m x 2m and is square in shape. Larger than the Copper mines level to accommodate larger size of pre-worked slate.

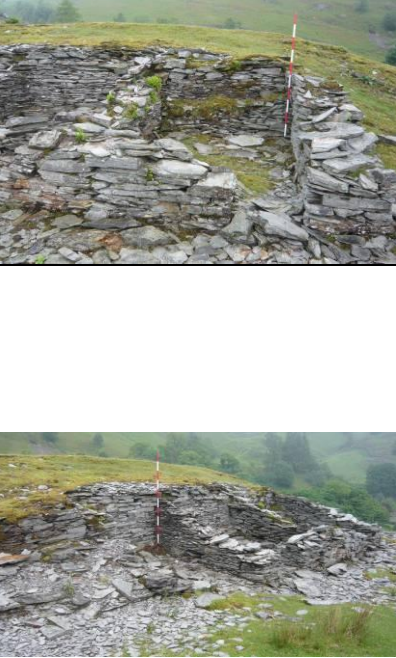
2007	Riving Sheds	330589, 500943	19th Century	Site Survey Second Edition	Moderate Some collapse on southern	A three/four cell structure, probably a riving shed. Slate

ID No	Type	NGR	Date	Source	Conditions Risks/Issues	Description	Image
				OS	side but seem relatively stable but need recording to monitor any decline.	<p>blocks would be transported from the quarry or closehead and split by hand in the sheds. Along the back wall is a stone bench, 0.30m wide, where the slate splitter would have sat and rested a slate block between his knees and hit it along the plain with a wooden hammer. The rear wall of the structure is built into the hillside and stands 1.50m high. Each cell is 2m across, although the third cell is smaller and has a curved wall. There seems to be a vent or drain running between the rooms. Each cell was entered from the east, but the wall on this side is in bad repair. Building in this area appears on First edition OS but current structure seems to be first shown on 2nd edition (1898)</p>

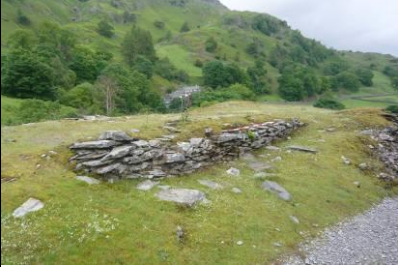
ID No	Type	NGR	Date	Source	Conditions Risks/Issues	Description	Image
2008	Platform	330546, 500903	19th Century	Site Survey	Good - Stable	Raised stone platform measuring approx. 5m wide and running for 7m before disappearing under a spoil heap. Constructed of stone facing walls in-filled with slate rubble. Seems to follow on from a linear feature shown on 3rd edition OS (now under spoil). Stands approx. 0.5m high. Might be a track for lifting gear of some form, does not look like a building

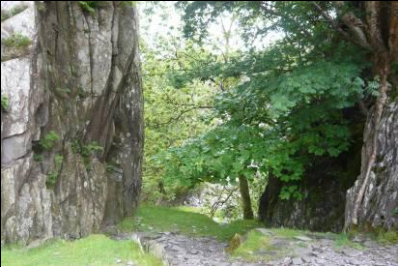
2009	Cutting	330541, 500875	19th century	Site Survey Third Edition OS	Moderate - some danger from tree growth undermining the quarry face.	Access cutting measuring approx. 6m across. Probably an access route similar to that further north (2013), but part of an earlier phase of operation, the working floor level now being substantially lower.

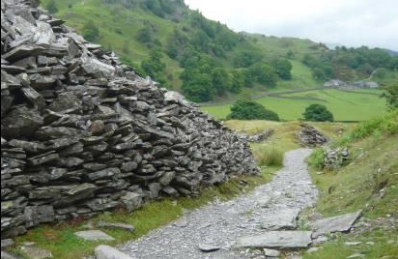
2010	Retaining wall	330505, 500857	19th Century? Modern?	Site Survey	Good/Stable	Pack wall along quarry path

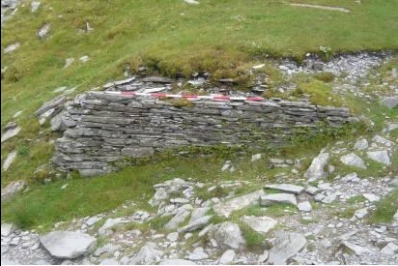
ID No	Type	NGR	Date	Source	Conditions Risks/Issues	Description	Image
2011	Retaining wall	330501, 500849	19th Century?	Site Survey	Good/Stable	Retaining wall or part of a buried structure (seems rather too well made to be a pack wall) stands 1m high and measures 3m across, with a fragment of a return wall running south into the bank. Runs along edge of modern path.

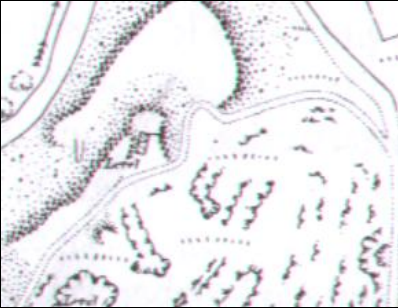
2012	Closehead	330582, 500943	19th Century?	Third Edition OS	Blocked Not visible from the surface	Closehead level shown on Third edition OS map as being located to the rear of the Riving Sheds. Now completely blocked by later rid.

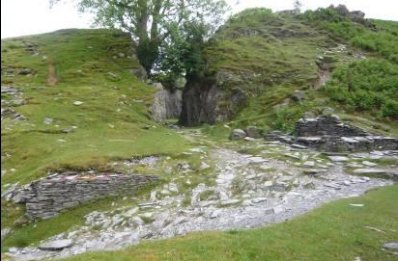
2013	Cutting (Level Drain)	330506, 500840	19th Century	First edition OS Site Survey	Moderate Stability is again threatened by trees growing up through the fissures in the rock.	Primary access cutting measuring approx. 6m across. Providing access to quarry track and riving sheds and associated with various buildings just outside the quarry. Not shown on first edition OS.

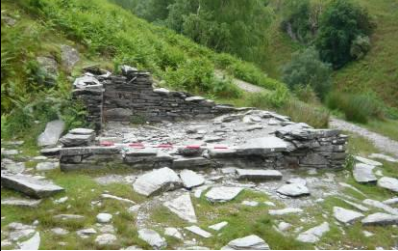
ID No	Type	NGR	Date	Source	Conditions Risks/Issues	Description	Image
2014	Building	330496, 500844	19th Century	Site Survey Second Edition OS	Good - but slowly deteriorating.	Stone building orientated SE to NW standing just at entrance to quarry cutting. Rear wall stands 0.80m high and doorway preserved in SE wall but other walls largely stand only a few courses high. Unknown function. A second building is shown in this location on the second edition OS but no evidence of this survives.

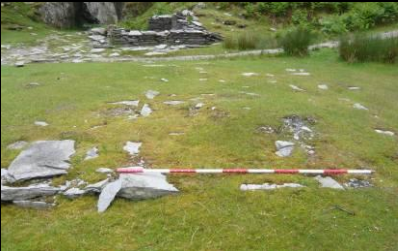
2015	Building Footprint	330490, 500853	19th Century	Site Survey Second Edition OS	Poor - may soon be lost as almost completely grassed over and only visible as a few stones	Building shown on second edition OS. Shown in detail on the third edition OS as a two celled building, possibly a riving shed. Today only survives as a footprint just visible poking through the grass.

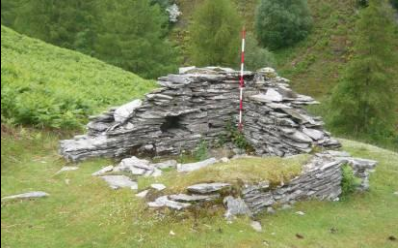
2016	Building	330445, 500781 330452, 500784	18th Century	Site Survey Second edition OS	Good but slowly deteriorating.	Small square building measuring 3 x 3m. Entrance on the south side, standing 1.30m high in places. Includes an aperture in the west wall. Function unknown but might be a small quarryman's dwelling. Associated with a small 3 sided

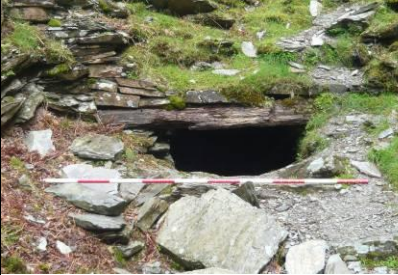
2018	Closehead	330479, 500760	19th Century	Third Edition OS Site Survey	Poor – timber lintel needs attention and there is a risk from imminent collapse and in-filling	Closehead or access level at the far SW end of the quarry. Entrance is partially blocked but timber lintel still survives in-situ. Associated with a stone bordered track (2020) running down to Quarry Cutting. This is the 'level drain' mentioned in Corry's History of Lancashire " <i>the slate is conveyed on trucks through a level drain into the side of the rock, at some height above the bottom of the pit</i> ".

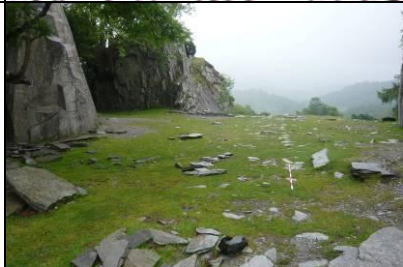
2020	Track leading from level	330481, 500761 330479, 500760.	19th Century	Second edition OS Site Survey	Moderate – track still visible but in danger of being hidden by quarry chipping and rid	Track leading from quarry adit and mentioned in Corry's History of Lancashire. Today, track is visible as a clear line of edging stones leading from the adit (2018). Feature first shown on

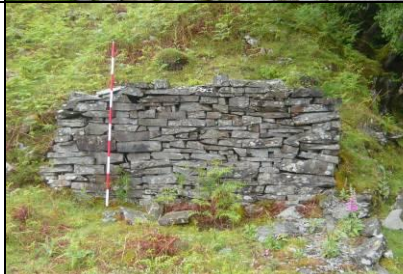
2021	Structure	330574, 500669	19th Century?	Site Survey	Moderate – slow deterioration	Remains of a stone structure, rear wall only surviving standing to a height of 1.60m. Fragments of a return wall also visible.

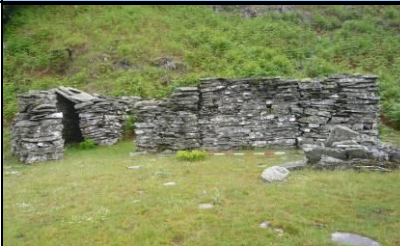
ID No	Type	NGR	Date	Source	Conditions Risks/Issues	Description	Image
2022	Building – Riving sheds?	330463. 500673	19th Century?	Site Survey	Good - Remarkably well preserved by deteriorating and needs stabilisation and consolidation.	Rectangular stone building orientated NS. Divided into two main cells with a small third cell at the SW. Third cell still has its slab slate roof and is enclosed by a curving south wall: function of this area is unknown but seems specialist. Each cell approx 2m across and features a rear stone Cupboard. Could be a riving shed but seems very small internally. Shows at least two phases of use.

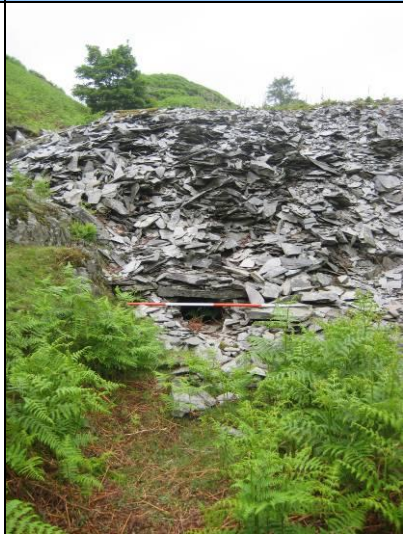
ID No	Type	NGR	Date	Source	Conditions Risks/Issues	Description	Image
2024	Slate Rid Tip	330608, 500809	19th Century	Third Edition OS Site Survey	Good - Mature tree growing on tip but poses no obvious threat.	Large slate tip derived from underground level (2023). Accessed from south by track (2030) and overlies track (2027). Main wheel leat (2026) culverted under the tip.

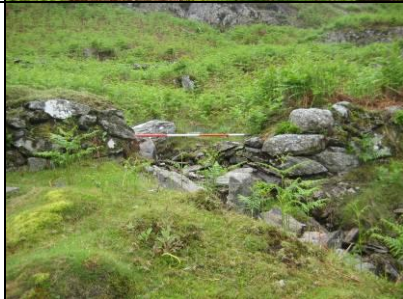
2025	Leat Overflow	330608, 500743 330652, 500785 330719, 500830	19th Century	Site Survey	Moderate, south side disturbed and eroded.	Overflow or spillway on leat (2026). Stone in-turn on N side with wooden boarding surviving on floor. Overflow channel runs NE down slope to join Yewdale Beck.

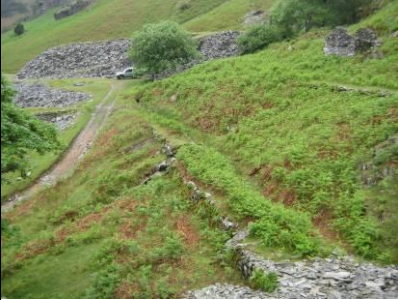
ID No	Type	NGR	Date	Source	Conditions Risks/Issues	Description	Image
2026	Leat for mill wheel	330612, 500768 330612, 500743	19 th century	Site Survey	Moderate but some recent disturbance and cleaning out at southern end.	Open trench leat running N-S with stone embankment on E side. At N end the leat is culverted under slate tip (2024). The S end has been re-cut to take water draining from Deep Level and the association with the holding pond and wheel pit is now unclear.

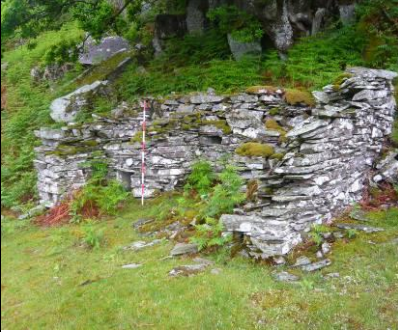
2031	Building, Smithy or workshop?	330479, 500637	19 th century	Site Survey	Moderate – building seems stable but bracken is an issue and could undermine structure gradually.	On slope above track (2030), a square, gabled structure with single entrance; roofless. Orientated N-S, approx. 6m in length and built against hillbank. Rear wall stands 2m high, east wall missing (or building may have been open on this side). 4 square apertures set in walls. Small

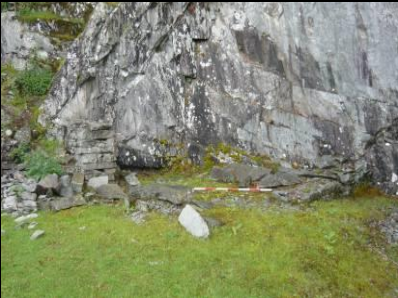
2033	Building	330570, 500693	19 th century	Site Survey	Good, stable – no immediate threats except people have tried to dig out adjacent ironwork (2034)	Square building built against the quarry face above and SW of Deep Level entrance. Majority only survives as footing but section of west wall stands 1m high – entrance probably on this side.

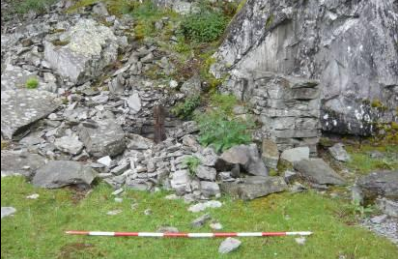
2034	Fragments of ironwork	330567, 500689 330578, 500689	19 th century	Site Survey	Moderate - Attempts have been made to dig out the possible winch plate.	Adjoining building (2033) to the S are the remains of ironwork – possible winch side plate. In addition, immediately NE are two iron bars (one is reused rail) set horizontally in ground.

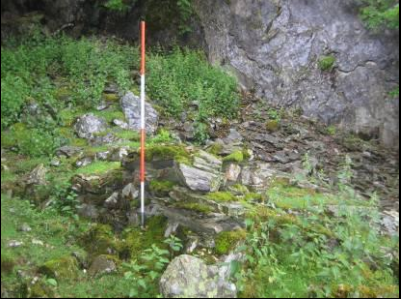
ID No	Type	NGR	Date	Source	Conditions Risks/Issues	Description	Image
2035	Structure	330550, 500681	19 th century	Site Survey	Moderate but in fragile condition.	Stone built flat topped ramp structure within highest section of Horse Crag Quarry.

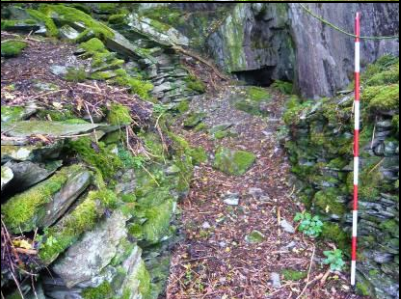
2037	Level /Closehead	330452, 500651	19 th century	Site Survey	Good /Moderate - Collapse into the cutting has partially blocked entrance but area seems stable now.	Open level in rock cutting. Charge holes visible around entrance

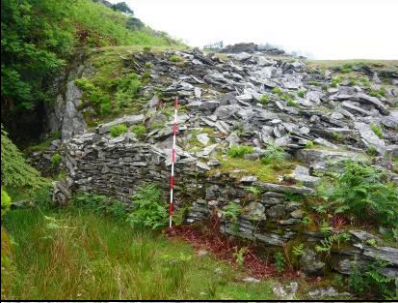
ID No	Type	NGR	Date	Source	Conditions Risks/Issues	Description	Image
2038	Closehead cutting	330475, 500662	19 th century	Site Survey	Small trees growing in fissures may cause problems in the future, also bracken undermining the stonework.	Cutting for level Entrance flanked by stone pack revetment walls.

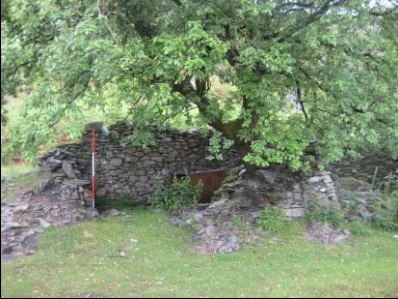
ID No	Type	NGR	Date	Source	Conditions Risks/Issues	Description	Image
2041	Building – smithy	330611, 500719	19 th century	Site Survey	Poor - Mature tree growing from hearth. Tree is undermining building but removal would cause more damage – record.	Two celled building, roofless, with entrances on east side. Possible raised hearth against south side of central dividing wall.

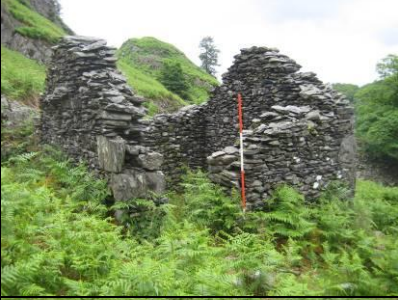
2042	Powder Magazine	330596, 500737	19 th century	Site Survey	Good - Roofless but otherwise complete and in good condition. Consolidation of wall-heads would help conservation.	On slope above track (2030) a square, gabled structure with single entrance; roofless. Small extension to the west.

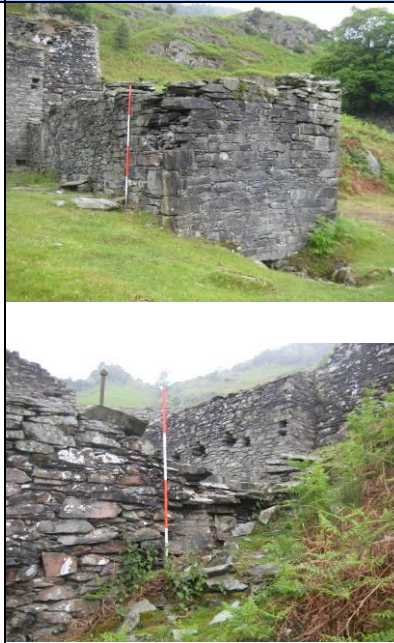
ID No	Type	NGR	Date	Source	Conditions Risks/Issues	Description	Image
2044	Wheel Pit	330648, 500725	19 th century	Site Survey Second/Third Edition OS	<p>Moderate – Needs stabilising. The structure is substantially complete but some of the coping stones are missing and this is letting water permeate the stonework. The stonework has partially collapsed at the NW and SE corners and there is a structural crack in the centre of the east face. According to CATMHS some of the coping stones have been damaged and thrown down during the last two or three years.</p> <p>The wheel pit is central to the site's interpretation. CATMHS members have indicated that this structure should be a priority for management and consolidation</p>	<p>Raised rectangular structure butting against holding pond (2045) to west and with recessed and lintelled outflow channel at east end. Some of the coping stones on the north and south sides retain massive iron bolts.</p>

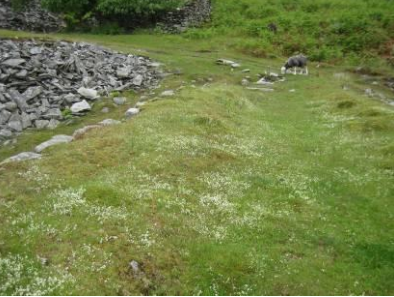
ID No	Type	NGR	Date	Source	Conditions Risks/Issues	Description	Image
2045	Holding Pond	330629, 500725	19 th century	Site Survey Second/Third Edition OS	<p>Moderate - North and south faces in good condition. East face partially collapsed – danger of stone facing/revetting falling into wheel pit below.</p> <p>Any consolidation here should be carried out in conjunction with the stabilisation of the wheel pit (2044).</p>	<p>Rectangular stone walled structure built against the slope to the west; butting against and raised above wheel pit (2044) to east. Surface is turfed with well preserved linear depression marking course of the former water channel.</p>

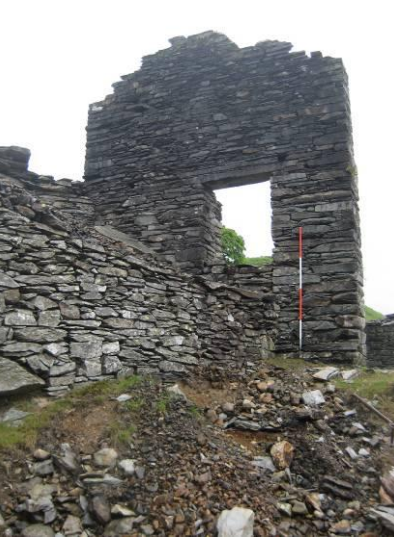
2046	Crushing House	330643, 500720.	19 th century	Site Survey Second/Third Edition OS	<p>Moderate condition and substantially complete. The structure would benefit from a structural assessment with particular attention being given to the wall head and door lintel of the south gable.</p> <p>The crusher house and wheel pit (2044) should be regarded as a single structural element in any future stabilization and interpretative project.</p>	<p>A three sided structure comprising two high retaining walls and incorporating the south wall of water wheel pit (2045). The west wall is a retaining wall built against the slope and overlaps the SW corner of waterwheel housing (2044). The south wall bonds with the west wall. The west end of the south wall is also built into the slope and at wall top level there is an entrance leading from the bank into the building. This entrance</p>

2046	Crushing House	330643, 500720.	19 th century	Moderate	Moderate condition and substantially complete. The structure would benefit from a structural assessment with particular attention being given to the wall head and door lintel of the south gable. The crusher house and wheel pit (2044) should be regarded as a single structural element in any future stabilization and interpretative project.	1
2032	Building	330636, 500667	19 th century	Moderate	Moderate - Window lintel cracked and stone work above slumping. Building has modern roof and is used as some form of temp. accommodation - chimney etc added to structure by recent occupants	1
2054	Copper spoil tip	330668, 500639	19 th century	Moderate	Moderate - Erosion gully on NE slope, probably from recent bike/motor bike activities. Monitoring suggested.	1
2042	Powder Magazine	330596,	19 th	Good	Good - Roofless but otherwise complete and in good condition. Consolidation of wall-	1

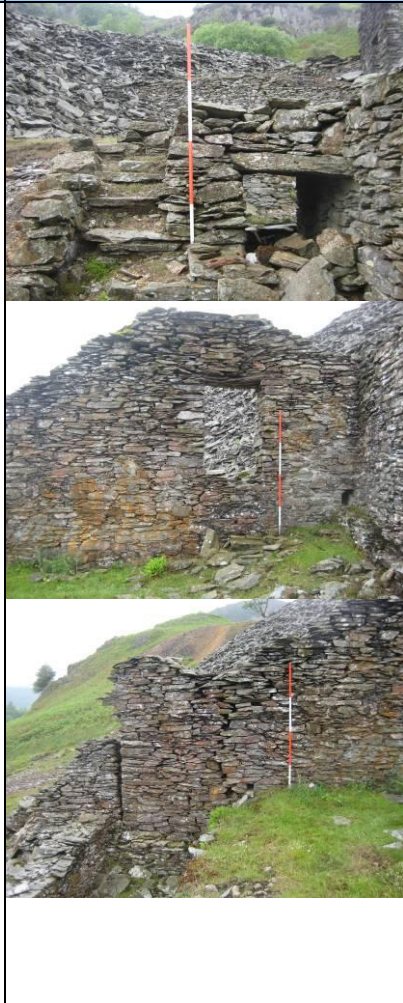
ID No	Type	NGR	Date	Source	Conditions Risks/Issues	Description	Image
2051	Dressing Mill	330667, 500722	19 th century	Site Survey Second/Third Edition OS	<p>Poor/Moderate - Against the SE corner are the remains of a second structure associated with a terraced wall (2049) running N-S parallel to and below the east wall of the main building. This structure is in poor condition (damaged door lintel, massive structural crack in South, unstable wall heads) and suffered considerable damage during the 2009 floods. A structural assessment is recommended as a matter of urgency.</p>	<p>Long rectangular structure terraced into the slope below the wheel pit and crusher house. The southern end is free-standing and gabled with a single window. Against the external face of the south wall is a culverted feature adjoining a flight of stone steps. The west side comprises two retaining walls separated by an area of collapse or, more likely, terracing; the southern end of the west wall survives to original wall height and incorporates two high level openings or hoppers. The east wall survives at foundation level only. The northern half of the building is divided by an internal N-S wall. Against the SE corner are the remains of a second structure associated with a terraced wall (2049) running N-S parallel to and below the east wall of the main</p>

2051	Dressing Mill	330667, 500722	19 th century	Poor	Poor/Moderate - Against the SE corner are the remains of a second structure associated with a terraced wall (2049) running N-S parallel to and below the east wall of the main building. This structure is in poor condition (damaged door lintel, massive structural crack in South, unstable wall heads) and suffered considerable damage during the 2009 floods. A structural assessment recommended as a matter of urgency.	1
2041	Building – smithy	330611, 500719	19 th century	Poor	Poor - Mature tree growing from hearth. Tree should be cut of at base and poisoned as long as felling can be safely achieved without causing any severe damage to the structure.	1
2061	Beck side wall	330742, 500749	19 th century	Poor	Poor - Cut by recent storm gullies in the area of the tailings ponds and wall core now exposed to erosion and further damage.	1
2062	Tailing tanks	330738,	19 th	Poor	Poor - Area cut by storm gullies. Severe risk of further erosion. There is a possibility of	1

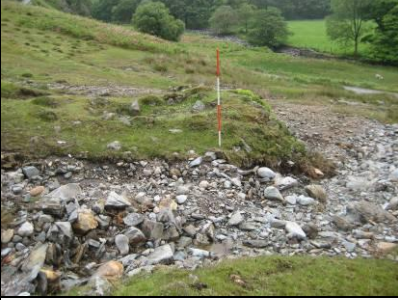
2053	Raised area drainage gully	330680, 500708	19 th century	Site Survey	Moderate condition. Damage to South side during recent flood and serious risk of damage or destruction from future flooding. Detailed recording recommended.	Rectangular mound, stone revetted to east, with rectangular central hollow. Associated with gully running to beck.

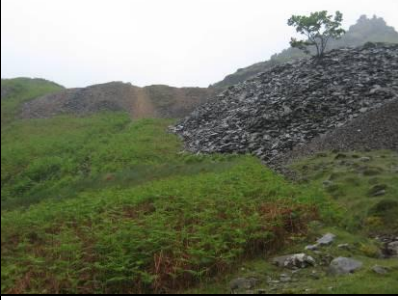
2054	Copper spoil tip	330668, 500639	19 th century	Site Survey Second/Third Edition OS	Moderate - Erosion gully on NE slope, probably from recent bike/motor bike activities. Monitoring suggested.	Copper tip at southern end of site. Flat topped. Overlain with slate waste to NW.

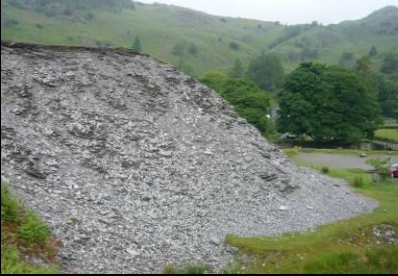
2060	Main Quarry rid tip	330588, 500979 330443, 500820	18 th century onwards	Site Survey	Good - Majority of the tip seems stable although the edges are slowly eroding. Only area of concern is the cracks along the edge above the car park. Spoil may also be a health and safety risk but no more than natural scree.	Slate spoil tip which extends for approx 250m along the north facing ridge above Tilberthwaite Gill evidence. Shows numerous episodes of dumping as well as several phases of pack wall revetment. Flat topped tip with top being occupied with buildings and phases of later dump.

ID No	Type	NGR	Date	Condition	Risks/Issues	Priority
		500737	century		heads would help conservation.	
2060	Main Quarry rid tip	330588, 500979 330443, 500820	18th century onwards	Good	Good - Majority of the tip seems stable although the edges are slowly eroding. Only area of concern is the cracks along the edge above the car park. Spoil may also be a health and safety risk but no more than natural scree.	1
2053	Raised area drainage gully	330680, 500708	19 th century	Moderate	Damage to South side during recent flood and serious risk of damage or destruction from future flooding. Detailed recording recommended.	1
2031	Building, Smithy or workshop?	330479, 500637	19 th century	Moderate	Building seems stable but bracken is an issue and could undermine structure gradually.	1
2006	Slate Closehead	330590, 500910	19th Century	Good	Potential issue with large sycamore (trunk 30cm in diameter) growing through rock just above the head entrance could threaten long term maintenance. Tree should be cut back and poisoned but could be a problem in terms of ecology, although outside any designated area.	2

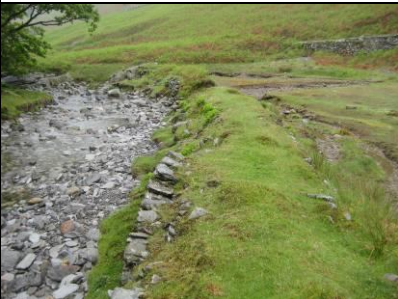
2061	Beck side wall	330742, 500749 330745, 500707.	19 th century	Site Survey	Poor - Cut by recent storm gullies in the area of the tailings ponds and wall core now exposed to erosion and further damage.	Earth core wall running parallel with west bank of Yewdale Beck, stone revetted on beck side. Runs N-S and intersected by a turfed wall running west to form a right angle. Marks the extent of the tailings area.

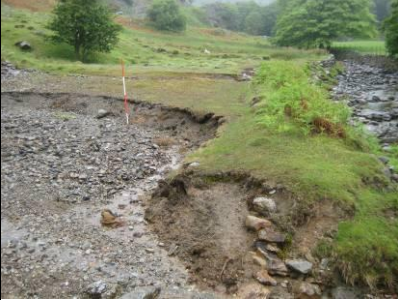
ID No	Type	NGR	Date	Source	Conditions Risks/Issues	Description	Image
2062	Tailing tanks	330738, 500719	19 th century	Site Survey	Poor - Area cut by storm gullies. Severe risk of further erosion. There is a possibility of heavy metal pollution if tailings material is carried down Yewdale Beck in future flood episodes. Chemical sampling and assessment may be required.	Below road, and west of Yewdale Beck, a flat, low lying area. Storm gullies cutting across the site have exposed multi-layered clay and sand deposits (settling and tailing deposits from the copper mill).

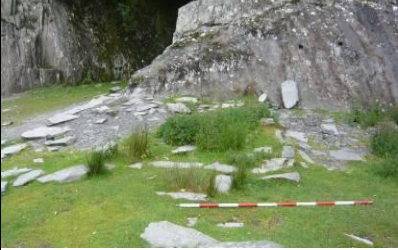
2064	Quarry Building	330517, 500829	19 th century	Site Survey	Moderate - Survives only as wall footings. Seems stable enough, although slowly deteriorating.	Building located on upper terrace of quarry. Measures approx 6 x 6m square and associated with a small yard area to the NE. Two sockets in the rock face would indicate some form of wooden structure, maybe a lifting derrick. Probably a riving shed for

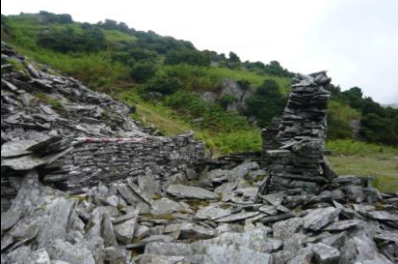
2072	Horse Crag Quarry Building	330465, 500508	19 th Century	Site Survey Third Edition Os	Very Poor Condition. The slate roof has collapsed in and undermined the gable wall making it lean alarmingly. The debris from surround ridd tip is also slipping into the interior and damaging what remains of the walls. Needs immediate attention.	Rectangular building measuring approx. 5m NW-SE and 4m wide. Gable currently stands 2.5m high but in danger of collapse. A number of hand driven shot holed found in the stonework across the building. Riving shed?

ID No	Type	NGR	Date	Condition	Risks/Issues	Priority
2072	Old Quarry Building	330465, 500508	19 th Century	Poor	Very Poor Condition. The slate roof has collapsed in and undermined the gable wall making it lean alarmingly. The debris from surround rid tip is also slipping into the interior and damaging what remains of the walls. Needs immediate attention.	1
2018	Closehead	330479, 500760	19 th Century	Poor	Timber lintel needs attention and there is a risk from imminent collapse and in-filling.	1
2050	Sunken Chamber	330658, 500712	19 th century	Moderate	Some risk of future flood damage with water running down slope from retaining walls (2047).	1
2047	Retaining walls south of Crushing House	330647, 500712	19 th century	Moderate	Risk of future flooding undercutting the base of the walls.	1
2022	Building – Riving sheds?	330463, 500673	19 th Century?	Good	Remarkably well preserved by deteriorating and needs stabilisation and consolidation.	1

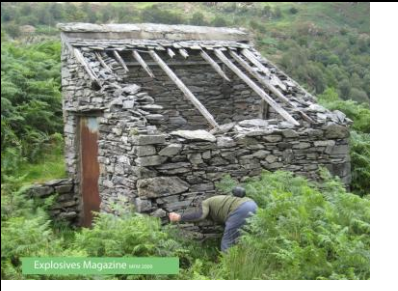
2073	Gunpowder store	33068 50058	19 th century	Ian Matheson pers comm	Poor condition, but surprisingly complete apart from much of its roof, and has a wooden door and part of the original wooden lining. Repair to the roof would protect the building and its fabric	Horse Crag powder house is located behind a mound and out of site of the rest of the mill, presumably due to its potentially explosive nature.
