APPENDIX 1 - GAZETTEER CONISTON

Conservation Management Plan – Coniston Copper Mine, Cumbria – Appendix 1: Site Gazetteer

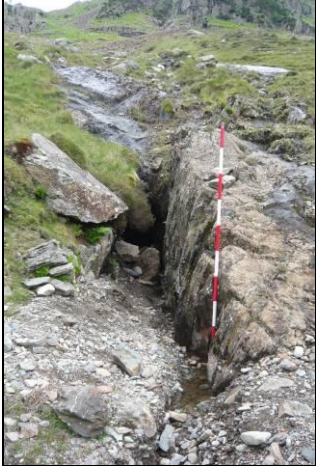
| ID No | Type | NGR | Date | Source | Conditions Risks/Issues | Description | Image |
|---|---|---|---|---|--|--|---|
| 1000 | Cobblers Level | 328815, 498955 | 17th Century | Site Survey First Edition OS RCHME Survey Holland 1981/89 | Good/Stable Some backfill debris but seems stable. Small bush growing on one side of entrance, not currently a problem but should be monitored. | A 17th century adit constructed to drain the Low-Work. This is recorded to be the first hand-driven tunnel at Coniston, taking 3 years to complete. It is a good example of a classic 'Coffin Level' and is easily accessible for visitors. The left-hand branch was driven steeply up to connect the bottom of the working stopes. The tunnel was probably widened at the base in the 18th century. | |

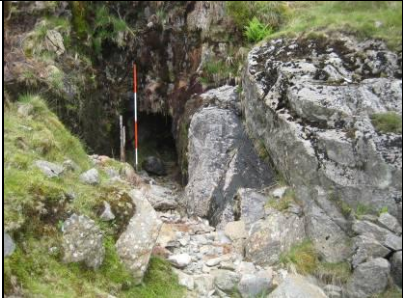
| ID No | Type | NGR | Date | Source | Conditions Risks/Issues | Description | Image |
|---|---|---|---|---|--|--|---|
| 1001 | Taylor's Level | 328782, 498951 | 19th century | Site Survey First Edition OS RCHME Survey Holland 1981/89 | Good Entrance partially covered by hill-wash and this is a problem given the proximity of the site to the beck | 19th century level, also featured a slate closehead (1910), which might account for some of the external features (Holland 1981, 55). Driven c. 1830. | |

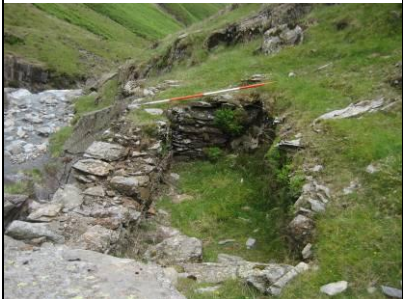
| ID No | Type | NGR | Date | Source | Conditions Risks/Issues | Description | Image |
|---|---|---|---|---|--|--|---|
| 1002 | Structures associated with Taylor's Level | 328798, 498941 | 19th century | Site Survey RCHME Survey Holland 1981/89 | Good | Revetment walling and structures on the west bank of Red Dell, associated with Taylor's Level. A rectangular structure described by Holland as the clearance pit for a water wheel located on the stream bed. (Holland 1981, 56). This would have been used to pump out the level. It might also be part of a | |

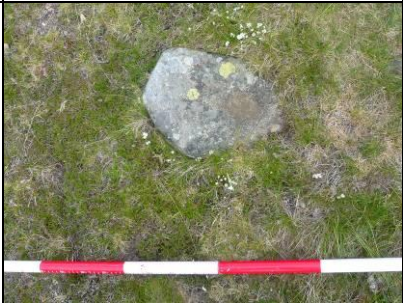
| ID No | Type | NGR | Date | Source | Conditions Risks/Issues | Description | Image |
|---|---|---|---|---|---|---|--|
| 1003 | Mortar Stone nr. Low Work | 328861, 498988 | 17th Century? | Site Survey | Good Stable but could easily be lost. | Mortar stone located just down slope from Low Work. Probably Elizabethan in date but could be earlier. Use to crush ore by hand. | |

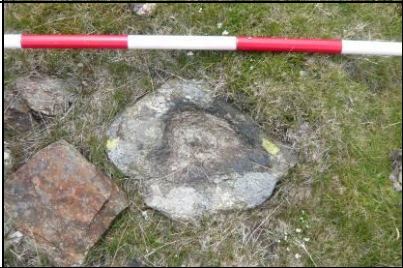
| ID No | Type | NGR | Date | Source | Conditions Risks/Issues | Description | Image |
|---|---|---|---|---|---|---|--|
| 1004 | Mortar Stone nr. Low Work | 328867, 498991 | 17th Century? | Site Survey | Good Stable but could easily be lost. | Mortar stone located just down slope from Low-Work. Probably Elizabethan in date but could be earlier. Use to crush ore by hand. | |

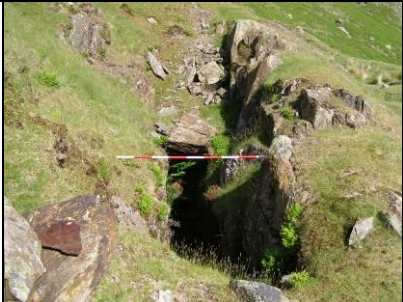
| ID No | Type | NGR | Date | Source | Conditions Risks/Issues | Description | Image |
|---|---|---|---|---|---|---|--|
| 1005 | Remains of Low Work | 328850, 499026 | 17th century | Site Survey First Edition OS RCHME Survey Holland 1981/89 | Good/Stable Working have been partially backfilled by later mining but are presently stable and show little signs of any subsequent erosion. | Remains of part of the working stopes associated with the Elizabethan Low- Works. Partially backfilled by later works at Bonsor East and Old Engine, but parts of works, following the vein, are still clearly visible. | |

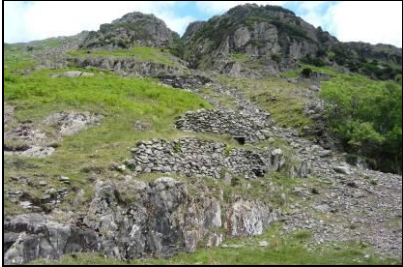
| ID No | Type | NGR | Date | Source | Conditions Risks/Issues | Description | Image |
|---|---|---|---|---|---|---|--|
| 1006 | Revetment Wall above Old Engine Shaft | 328862, 499057 | 19th century (& earlier) | Site Survey RCHME Survey | Moderate Structures continue to hold back wash but hillside is still eroding in places and the continued pressure on these structures means they are | Series of walls arranged along the hillside above Old Engine shaft and the remains of Low-Works. These are probably 19th century in date and erected to prevent hill wash falling into the structures below. However, some | |

| ID No | Type | NGR | Date | Source | Conditions Risks/Issues | Description | Image |
|---|---|---|---|--|--|---|--|
| | | | | | susceptible to deterioration and need to be regularly monitored. Collapse could threaten remains of Old Engine Wheel Pit below, and block Low Works | of the structures may be earlier in date, possibly 17th century, as there would have been a need to protect the open stopes of Low-Work from hillwash during this period. | |

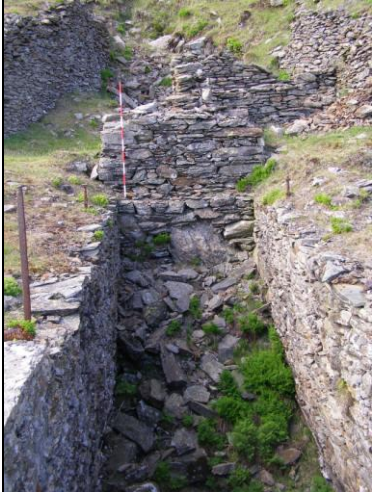
| ID No | Type | NGR | Date | Source | Conditions Risks/Issues | Description | Image |
|---|---|---|---|--|--|---|--|
| 1007 | Bonsor East Wheel | 328923, 498989 | 18th Century | Site Survey RCHME Survey Holland 1981 | A well preserved group comprising wheel pit, launder pillar and associated building (office/store?) Retaining walls east and south east of wheel pit have collapsed in places and there is a structural bulge in the east wall of the wheel pit. Monitoring recommended. | Wheel erected by Charles Roe of the Macclesfield Copper Company in the mid 18th century to pump out Bonsor East shaft (1055). A new, larger wheel was installed in 1830 which both pumped the mine and raised the ore. | |

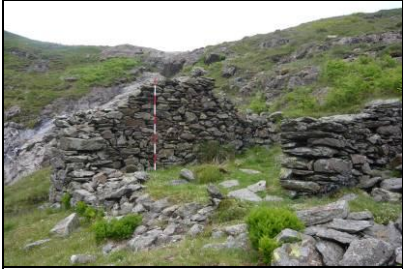
| ID No | Type | NGR | Date | Source | Conditions Risks/Issues | Description | Image |
|---|---|---|---|---|---|---|---|
| 1012 | Building | 328805, 498989 | 17th Century? | Site Survey RCHME | Moderate – seems stable but gradual deterioration although no immediate threat. | Two celled stone building orientated E-W. Western gable preserved. Two celled structure – southern side surviving only as footings. Date of building (and adjacent 2013) unknown but could potentially be 17th century and associated with nearby dressing floors and Low Works. | |

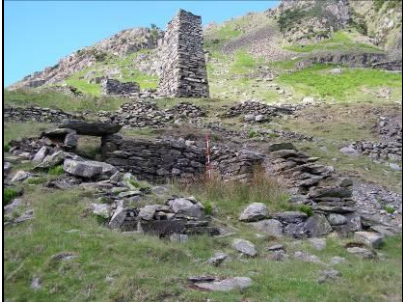
| ID No | Type | NGR | Date | Source | Conditions Risks/Issues | Description | Image |
|---|---|---|---|---|---|---|---|
| 1013 | Building | 328808, 499022 | 17th Century | Site Survey RCHME | Moderate – seems stable but gradual deterioration although no immediate threat. | Building with rear wall blocked by later 18th century spoil indicating structure could be 17th Century. Square in shape with at least two entrances. The northern entrance retains a massive stone lintel. Stub wall extension to the west. The absence of dressing waste in or close to this building and to 1012 suggests a domestic rather than | |

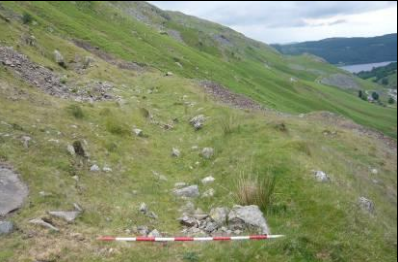
| ID No | Type | NGR | Date | Source | Conditions Risks/Issues | Description | Image |
|---|---|---|---|---|---|---|---|
| 1014 | Bonsor East Leat | 328914, 499001 | 18th Century | Site Survey RCHME | Moderate – stable, some gradual erosion but not at immediate risk. Leat grassed over and dry. | Leat supplying Bonsor East Wheel, measures 2m wide and some evidence of stone lining in places. Western end concealed by later spoil but may have once served as an overflow for the Old Engine Shaft Wheel. | |

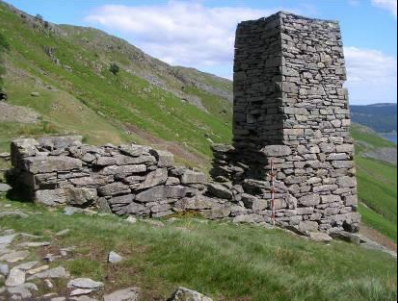
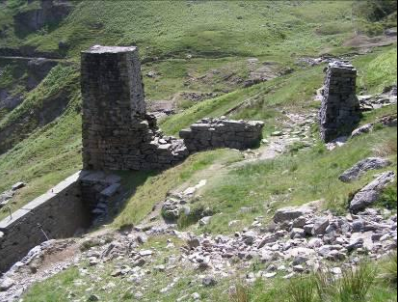
| ID No | Type | NGR | Date | Source | Conditions Risks/Issues | Description | Image |
|---|---|---|---|---|---|---|---|
| 1015 | Old Engine Shaft Wheel | 328820, 499048 | 19th century | Site Survey RCHME | Moderate. The revetment wall at the end of the tailrace has partially collapsed and there is a threat of erosion. The first launder pillar is stable, and the second has collapsed. The third launder pillar is the principal site feature and its top was concrete capped by CATMHS in the 1980s and was then the subject of a further, major consolidation programme arranged by the LDNPA with English Heritage funding. It has lost a considerable amount of facing stone on its north eastern face and appears to be listing slightly. | Installed in 1830, and altered in 1850, and again in 1870. Remains of include wheel pit and stone tower for wooden launders supplying water to the overshot wheel. Leat provided water from Red Dell coming in from the north and running out via a tailrace to the south. Wheel used for both pumping the works and raising ore. | |

| ID No | Type | NGR | Date | Source | Conditions Risks/Issues | Description | Image |
|---|---|---|---|---|---|--|--|
| | | | | | Its overall stability is further compromised by a timber or machinery slot which passes through and weakens the fabric on the south western face. The wheel pit is in good condition but some of the coping stones are displaced. Given the comparatively good survival of this important feature and its dominant landscape position a full structural survey and assessment is suggested. | | |

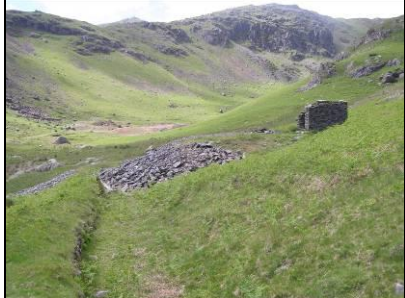
| ID No | Type | NGR | Date | Source | Conditions Risks/Issues | Description | Image |
|---|---|---|---|---|---|--|--|
| 1016 | Leat for Old Engine Shaft Wheel | 328676, 499122, 328813, 499064 | 19th Century | Site Survey RCHME | Good. Stable stone revetting and grassed surface. Low level threat of further erosion where leat crosses Red Dell Beck. | Leat supplying overshot wheel. Leat partially blocked by rid from Lad Stones End slate quarry which was driven in 1910, indicating wheel was probably out of commission by this date. | |

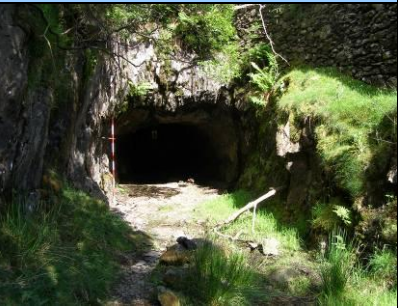
| ID No | Type | NGR | Date | Source | Conditions Risks/Issues | Description | Image |
|---|---|---|---|---|---|--|--|
| 1017 | Old Engine Shaft Level | 328890, 499054 | 19th century | Site Survey RCHME | Good. Level cut in competent rock and far end securely fenced to allow visitors safe view of shaft top. Longer term threat of further land slip in cutting to northwest of level | Entrance to the Old Engine Level shaft which is 518m ft deep. The shaft was also used for haulage and pumping up to the deep level, superseding the smaller East Bonsor Shaft. Associated with Old Engine shaft wheel (1015) and | |

| ID No | Type | NGR | Date | Source | Conditions Risks/Issues | Description | Image |
|---|---|---|---|---|---|--|---|
| | | | | | entrance. | a wooden trough for housing pump rods or guide wheel is visible in entrance. Iron brackets which once carried a drainage pipe are also visible along the walls of the entrance. The shaft itself is fenced off but the iron sheave wheel, used in winding, is still clearly visible (recently restored by CATHMs). Shaft also features a balance bob plate. Overall depth of drop to base is 425m. | |

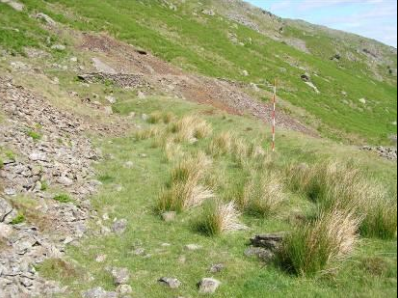
| ID No | Type | NGR | Date | Source | Conditions Risks/Issues | Description | Image |
|---|---|---|---|---|---|--|---|
| 1018 | Bonsor East Wheel Holding Pond | 328896, 499005 | 18th century | Site Survey RCHME | Part of northern section of retaining wall above wheel pit has collapsed. Danger of erosion and further collapse. Monitoring recommended. | Holding pond associated with leat (2014) and East Bonsor Wheel (1007). | |

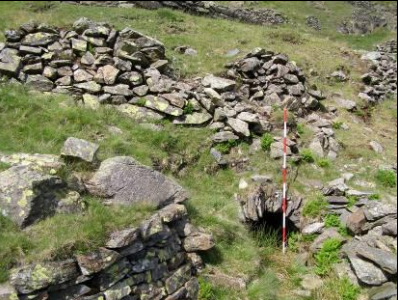
| ID No | Type | NGR | Date | Source | Conditions Risks/Issues | Description | Image |
|---|---|---|---|---|---|--|---|
| 1019 | Old Engine Shaft Wheel Tailrace | 328767, 499035 328818, 499040 | 19th century | Site Survey RCHME | Good condition | Tailrace associated with Old Engine Shaft Wheel | |

| ID No | Type | NGR | Date | Condition | Conditions Risks/Issues |
|---|---|--|---|---|--|
| 1019 | Old Engine Shaft Wheel Tailrace | 328767, 499035 328818, 499040 | 19th century | Good | Good condition |

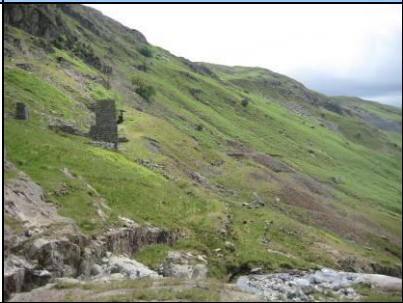
| ID No | Type | NGR | Date | Source | Conditions Risks/Issues | Description | Image |
|---|---|--|---|---|---|---|--|
| 1020 | Channel where tailrace crosses beck | 328764, 499034 | 19th Century | Site Survey RCHME Survey First Edition OS | Good – some silting but movement of water keeps channel relatively clear. Gradual erosion of the iron work, but slow deterioration. | Rock cut channel across beck for carrying water from Old Engine Wheel around to Paddy End Mill. Evidence of socket holes and iron fittings indicating maybe some form of wooden trough carrying the water. | |

| ID No | Type | NGR | Date | Condition | Conditions Risks/Issues |
|---|---|--|---|---|--|
| 1020 | Channel where tailrace crosses beck | 328764, 499034 | 19th Century | Good | Some silting but movement of water keeps channel relatively clear. Gradual erosion of the iron work, but slow deterioration. |

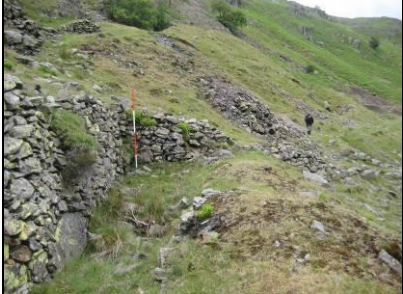
| ID No | Type | NGR | Date | Source | Conditions Risks/Issues | Description | Image |
|---|---|--|---|---|---|---|--|
| 1021 | East Bonsor Wheel Tailrace | 328925, 498980 328934, 498931 | 18th Century | Site Survey RCHME Survey First Edition OS | Poor. Retaining wall above tail race has collapsed in places and the channel is partly concealed with tumbled stone. Monitor condition. | Partially revetted channel leading south east down slope from East Bonsor wheelpit. | |

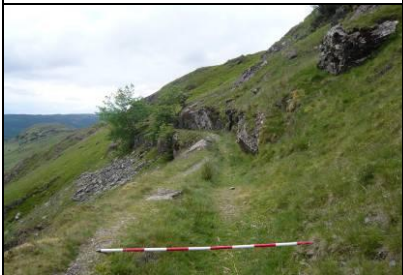
| ID No | Type | NGR | Date | Source | Conditions Risks/Issues | Description | Image |
|---|---|--|---|---|---|---|--|
| 1022 | Paddy End Leat | 328660, 498752 328735, 499046. 328629, 498735 328417 498817 | 19th century | Site Survey RCHME Survey First Edition OS | Good, some areas disturbed by vegetation but course of feature remains largely evident and well preserved. | Leat running from red Dell beck to the Paddy End Mill. Feature measures approx. 1.5m wide and is cut through rock face in some areas. Leat later re-used in the early 20th century by the French to provide water to the power house. Leat runs underground for a section (328643, 498742), there is also evidence of it water being carried on a wooden trough around rock outcrops – some wooden planks remain in-situ. | |

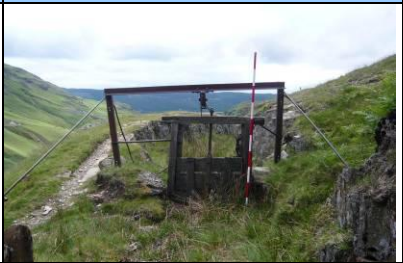
| ID No | Type | NGR | Date | Source | Conditions Risks/Issues | Description | Image |
|---|---|---|--|---|--|---|---|
| 1023 | Wooden sluice gate | 328774, 498844 | 20th century | Site Survey RCHME Survey | Good but at risk from deterioration | Sluice and wooden sluice gate associated with the early 20th century re-use of the Paddy End leat. | |

| ID No | Type | NGR | Date | Condition | Conditions Risks/Issues |
|---|---|---|---|---|---|
| 1023 | Wooden sluice gate | 328774, 498844 | 20th century | Good | Good but at risk from deterioration |

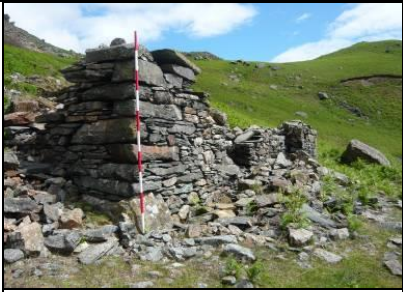
| ID No | Type | NGR | Date | Source | Conditions Risks/Issues | Description | Image |
|---|---|---|---|--|---|--|---|
| 1026 | Paddy End Offices | 328424, 498834 | 19th century | Site Survey RCHME Survey First Edition OS | Poor – building damaged when UU Water main burst. Interior full of debris. Much of the rear (north) side of the building has been damaged but the front (south) still stands up to 2m high. | Office shown on RCHME survey as comprising a central bay with small offshot to the north but form is less distinct following collapse. Building entered from the south. Overlooks the Paddy End Dressing Floors. | |

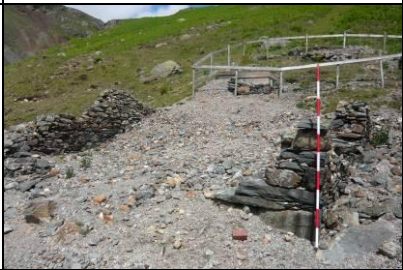
| ID No | Type | NGR | Date | Source | Conditions Risks/Issues | Description | Image |
|---|---|---|---|--|---|--|---|
| 1027 | Paddy End Smithy | 328390, 498836 | 19th century | Site Survey RCHME Survey First Edition OS | Very Poor – building largely destroyed when water pipe burst. | Shown as a rectangular building on the RCHME survey, with an entrance on the southern side. Today, only the two side walls survive, both long walls being destroyed. The interior is full of loose stone debris. | |

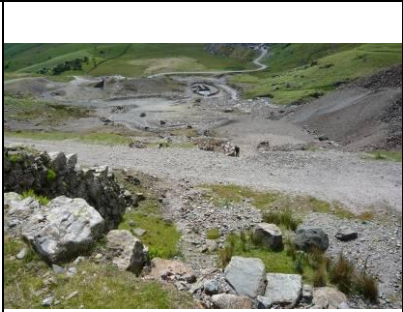
| ID No | Type | NGR | Date | Source | Conditions Risks/Issues | Description | Image |
|---|---|---|---|--|---|--|---|
| 1028 | Paddy End Dressing Floor | 328405, 498754 | 19th century | Site Survey RCHME Survey First Edition OS Oxford Archaeology North survey | Poor – Moderate – area recently damaged by the burst UU pipe which cut a swathe through a large section of the area. Little direct damage from recent flooding except regarding spoil tips on eastern edge. | A good example, albeit much damaged, of a mid 19th century mill complex with a series of integrated processing floors terraced into the hillside. | |

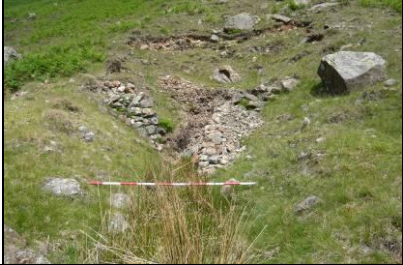
| ID No | Type | NGR | Date | Source | Conditions Risks/Issues | Description | Image |
|---|---|---|---|---|--|--|--|
| 1030 | Trial Level | 328369, 498850 | 19th Century | Site Survey RCHME Survey | Moderate – some erosion along the break of slope and possible damage from burst main and some sheep scrapes | Trail level with some pack wall revetment and associated spoil tip but level does not appear to have progressed very far before being abandoned. | |

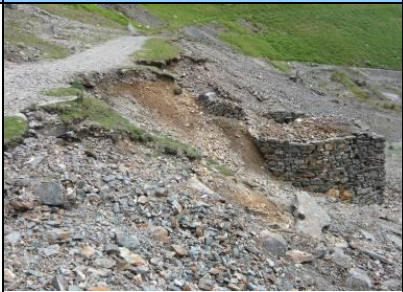
| ID No | Type | NGR | Date | Source | Conditions Risks/Issues | Description | Image |
|---|---|--|---|---|--|---|--|
| 1032 | Paddy End Mill | 328381, 498821 | 19th Century | Site Survey RCHME Survey First Edition OS | Moderate/Poor. - Flood and erosion gullies have damaged some of the stone structures and exposed sections of wooden launders. Suggest assessment (including 1028) to determine extent of recent damage using OAU survey as a base line. The OAU survey was carried out prior to conservation work by the LDNPA with funding from United Utilities following the burst water main. Consolidation of track and related drainage might help to control further deterioration. | Group of structures immediately south of track associated with primary ore sorting and crushing. Forms the first stage in the dressing process (integrated with 1028) | |

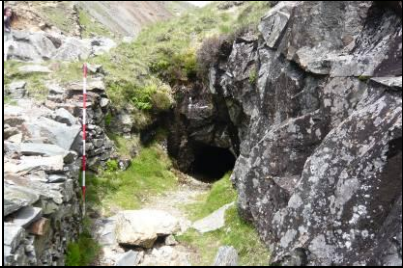
| ID No | Type | NGR | Date | Source | Conditions Risks/Issues | Description | Image |
|---|---|--|---|---|--|---|--|
| 1033 | Hospital Level | 328296, 498857 | 19th Century | Site Survey RCHME Survey First Edition OS | Good/Stable, some backfill but this is old. Also some large stones recently brought down from above. | Rock cut level set close behind incline. | |

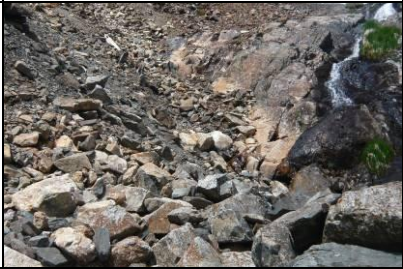
| ID No | Type | NGR | Date | Source | Conditions Risks/Issues | Description | Image |
|---|---|---|---|--|---|--|--|
| 1038 | Hospital Shaft | 328218, 498940 | 19th Century | Site Survey RCHME Survey | Entrance almost completely lost under spoil slippage, only a fragment of wooden lintel seen above ground | Entrance to Hospital Shaft. | |

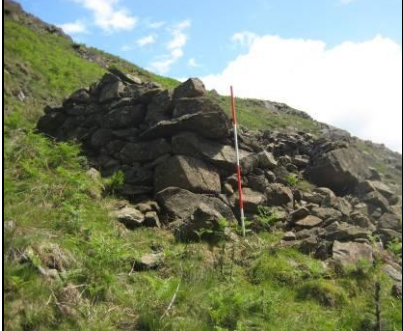
| ID No | Type | NGR | Date | Source | Conditions Risks/Issues | Description | Image |
|---|---|---|---|--|---|--|--|
| 1039 | Pylon base | 328255, 498918 | 19th Century (1878) | Site Survey RCHME Survey Holland 1981 + 1986 | Moderate. Substantially intact but location on steep slope poses threat to long term stability. | Square stone platform, a possible pylon base associated with a wire rope haulage system. | |

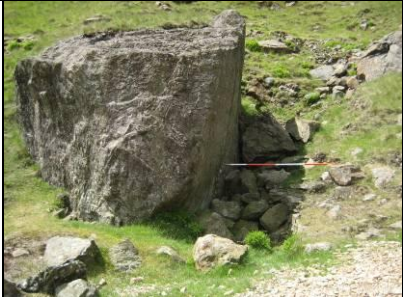
| ID No | Type | NGR | Date | Source | Conditions Risks/Issues | Description | Image |
|---|---|---|---|---|---|--|--|
| 1042 | Grey Crag Level | 328286, 498842 | 19th Century | Site Survey RCHME Survey | Poor. Entrance collapsed. | Principal low level adit for the Paddy End mill until an internal connection - Hospital Shaft – was made with Deep Level. | |

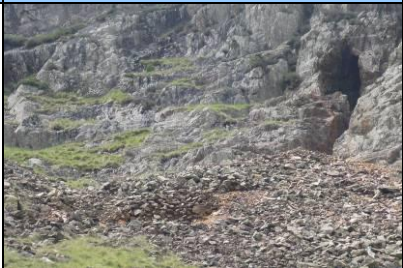
| ID No | Type | NGR | Date | Source | Conditions Risks/Issues | Description | Image |
|---|---|---|---|---|--|---|--|
| 1044 | Sebastian Level | 328110, 498988 | 17th century | Site Survey Fleming pers. com | Buried by later spoil but just visible on the surface | Probable location of Sebastian level, known to have been sunk in 1617 to provide drainage to the numerous working in operation at Simon's Nick (Leverwater). | |

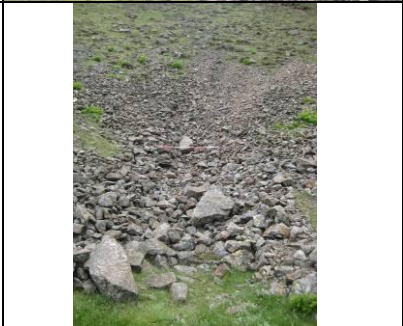
| ID No | Type | NGR | Date | Source | Conditions Risks/Issues | Description | Image |
|---|---|---|---|---|--|---|--|
| 1045 | Top Level | 328159, 498971 | 19th Century | Site Survey RCHME Survey | Level entrance buried under scree and spoil. | Driven to work the veins under the Back Strings (1050). When first worked ore was taken down slope from the level entrance to the head of the incline at Middle Level. | |

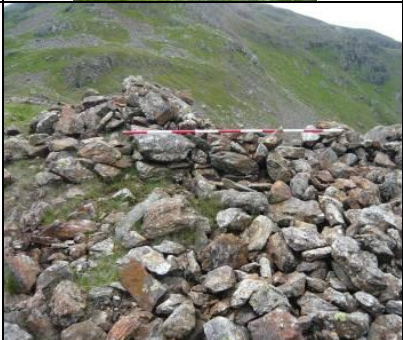
| ID No | Type | NGR | Date | Source | Conditions Risks/Issues | Description | Image |
|---|---|---|---|---|--|---|--|
| 1046 | Structure | 328047, 499049 | 17th Century | Site Survey RCHME Survey | Stable – some risk to the mortar stones being lost or obscured | Rectangular structure built of rough hewn stones, orientated SW to NW, the north wall formed of natural bedrock. Survives only a couple of courses high. Two mortar stones incorporated into build and at least 2 more located close by. Appears to be hut for dressing ore. | |

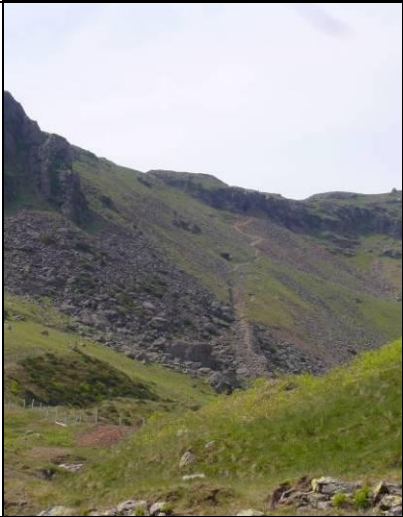
| ID No | Type | NGR | Date | Source | Conditions Risks/Issues | Description | Image |
|---|--|---|---|--|---|--|---|
| 1059 | Thriddle Incline | 328655, 499088 328602, 499105 | 19th century | Site Survey RCHME Survey | Poor – Moderate, section of the incline are well preserved but other areas are in a poor state of preservation, particularly near the base. The main problem is the integrity of the outer walls, once these fail then the rubble core will disintegrated into scree. Decline aggravated by foot fall of hikers using the route to access the ridge | Constructed to support a set of rollers which carried pumping rods from New Engine Wheel to the Bouncy mine level which in turn served to pump the horizons of the Flemings, Taylor and Deep levels. Constructed of stone, with a rubble core in-fill. | |

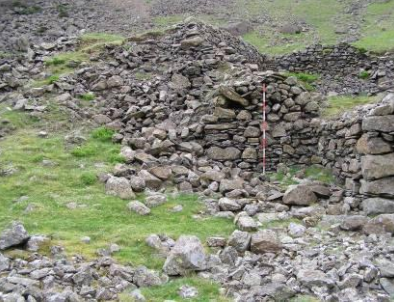
| ID No | Type | NGR | Date | Source | Conditions Risks/Issues | Description | Image |
|---|---|---|---|--|--|--|---|
| 1061 | Red Dell Mill | 328556, 499186 | | Site Survey RCHME Survey Holland 1981 Fleming 2007 | Good – moderate. East face of water wheel housing has collapsed but now appears to be in a stable condition. No obvious threat but monitoring recommended. | <p>Holland argues that this a 17th century stamp mill, or possibly the 18th century when it is known from documentary sources that Charles Roe had a mill at the mines. However the holding pond of the present structure appears to overlay the entrance to Fleming Level, known to date to have been driven in 1820. Therefore part of the mill must post-date this. There is also evidence of shot holes on the masonry which would indicate a post 1694 date. Further, the German workings at this time were lower down the valley so they would not carry heavy ore uphill to process it. Based on this evidence it would seem more likely that the mill was constructed by Taylor sometime in the 1830s</p> <p>Nothing survives of the wheel pit suggesting that the wheel would have been a free-standing structure constructed of wood and fed by wooden flumes mounted on stilts. However the remains of a masonry feed channel and lined holding pond can still be seen but these could date</p> | |

| ID No | Type | NGR | Date | Condition | Conditions Risks/Issues |
|---|---|--|---|---|---|
| 1061 | Red Dell Mill | 328556, 499186 | Various? | Good | Good – moderate. East face of water wheel housing has collapsed but now appears to be in a stable condition. No obvious threat but monitoring recommended. |

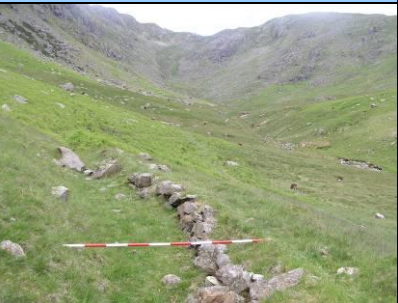
| ID No | Type | NGR | Date | Source | Conditions Risks/Issues | Description | Image |
|---|--|---|---|---|---|--|--|
| | | | | | at Red Dell Beck possibly at risk from flood damage. | (1063) acting as both tailrace and leat for New Engine Shaft Wheel. Replaced in the 19th century by race from Levers Water. | |

| ID No | Type | NGR | Date | Condition | Conditions Risks/Issues |
|---|---|--|---|---|---|
| 1065 | Red Dell Mill leat | 328572, 499341 328542, 499204 | 18th Century? | Good | Open channel, generally intact. Some loss of embankment where leat crosses boggy ground. Remains of low, boulder dam at Red Dell Beck possibly at risk from flood damage. |

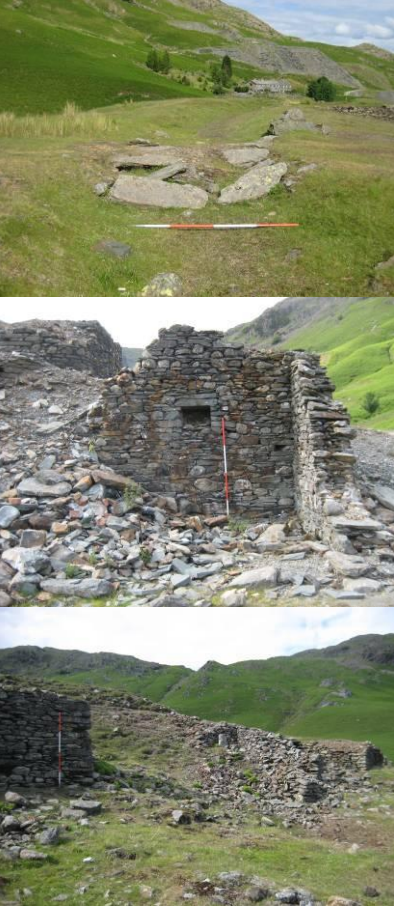
| ID No | Type | NGR | Date | Source | Conditions Risks/Issues | Description | Image |
|---|---|---|---|--|---|---|--|
| 1070 | Bonsor Low Mill & Dressing Floors | 329061, 498459 | 19th Century | Site Survey RCHME Survey Holland 1981 | <p>Moderate. Many of the retaining walls and associated features have collapsed or suffered some degree of damage but most now appear to be in a stable condition. The earthwork remains of the jigging, buddling and settling areas are also stable. The main threat to the latter is from vehicle damage and to a lesser extent from flooding. Anecdotal evidence suggests that the large spoil tip south west of the mill is occasionally used as a source of aggregate/hard core. The Low Mill sites cover a comparatively large area with good potential survival of below ground archaeology associated with the final parts of the ore dressing process. It is also the least understood section of the Coniston copper mines complex. Detailed survey and interpretation is</p> | <p>Final phase of processing the ore onsite. A complex of leats, water wheel housings, retaining walls and earthworks associated with concentrating copper ore (jigging, buddling and settling). The dressing floors were laid out by John Barratt in the 1820s, possibly on the site of an earlier mill. Some of the buildings were reused in the 1890s by Warsop's copper smelter .</p> | |

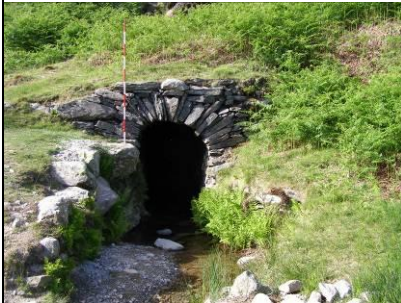
| ID No | Type | NGR | Date | Source | Conditions Risks/Issues | Description | Image |
|---|---|---|---|---|---|--|--|
| 1071 | Deep Level | 329061 498459 | 19th Century (1825) | Site Survey RCHME Survey | Good. Arched stone entrance in fair condition. Recent flooding has created two large erosion gullies on the slope above and to either side of the level which could lead to further land slips. Deep Level still drains the mine and blockage of the entrance could lead to a potentially dangerous backup of mine water. The erosion gullies should be monitored, perhaps with advice from a mining engineer regarding the consequences if the level became blocked. | Level started in 1825. Once complete, nearly all of the ore from the mine was transported via deep level using horse drawn wagons. | |

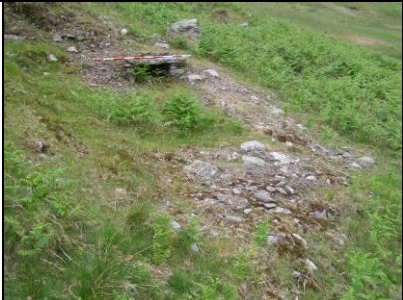
| ID No | Type | NGR | Date | Source | Conditions Risks/Issues | Description | Image |
|---|---|---|---|--|---|--|--|
| 1076 | Building (blacksmith's shop?) | 328645, 499077 | 18 th /19 th century | Site Survey RCHME Survey (building 104) | Moderate. Foundations only. | Rectangular building 4.4m x 3.5m, reduced to foundations, with entrance in south east corner. Quantities of cinders suggest use as blacksmith's shop. | |

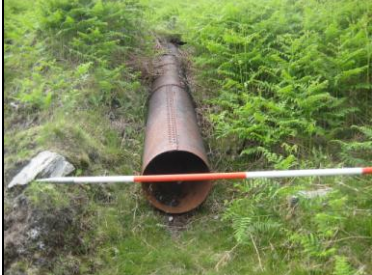
| ID No | Type | NGR | Date | Source | Conditions Risks/Issues | Description | Image |
|---|---|--|---|---|--|---|---|
| 1081 | Pelton Wheel pipeline | 328809, 498813 328917, 498736 | 19 th century | Site Survey Holland 1981 | Moderate, vestiges of the wheel still remain as do structures relating to the pipeline | Pelton wheel fed by a pipeline from Lever Water. Erected in the 1880s to power the Bonsor Saw Mill. | |
