LOW BONSOR DRESSING MILL

ARCHAEOLOGICAL
COMMUNITY LANDSCAPE
AND BUILDING SURVEY

LOW BONSOR DRESSING MILL,
CONISTON, CUMBRIA

NAA 18/03
February 2018

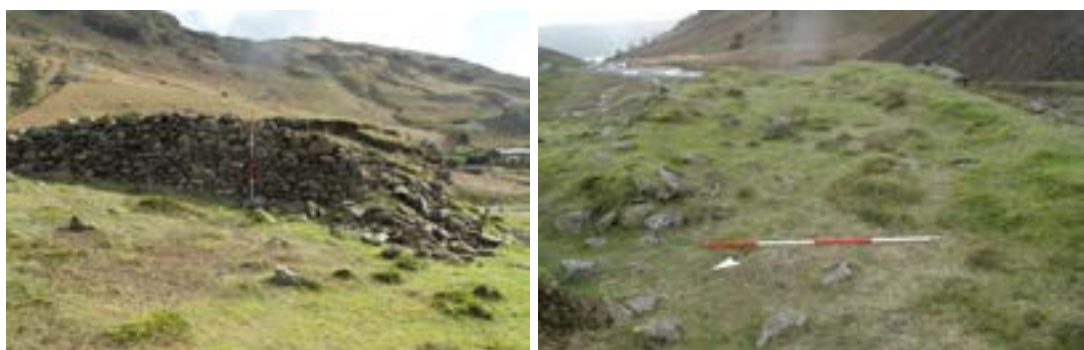
Plates 24 & 25: launder associated with Stamping mill 2; retaining wall 223 (left) and grassed over top of feature (right).

- 6.19 The south end of the pier (wall 222) is in poor condition and much of the masonry has collapsed, but historic photograph P3 (Plate 9) shows a raised timber launder running

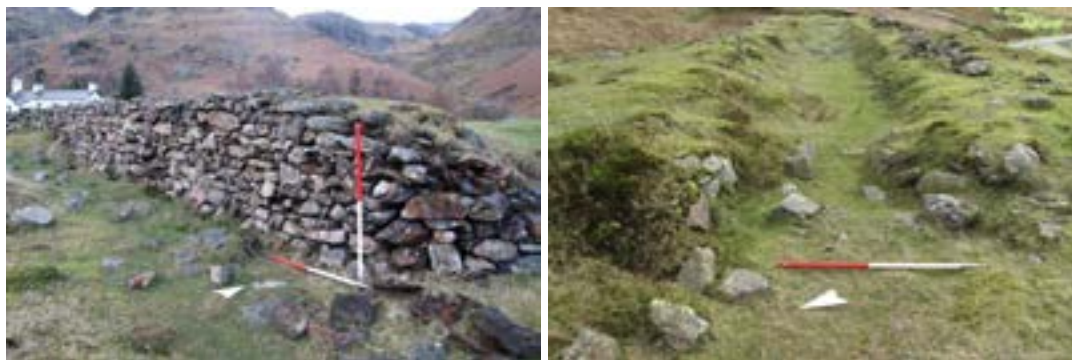
- 6.21 Stamping mill 3 is located 35m east of Stamping mill 2. The mill is in poor condition and the main surviving features are the launder pier (210) and water wheel pit (340). Pier 210 connects to the west with leat 206 and launder pier 220 but has a much narrower water channel than 220. It is retained by three walls (211, 212 and 213). An area of comparatively flat ground separates the east end of 210 from the top of retaining wall (321) and the stamps wheel pit (340).

Plates 26 & 27: launder pillar associated with Stamping mill 3; retaining wall 213 (left) and grassed over top of feature (right).

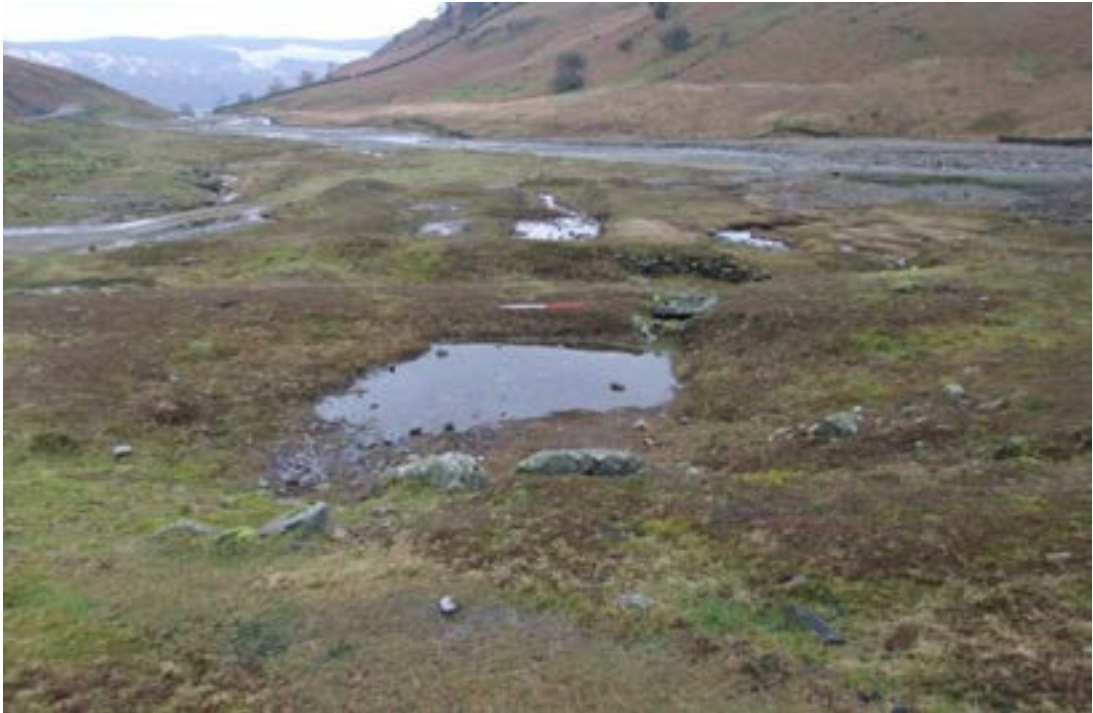
- 6.35 The Low Bonsor mill survey found evidence for one round buddle associated with Area 1b and two with Area 1c. The buddle in Area 1b survives as a 6.2m diameter hollow (440) excavated into the bank immediately south-east of building platform 410. A short, culverted drain (441) at the south side of 440 connects with the settling tank (442). The 1890 OS map marks two other circular buddles in Area 1b; one is a few meters north-east of buddle 440 and the other lies immediately in front of the wheel for Stamping mill 2. These additional buddles appear to have been destroyed when the water pipeline was constructed, but their wooden superstructures (the slimes

Plate 29: *hollow associated with circular buddle (440) located in Area 1b.*

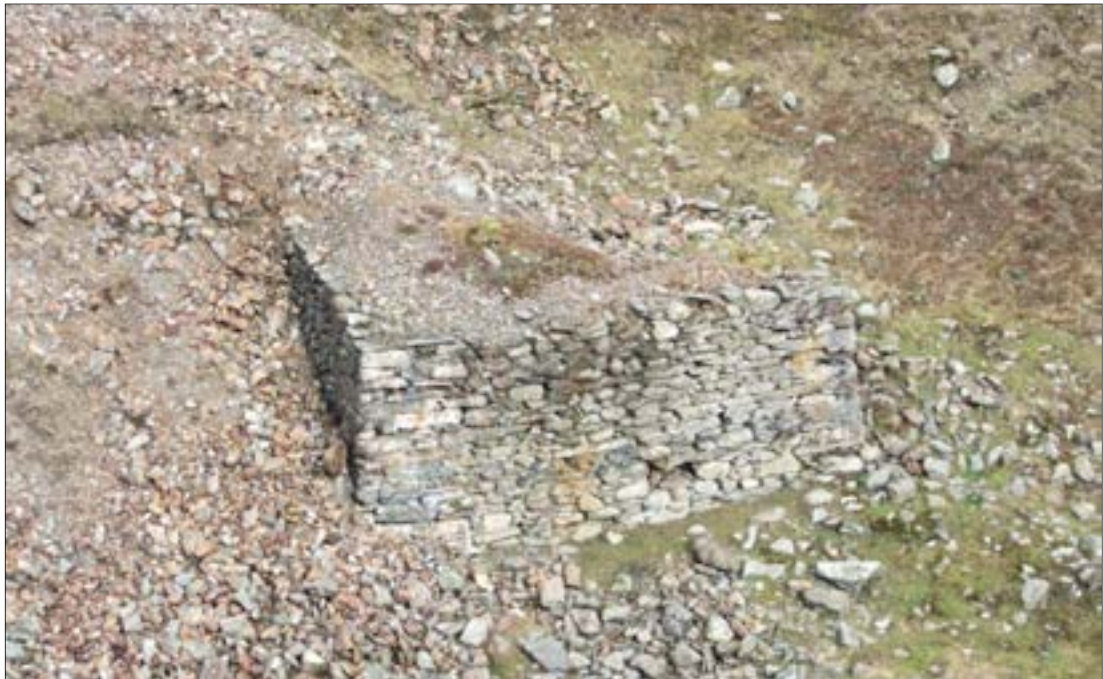
- 6.53 The principal surviving evidence for Stamping mill 1 is a large masonry pillar (430) (Plate 36) constructed into the terrace bank some 8m west of the office (420). The pillar comprises a substantial south-facing wall (431), 2.6m high by 5.0m wide, with a small ground-level culvert towards the western corner and a suggestion of timber slots by the eastern and western edges. The two side walls (432 and 433) set into the terrace bank are in a poor condition and the area between wall 433 and the office (420) has been severely eroded by flood action. The top surface of pillar 430

Plate 35: stone pier (340); the only surviving evidence of Stamping mill 1.

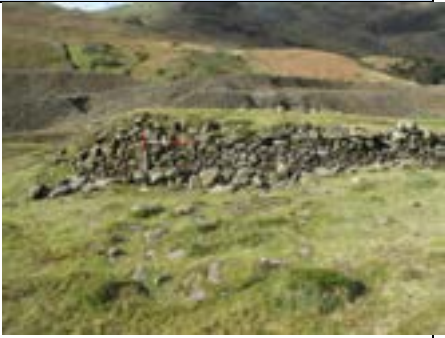
222	Wall - random rubble wall on S (end) side of launder pier (220). 4.8m wide x 1.9m high. Battered profile with a slight curve. In poor condition, E and W corners collapsed.	High - as above	Launder pier (220) – element of.	High	As above

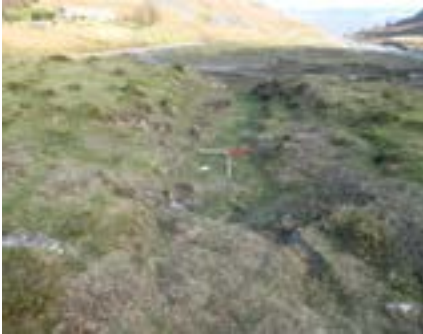
254	<p>Culvert - an exposed section of stone culvert missing its capping stones, 4.4m x 1m wide. The culvert has been destroyed to the NE by the modern water pipeline and continues for at least 16.7m to the SW (possibly to</p>	<p>High - good evidential value as its function and date have yet to be established. Potential for further research, thus adding to interpretation and knowledge of site. It is</p>	Culvert outfall (256) Gully (253)	High	Unknown

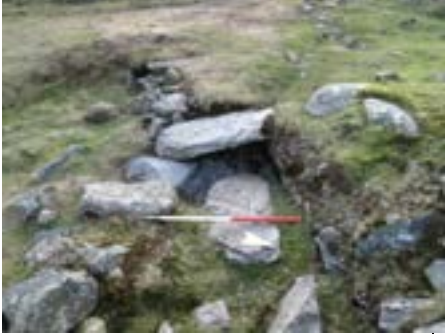
255	Tramway - linear feature, probable tramway, defined by gravel spread demarcated by stone side stones and spoil. Cut to NE by a flood gully and eroded on spoil dump to SE	High – good evidential value for tramway and transport system and the formation of the later spoil dumps.			Shown on 1890 OS

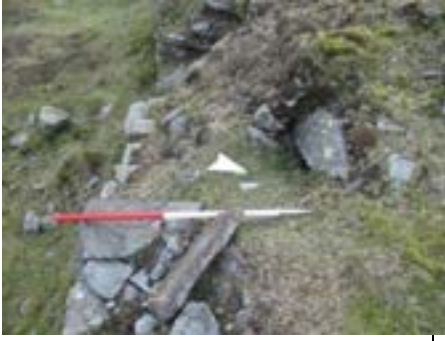
404	Timber structure - damaged timber structure exposed at SE end of gully (253) and spanning gap or break between walls (401) and (405). Two planks, 0.95m and 0.65m respectively, set on vertical timbers to S; planks 0.3m wide and uprights approx. 0.12m x 0.08m in section. Possible water management feature (remains of sluice gate?)	High – good evidential value for water control, possibly linked to putative water wheel at SW end of building (410)	Wall (401) Wall (405) Building (410) Gully/lead (253)	High	Shown on 1890 OS map

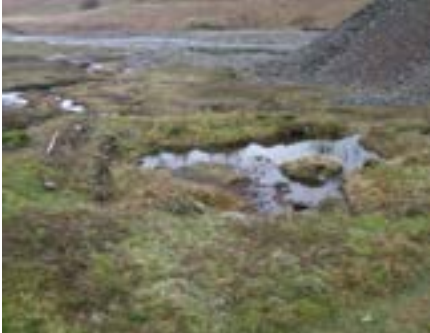
Context	Description	Significance	Assoc. with	Contribution to Significance	Date	Photo
447	Settling pond - rectangular pond or tank with stone revetments at NW corner. Badly damaged by erosion from flood gully. General dimensions: 5.9m x 5.1m x 0.8m deep.	High - as above.	Terrace bank (508) Terrace bank (509)	High	On 1890 OS map

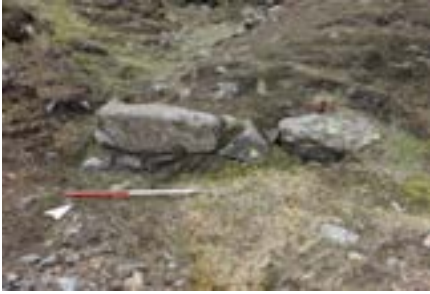
505	Round buddle - little remains of the buddle identified in the RCHME survey. It survives as an unvegetated area approx. 5m x 6m with some small displaced timber to the NE. To the SW is a concentration of fine sand, probably buddle waste.	Moderate - the poor condition of this feature reduces its evidential value. There is however potential for belowground archaeological survival and the feature as group value with the other buddles on site (440) and (502).		Moderate	Before 1890
