Penny Rigg Copper Mill, Cumbria

Conservation Management Plan

Report date: December
2010

Report no. 0091/2-10

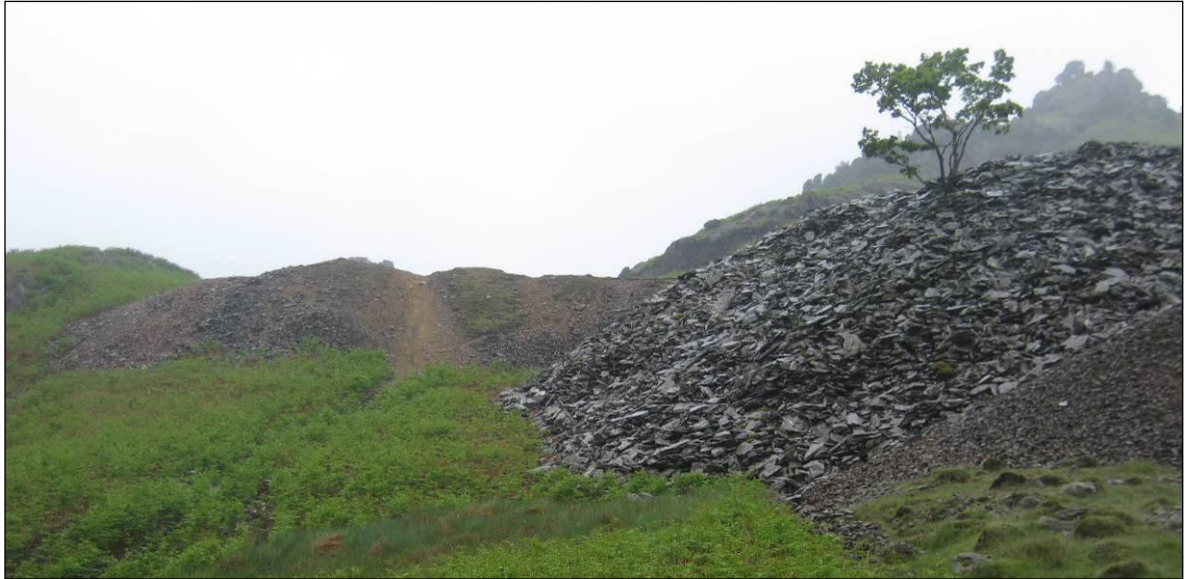
Plate 7: two types of spoil tip: on the left of the picture is the yellow-orange, mineral rich copper ore, while to the right dark grey slate rid. Unfortunately, the old mineral waste heap has become a popular route for mountain bikers, creating a scar on the face of the feature.

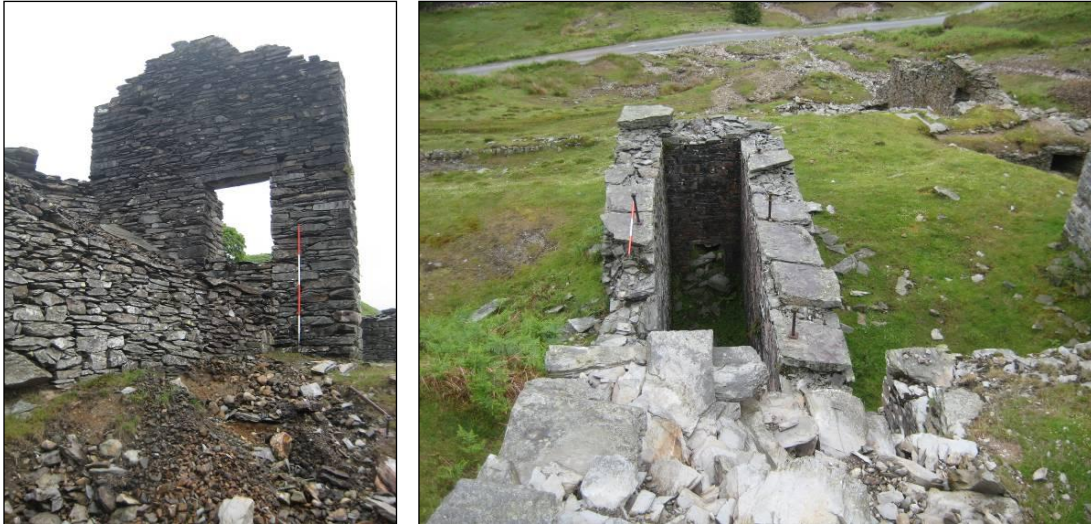
Plates 8 & 9: entrance to the upper floor of the crushing house still clearly preserved; ore was delivered via this directly to the upper floor of the crushing mill and then fed into the crusher below. And the wheel pit (2044) of the 32m diameter wheel which drove the crushing and stamping machinery – looking south from the holding pond (2045)

Once sorted, the ore was moved from the sheds to the Crushing Mill (2046); probably in wheel barrows. The processing plant was laid out in a series of terraces arranged down the hill slope to facilitate the movement of the mineral between processes. Sorted ore would have been taken into the Crushing Mill through the entrance in the south wall - the terracing meant that this would have led directly onto the top floor of the building – and was then loaded into a hopper which fed directly down into the crusher located in the room below. The crushing machinery was operated by a 32 feet diameter water wheel located to the north (2044).

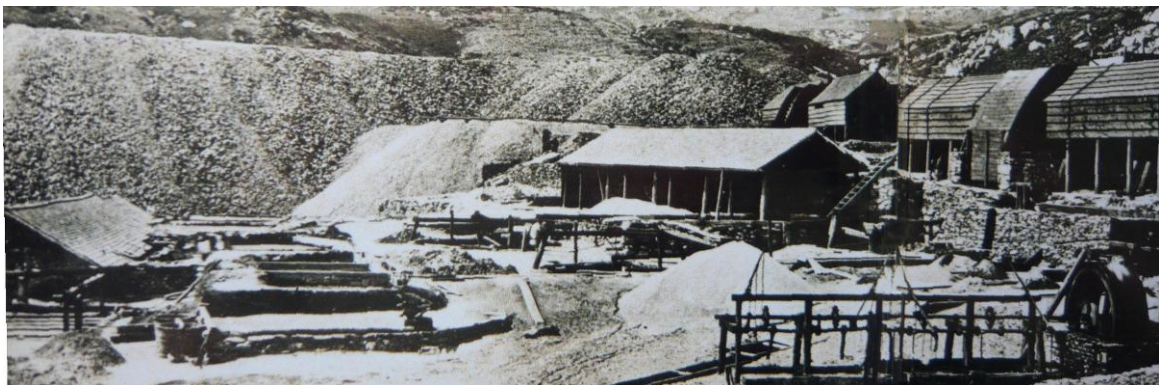
Plates 10: Dressing floors at Bonsor Low Mill at Coniston Copper Mine – a rack of jigs is clearly visible in the foreground and buddles to the left. The crushers were in the buildings to the right, on the terraces, while the large building in the middle may have been a bucking shed.

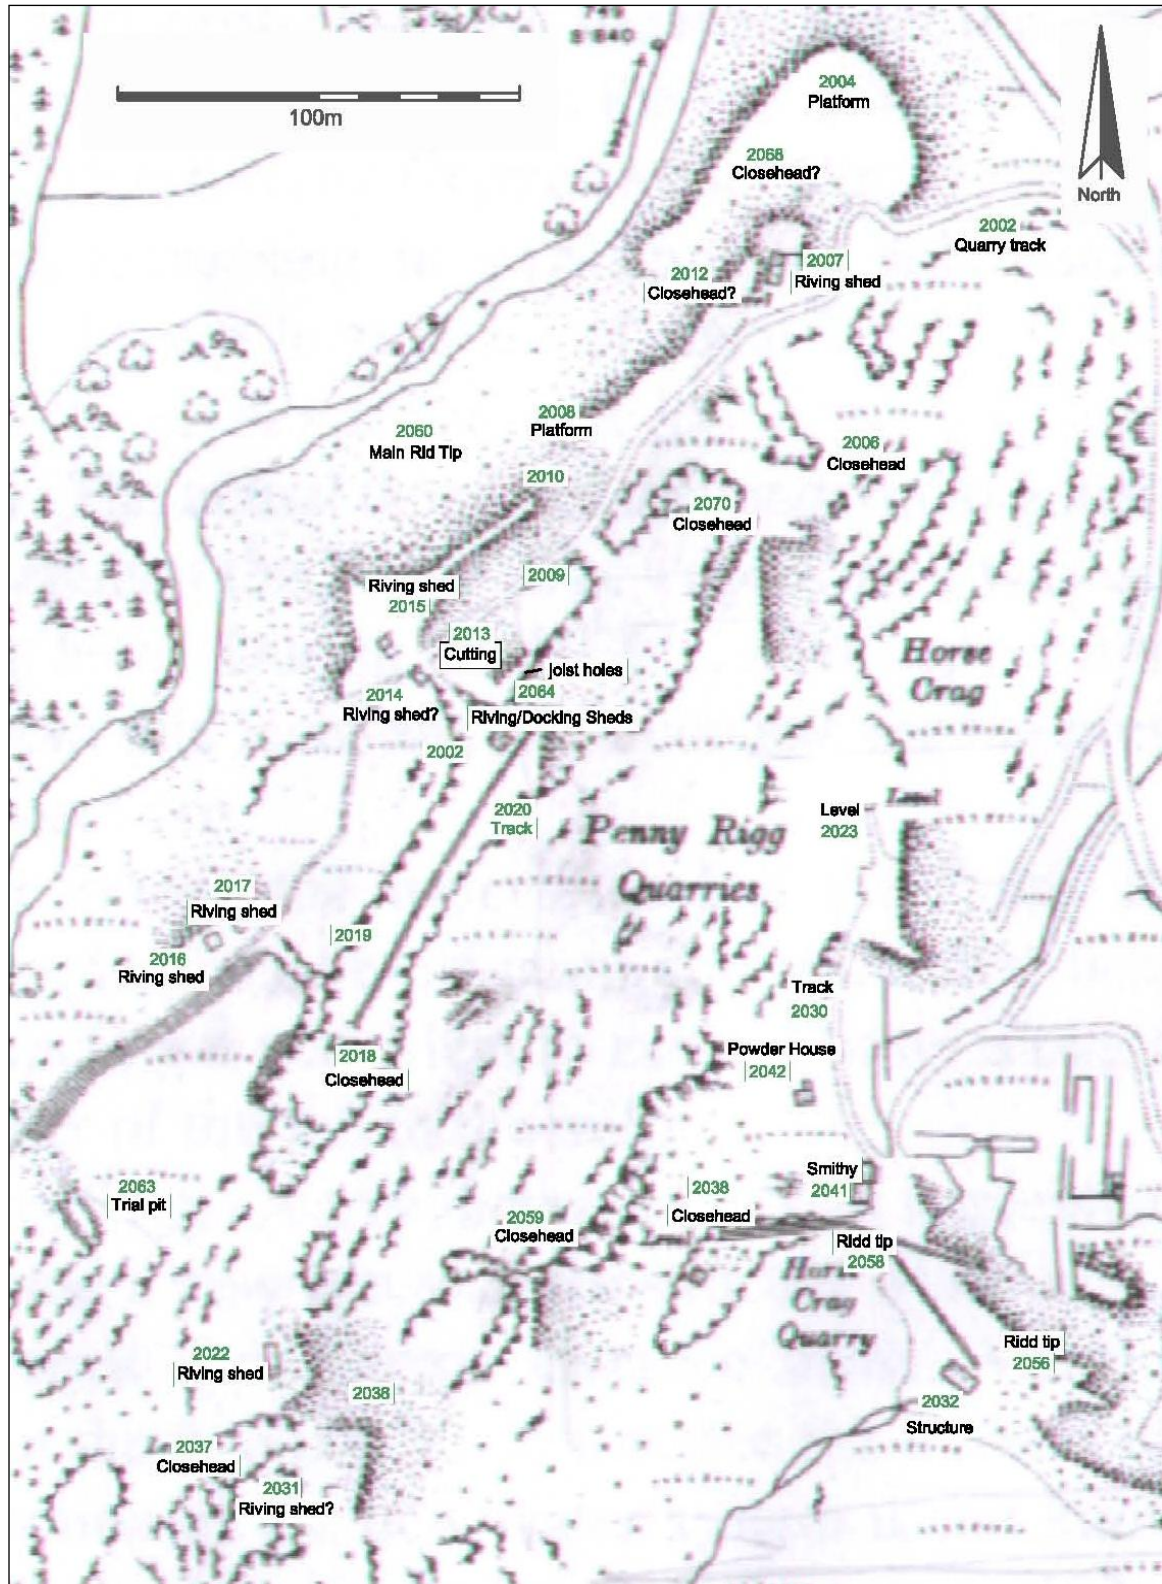
Figure 12: key quarry features overlain onto third edition OS map (1915)

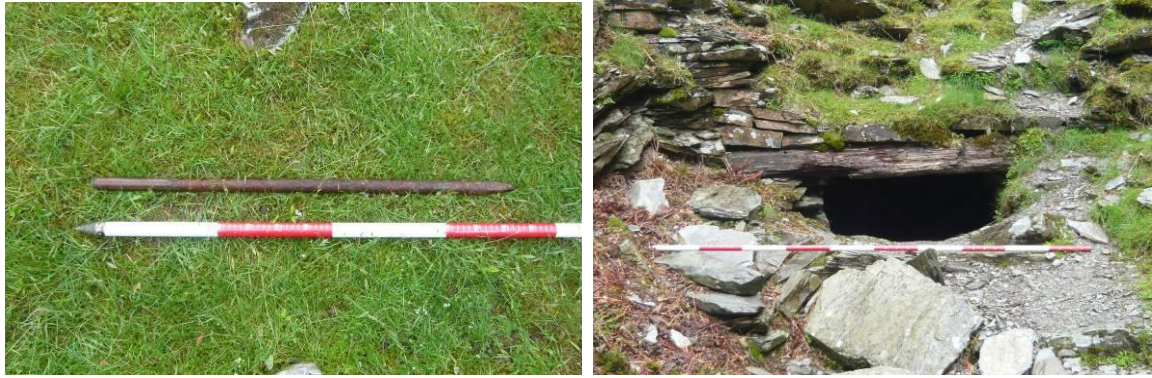
Plates 13 & 14: jumper found in-situ at Penny Rigg Quarry and the entrance to the closehead (2018)

Both surface and closehead mining was undertaken using a combination of blasting and hand picking. Tell tale shot holes can still be seen all over the quarry face, both the triangular holes of the hand-driven jumpers and the smooth bored holes of the mechanised drills. Originally made of iron and later of steel, a jumper was a slender rod with a chiseled end and was usually forged on site at the smithy. They were used to drill a hole in the rock to take a gunpowder charge. Later these were replaced by compressed air mechanical drills, but this was not until the 1880s. A jumper was found still *in-situ* on site (NY 30568 00088), at the north-eastern end of the quarry. The distribution of triangular to circular shot holes could potentially date the older sections of the quarry face, although there may have been considerable later activity, but there does seem to be a propensity of hand driven holes at the south-western end of the quarry.

The surface slate was worked in terraces, rising up in two major increments from the lowest point at the north-eastern end of the quarry. The top level was the last to be worked, and this includes the entrance to the level (2018), or closehead, mentioned in the excerpt from Corry. This is now completely blocked after only a few metres and is extremely dangerous. The wooden lintel supporting the entrance is in a poor state of repair and liable to collapse. There were a number of other closeheads operating around the quarry. Although the phasing of these is not clear, one of the later ones may have been the shallow level at the north-eastern end of the site (2006) and a second small working begun at the northern end of the main quarry pit (2070). There was another level (2012) shown on the slope of the promontory on the third edition OS map (published in 1915) (Figure 12) but this has been completely blocked by quarry waste, although this might be linked with the remains of a possible adit found further down the slope (2068).

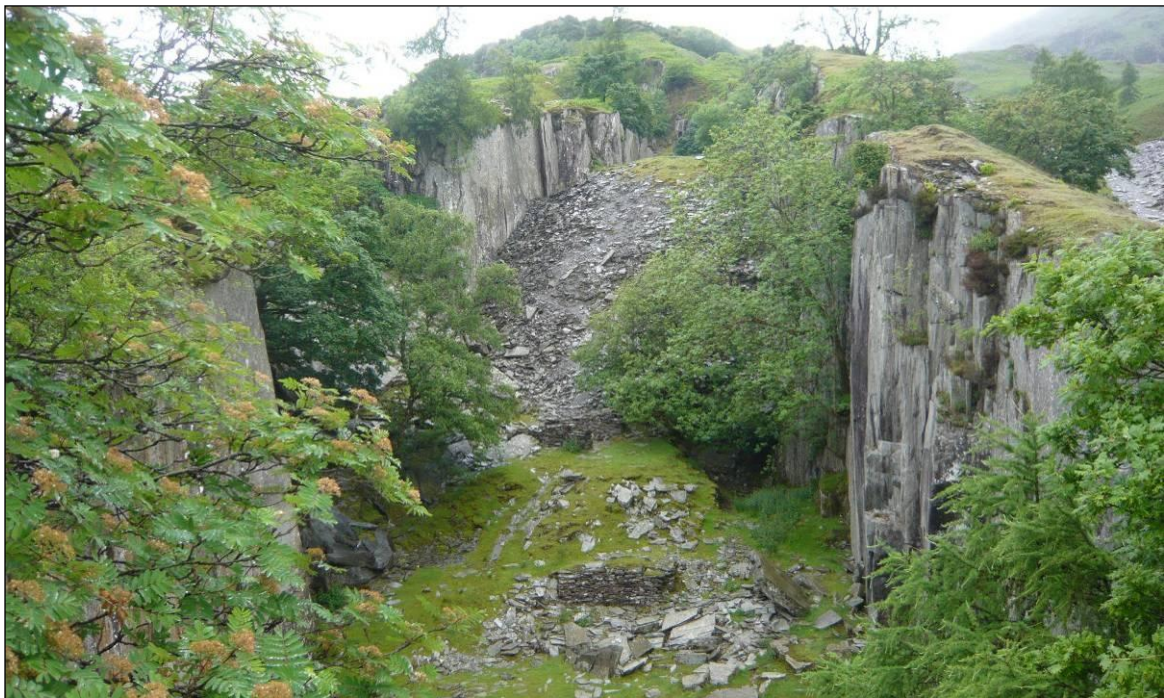
Plate 15: view south-west down Penny Rigg Quarry (2000) showing the progression of the terraces, with the older works at the lowest level in the foreground. The various structures at the base of the quarry are riving and processing sheds.

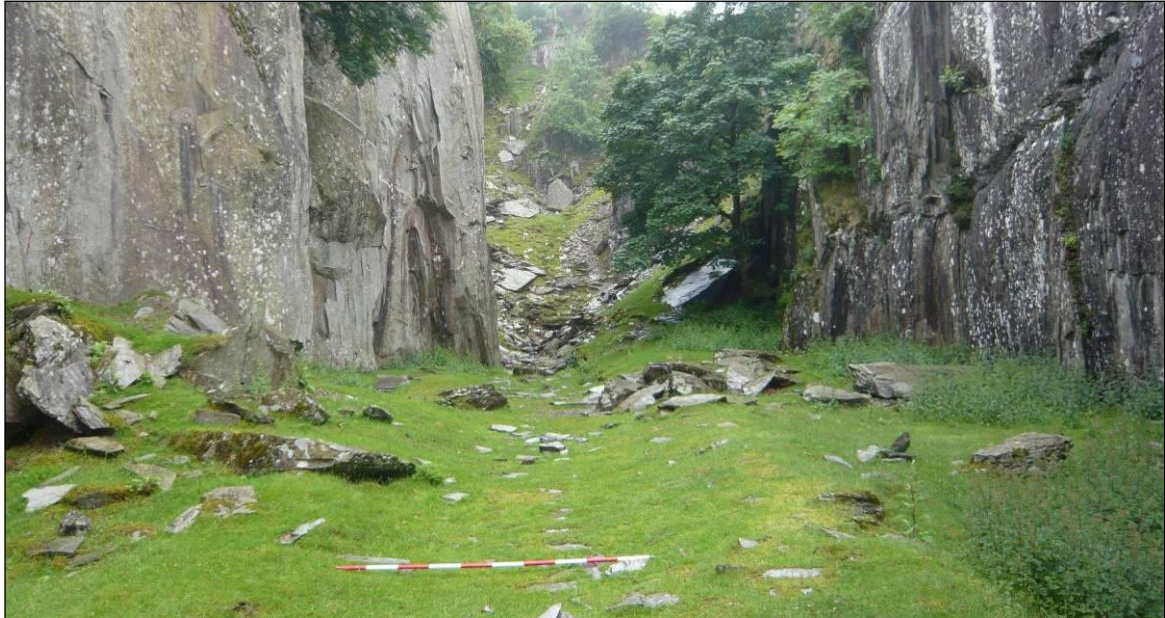
Plate 16: path of the former track (2020) leading from the closehead (2020) in the distance, to the riving sheds on the top level of the quarry

Initially, the slate was cut into large blocks or 'clogs', this was then transported from the underground workings on trucks which Corry refers to in his article. These were then transported by a surface track to the docking and riving huts on the top terrace (2020). The path of this track (2020) leading from the entrance of the 'level drain' (2018) can still clearly be seen.

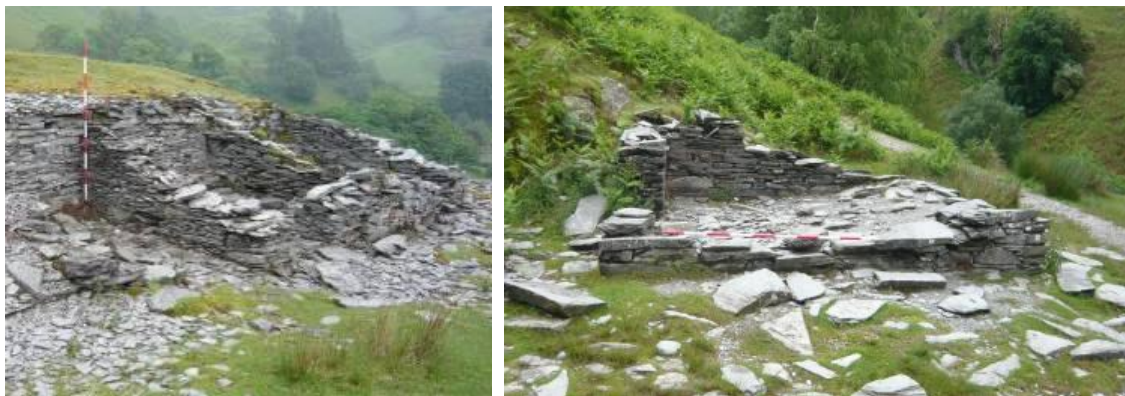
Plates 17 & 18: well preserved riving shed (2007) at north-eastern end of quarry and riving shed or dwelling (2014) close to quarry entrance.

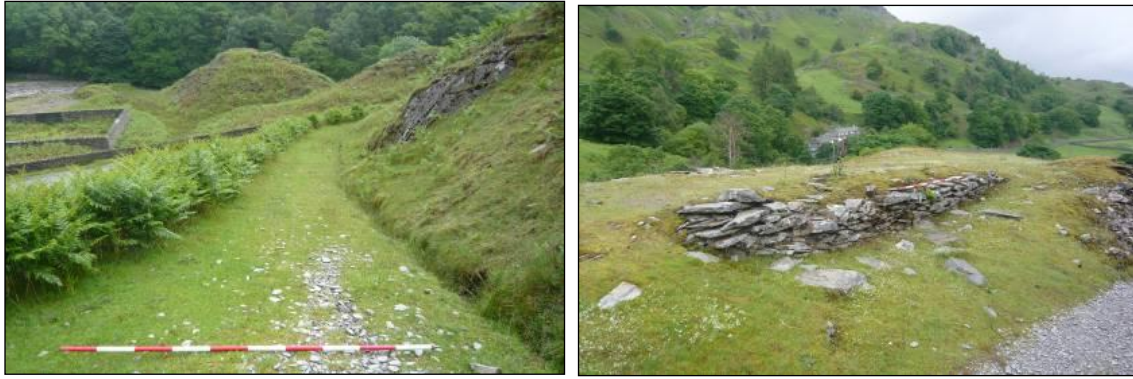
Plates 19 & 20: quarry road (2002) and platform adjacent to the road (2008) which was possibly a platform for a loading gantry of water balance.

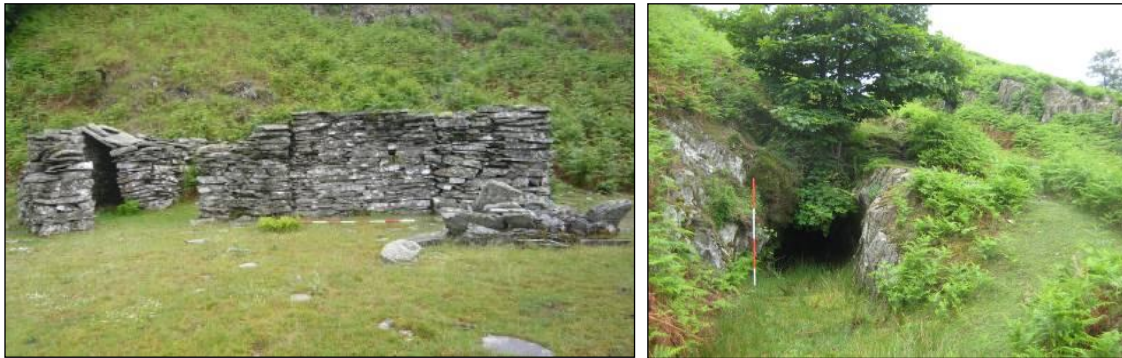
Plates 21 & 22: smaller quarries in the area - very well preserved structure (2022) (probably a living shed) adjacent to small closehead (2023).

In addition to Horse Crag, there were a series of other smaller quarries in the area. To the west of Horse Crag, further up the hill slope there is a small closehead (2059). This does not appear on the 2nd edition OS map and probably dates to the first decade of the 20th century: it is clearly shown on the 1915 map. To the south-west of this there is another small closehead (2037) and surface quarry which is first shown on the 1850 first edition OS map. This is a well preserved group featuring a level entrance with rather impressive retaining walls, quite similar to that at the south-western end of Penny Rigg (2018). There is also a very well preserved riving shed adjacent. This is a rectangular stone building orientated north to south and divided into two main cells with a small third cell at the south-western end. It has a slab slate roof still *in-situ* and is enclosed by a curving south wall (again similar to (2007) at Penny Rigg). Each cell measures approximately 2m

across and features a rear stone cupboard. There is a second associated building on the opposite side of the level; this might be a workshop or smithy.

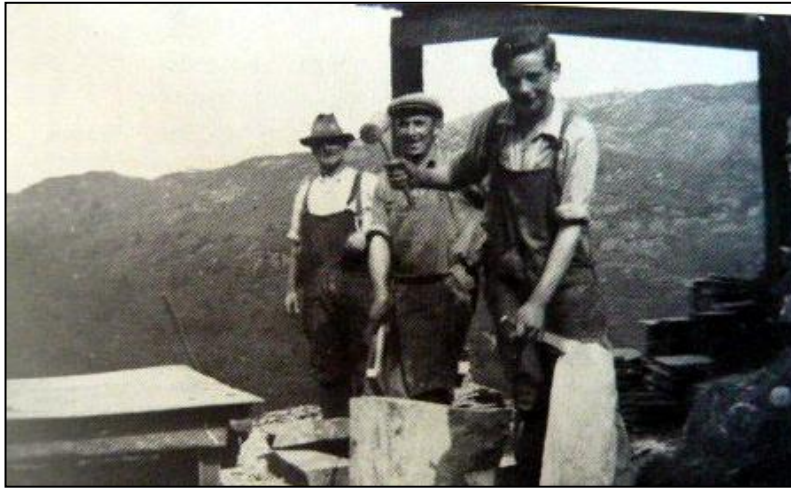
Plate 23: Splitting slate at Horse Crag Quarry - John W. Shaw in the background (from Holland 1986, 529)

In 1993, with his plans to re-open the copper mine failing, Oscar Gnosspelius turned his attentions instead to the good slate to be had at Horse Crag. Gnosspelius had spent a year working as an engineer in a quarry in Sweden so understood what was necessary to run a successful venture. It was decided that John W. Shaw, working with several local workmen, would open up a closehead off of the old adit, as well as working the surface quarry at the entrance (Figure 6). This was a relatively small affair, although later a paraffin engined air-compressor was mounted on an iron wheel chassis to enable the drilling of shot holes. Fittings associated with this compressor can still be seen around the Level entrance. The quarry operated until 1938 when Shaw finally retired. The Greenburn and Tilberthwaite Mining Company went into liquidation four years later in 1842. More recently, in 1989, George Tarr obtained planning permission to re-open the quarry and start working the closehead. He worked the mine for 10 years but eventually abandoned the venture in 2000 to concentrate on other commitments.

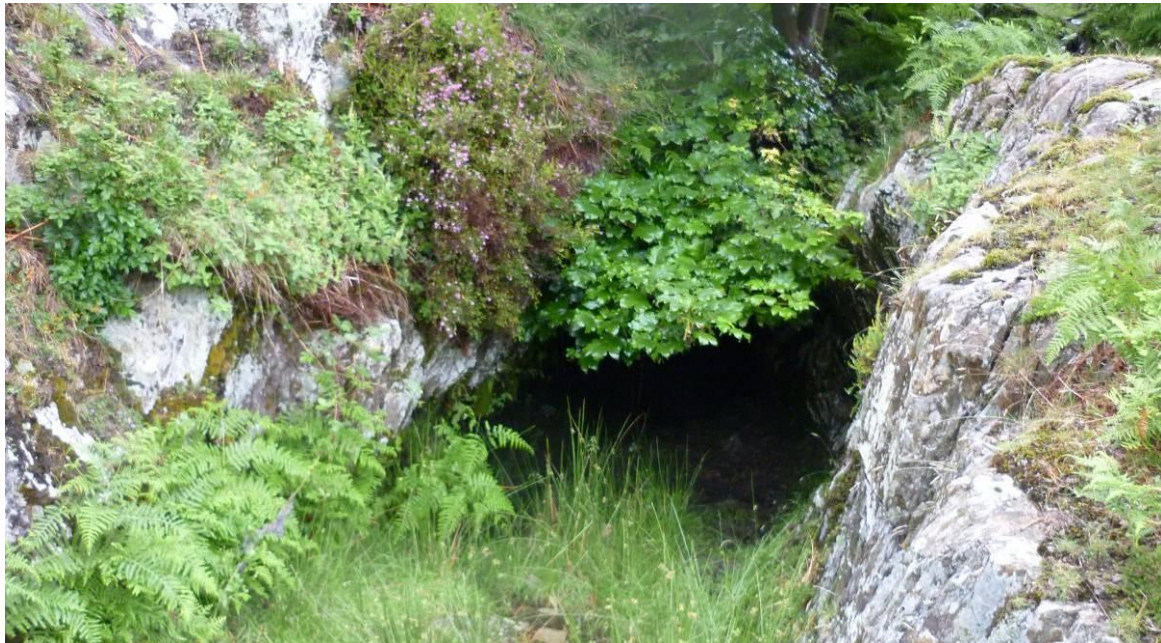
Plate 28: Entrance to mine on the south side of Penny Rigg quarry, excellent bat hibernation potential.

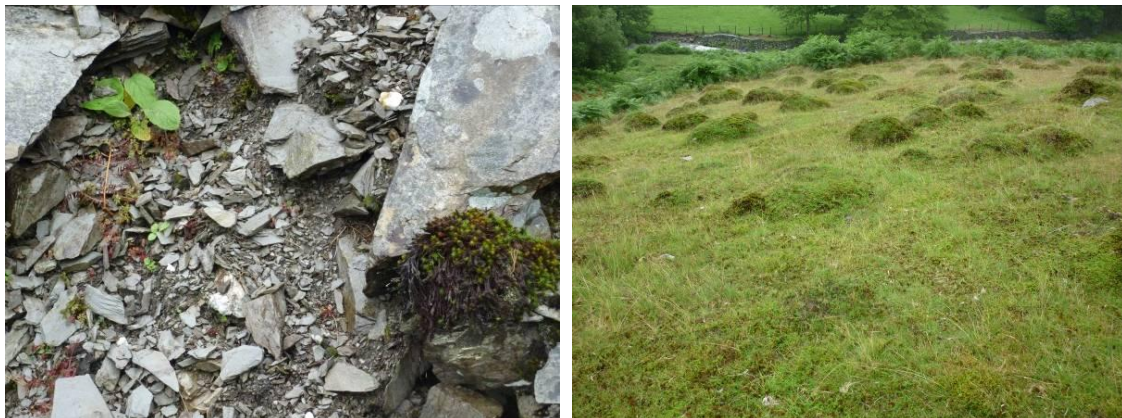
Plates 29 & 30 One of the less vegetated spoil heaps to the south east of the site only a few mosses and plants (here fox glove and herb-Robert) have colonised. This ridg tip has vegetated completely – possibly an indication of the later slate mining activities.

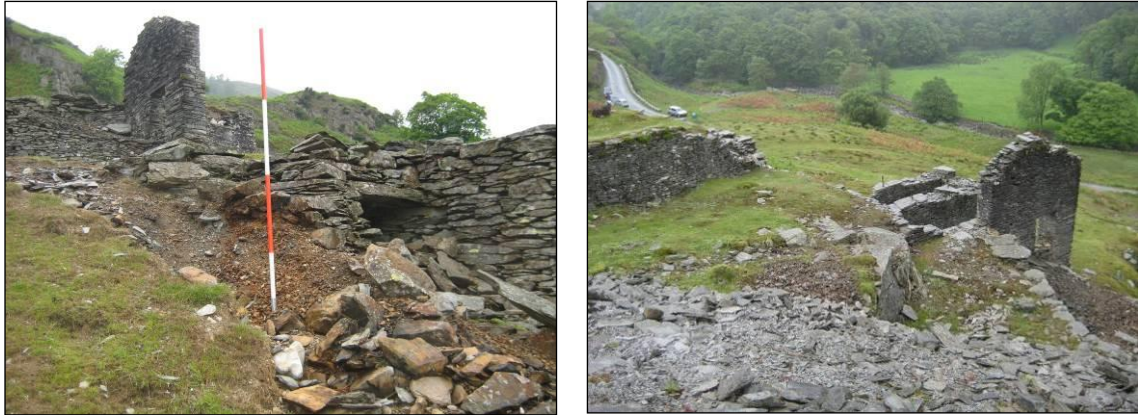
Plate 38 & 39: Penny Rigg Copper Mill, one of the best preserved single phase mills in the country

Well preserved copper mills of this size and period are comparatively rare in England, and the best parallels to Penny Rigg are found elsewhere in the Lake District. The Upper and Low Mills at the Coniston mines contain many of the features which can be seen at Penny Rigg but these were much larger, multi-phase operations and the archaeological remains are considerably more complex. The nearby Greenburn copper mine on the north flank of Wetherlam is of a similar size but is more complete than Penny Rigg. It is also a slightly later operation as shown by its use of more complex ore recovery techniques such as acid leaching (a system which only starts to be employed in British metal mining towards the end of the 19th century). Penny Rigg by contrast is perhaps a better example of a typical mid 19th century mill. There were a number of contemporary copper mills elsewhere in Cumbria (for example Roughtongill, Redgill and Goldscope) but few standing structures survive today at these sites.

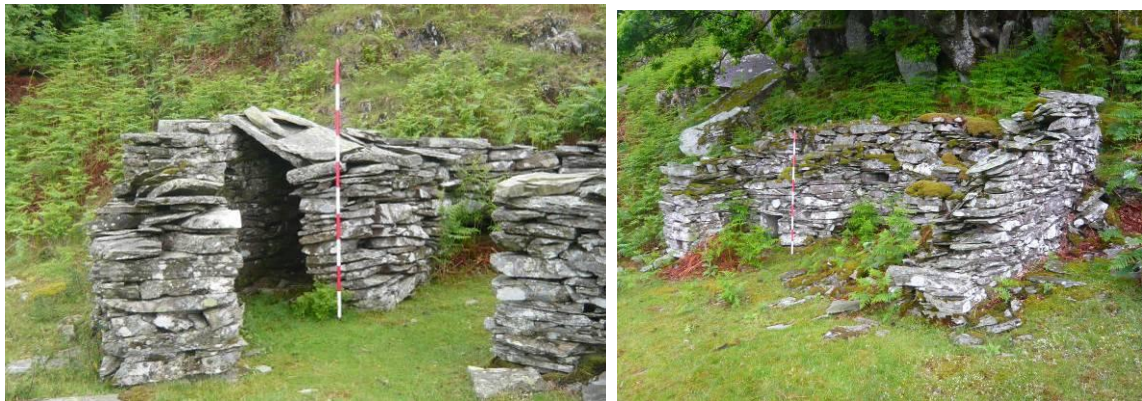
Plate 40 & 41: slate quarry buildings – the overall the preservation of these buildings is quite considerable, especially down the slope from the main Penny Rigg Quarry. These two buildings (2022) and (2031) lie on the south-east slope of Horse Crag. The first (2022) even has the slate slab roof preserved over the end cell.

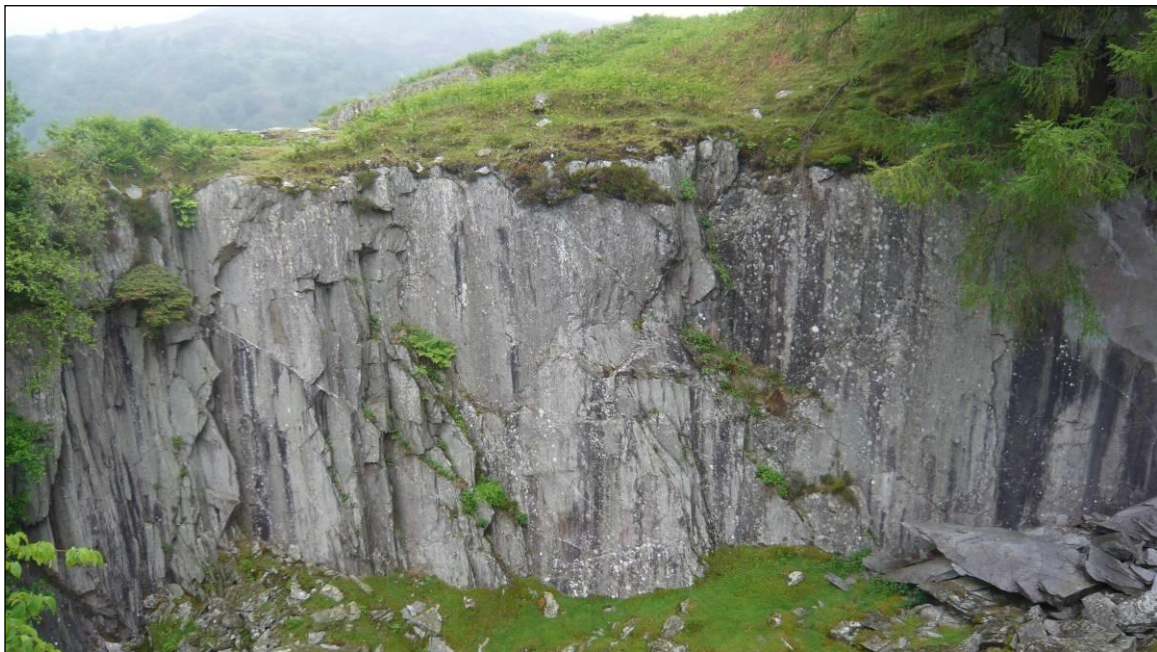
Plate 44: view looking down into the quarry – the size of the quarry pit and its impact on those visiting the site is of considerable significance to the aesthetic value of the site.

The overall size of the Penny Rigg quarry pit is also quite an important factor and is a dominant feature on the landscape. Although relatively small in comparison with modern quarries, the fact that this is a pit, rather than surface quarry, seems to add to its general impact. The worked faces seem looming and imposing when viewed from below and sheer and vertiginous from above.

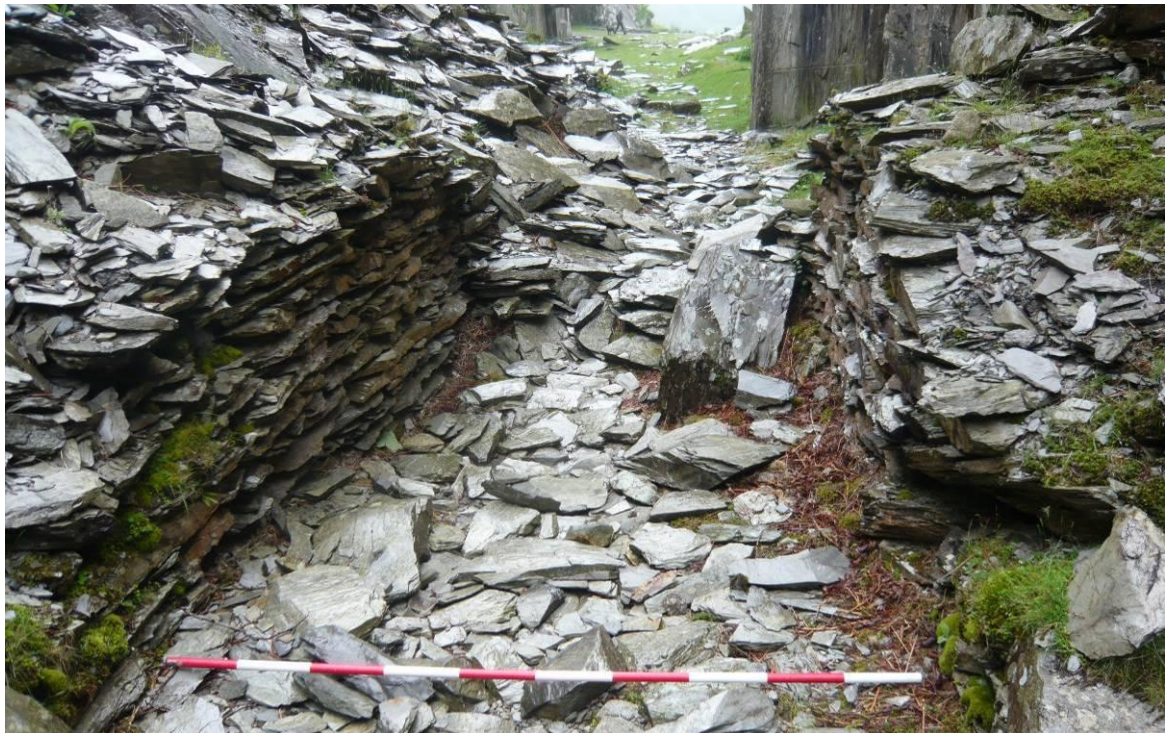
Plate 47: *entrance to the closehead (2018) in Penny Rigg Quarry – the levels of preservation on the site, across a wide range of features, is very high.*

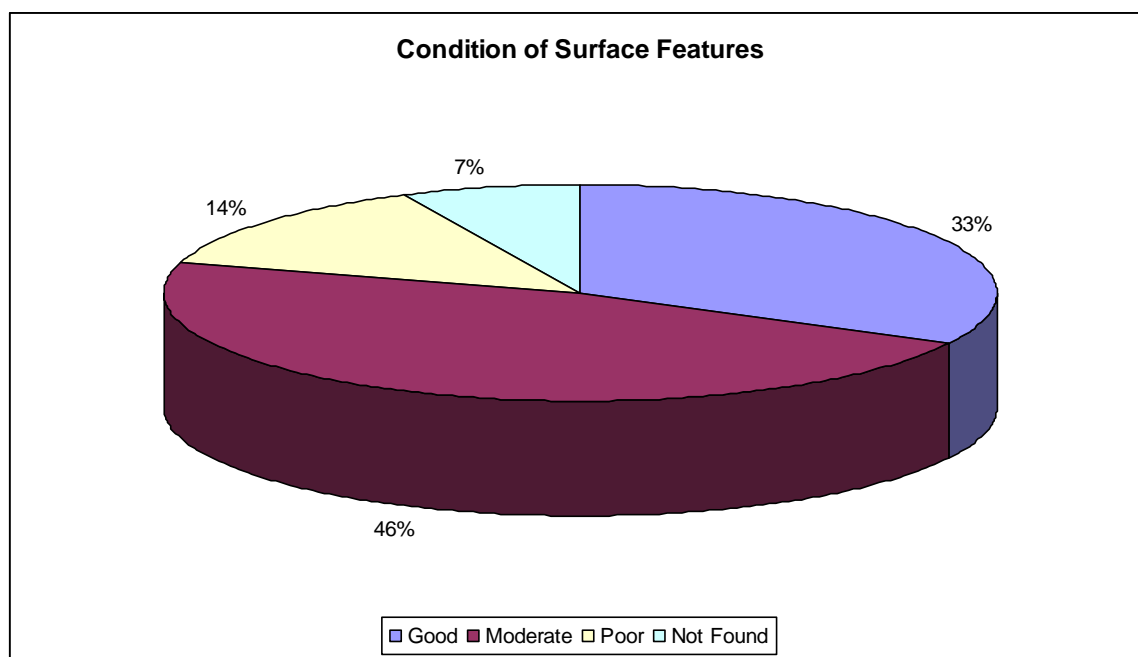
Figure 17: overall condition of the key features identified across the site as detailed in the gazetteer.

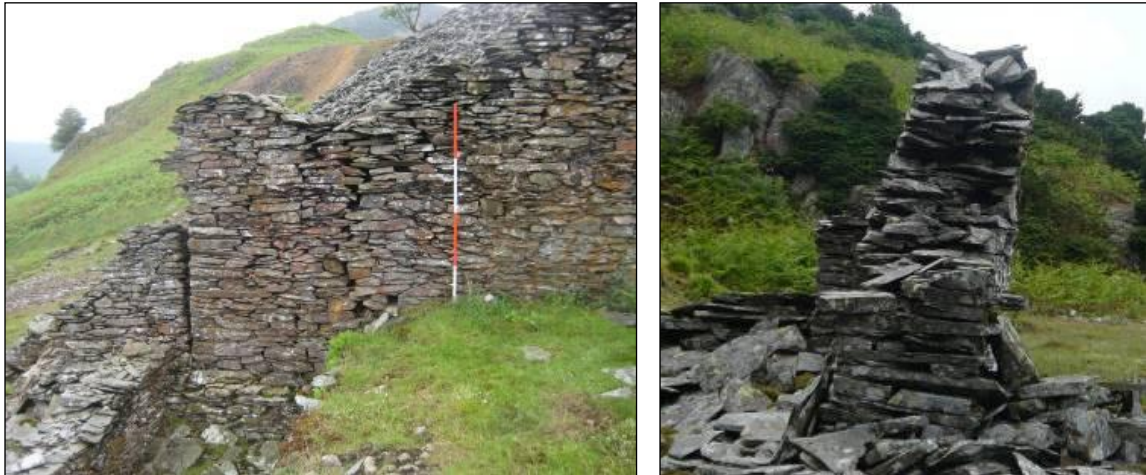
Plates 48 & 49: severe cracking in the wall of the (2051) and leaning gable wall in danger of imminent collapse on building (2072) at the old quarry (2071).

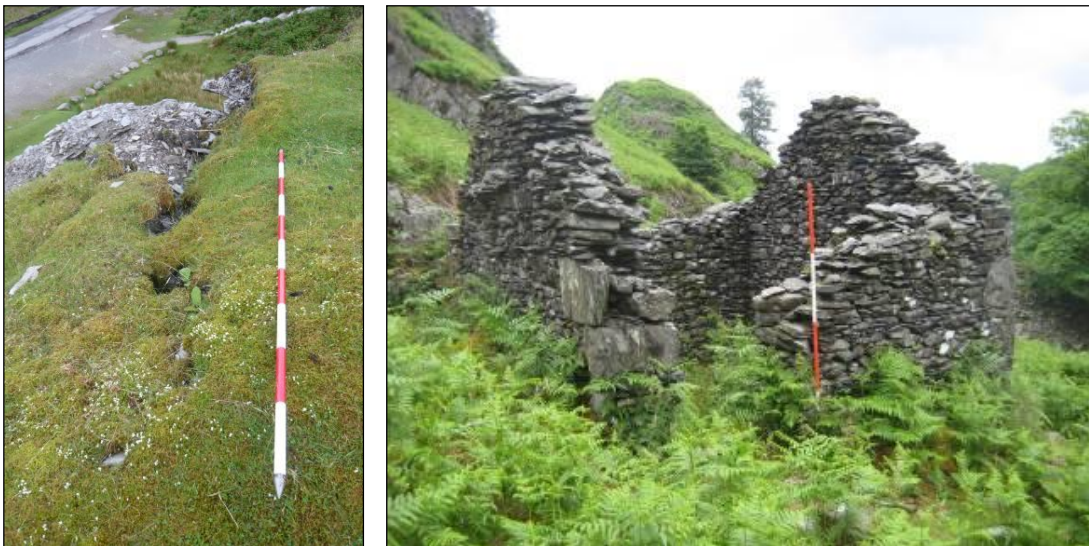
Plates 50 & 51: *crack along the north-eastern edge of the main rid tip at Penny Rigg Quarry and bracken growth surrounding the powder magazine (2042) and weakening the stonework over time.*

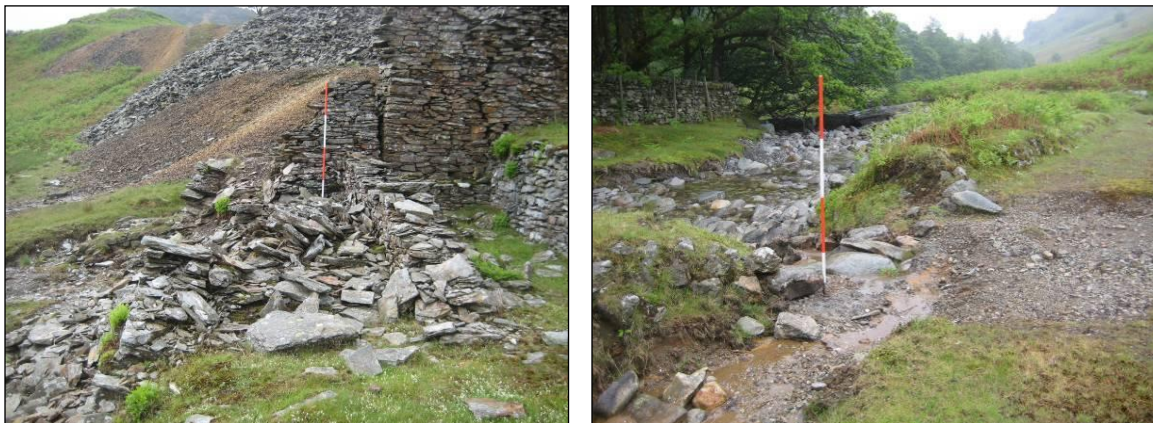
Plates 52 & 53: flood damage winter 2009/10 – damage to Dressing Mill (2051) and erosion along the Yewdale beck, potential washing contaminated soil into the river.

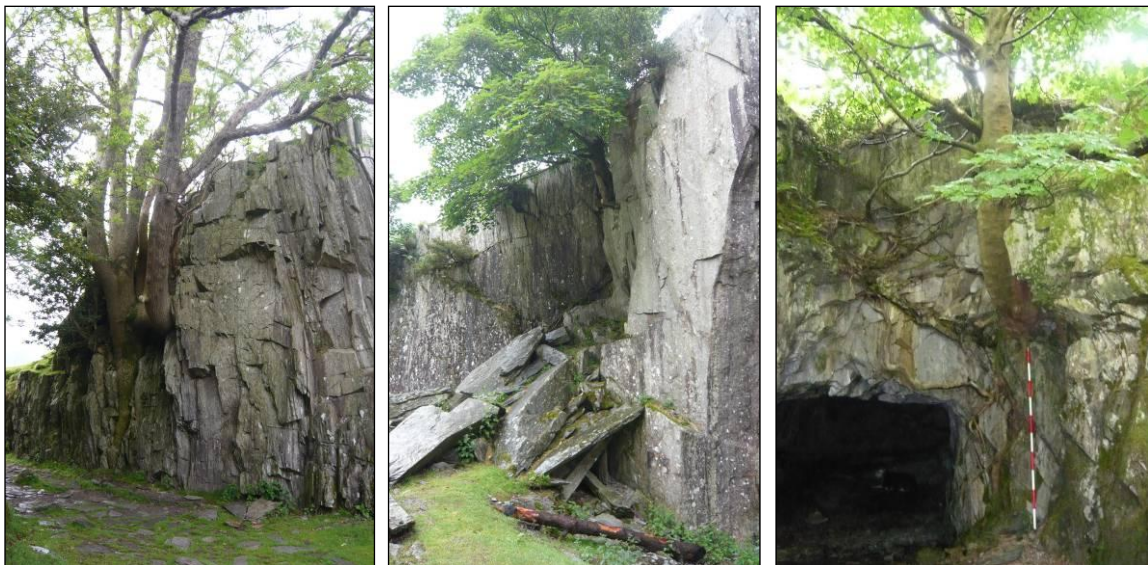
Plates 54 - 56: self seeded trees growing around Penny Rigg Quarry, the first in the wall of cutting (2013) the second on the north on the top terrace has caused a rock fall and the third above the closehead (2006) threatens to collapse the level entrance in the future.

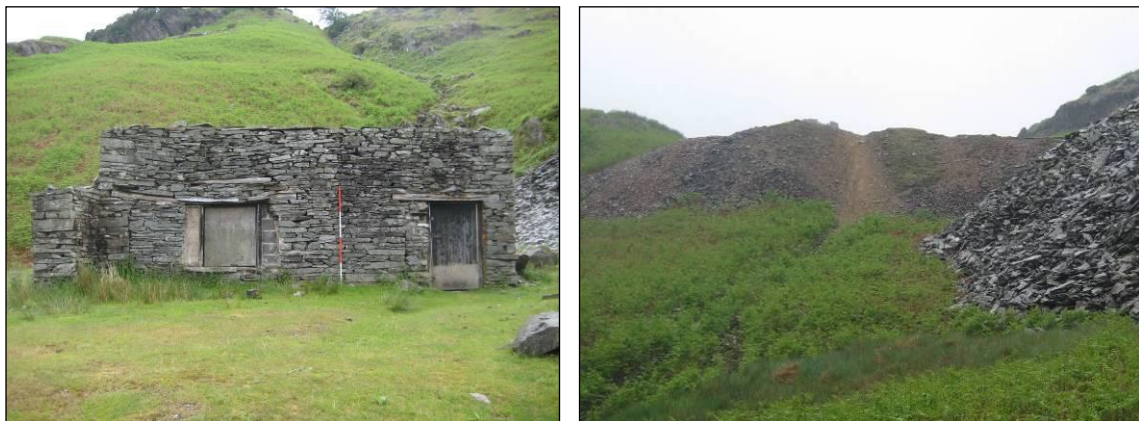
Plates 57 & 58: quarry building re-used as bothy (2032) note damage to window lintel and trail bike scars on the side of mineral waste tip (2055)
