CONISTON COPPER PROJECT  
COMMUNITY EXCAVATION

PENNY RIGG COPPER MILL,  
CONISTON, CUMBRIA

NAA 18/37  
May 2018

**CONISTON COPPER PROJECT COMMUNITY EXCAVATION  
PENNY RIGG COPPER MILL, CONISTON, CUMBRIA  
ARCHAEOLOGICAL EVALUATION REPORT**

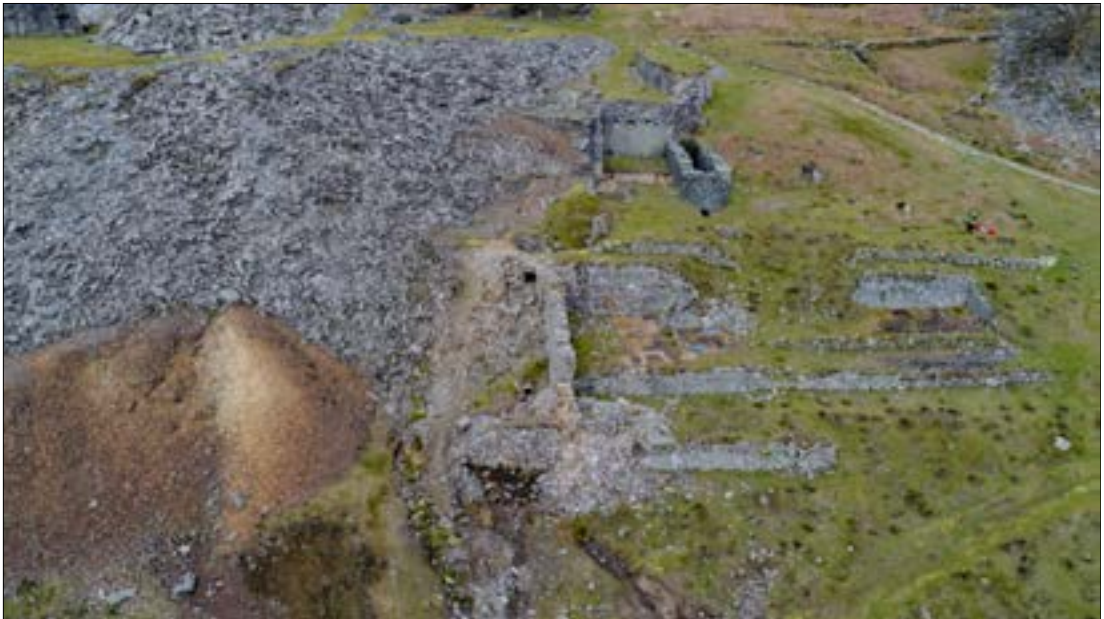
*Plate 1: general view of the mill complex from the east. The crusher house and water wheel pit are top centre with the jig house below. (Image courtesy of Mike Mitchell).*

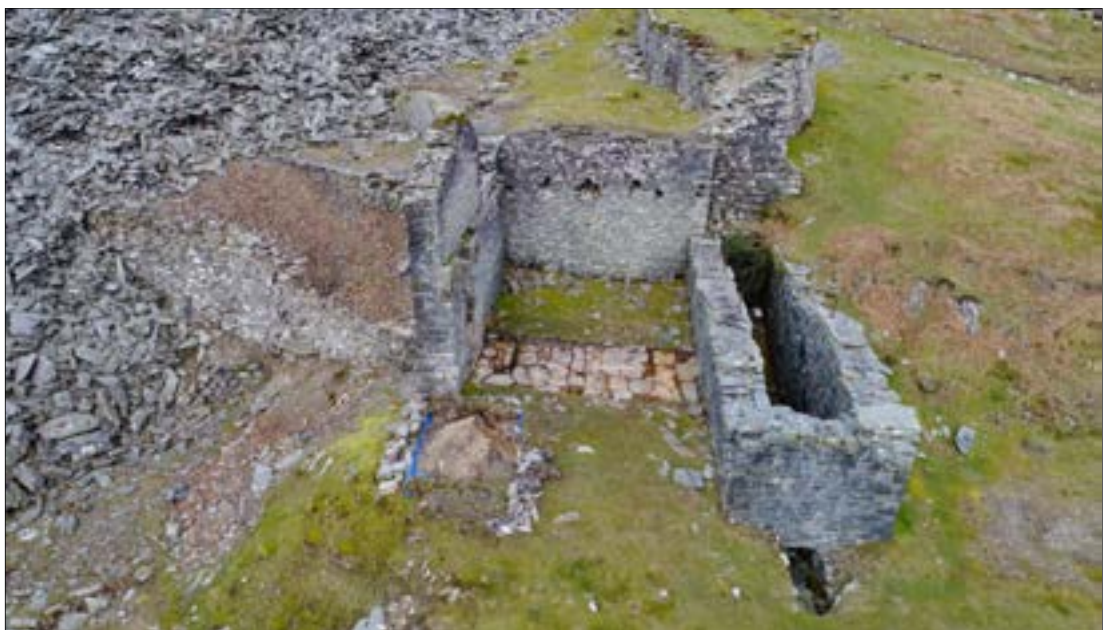
*Plate 2: view of the crusher house and Trench 1 from the east. (Image courtesy of Mike Mitchell).*

- 6.1 Trench 1, measuring 3m x 6m, was located within the crusher house and aligned to correspond with the centre of the water wheel (Fig. 3; Plate 2). It was anticipated that a trench in this position might provide information on the layout and function of some of the machinery that transferred power from the water wheel's axle to the crusher.

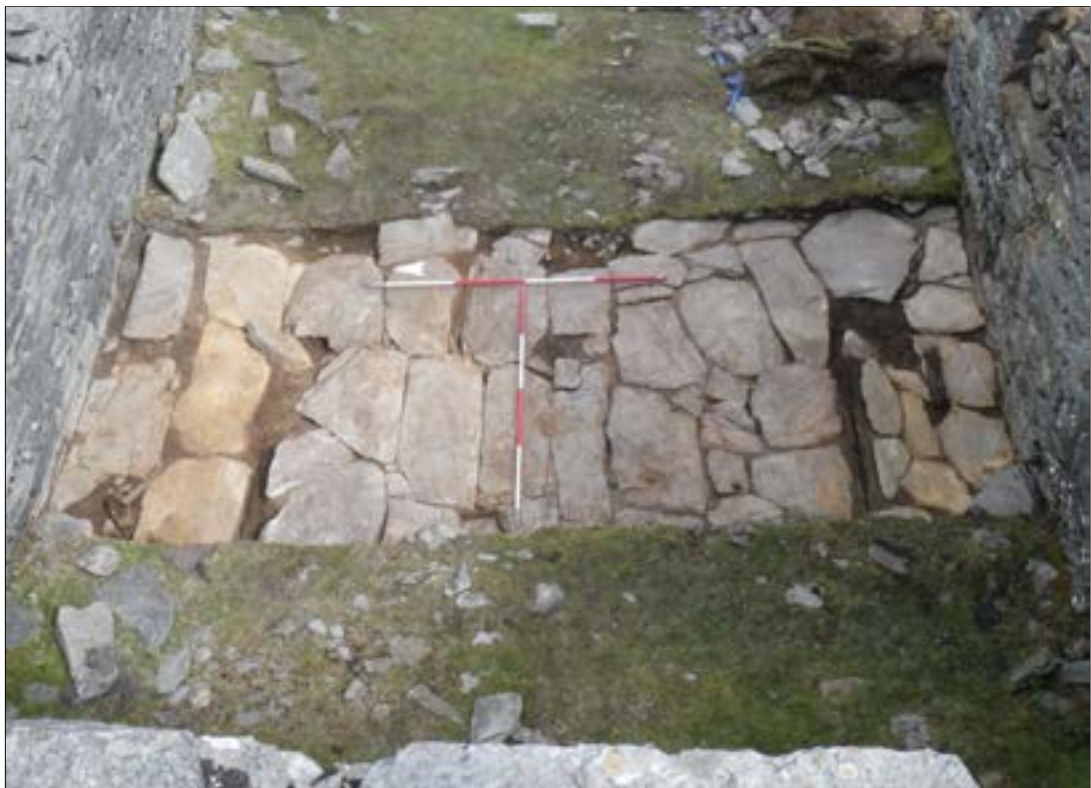
*Plate 3: Trench 1 from the west with a clear view of flagstone surface 008–010.*

- 6.2 The earliest deposit uncovered was a substantial flagstone floor composed of rectangular or near-rectangular slabs of Borrowdale Volcanic rock (Plate 3). This was recorded as three contiguous flagstone surfaces (**008**, **009** and **010**) because of variations in construction, but the whole floor appears to have been built as part of a single-phase (Plate 3).

- 6.4 Surface **009** was in the central section of the trench and covered an area of approximately 3m x 3.6m (Fig. 3). It was demarcated to the south by timber **007** and to the north by a narrow, rectangular gap. The flagstones forming **009** were comparatively large (up to 0.6m x 1.7m), set close to one another and laid on an east-west alignment.

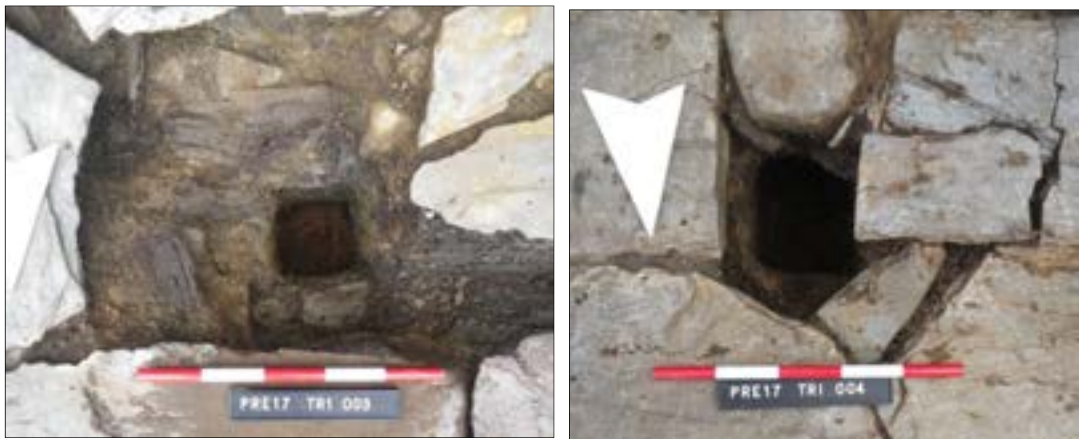
*Plates 4 and 5: posthole 010 after removal of fill 003 (left), and posthole 012 after removal of fill 004 (right).*

- 6.6 The flagstone surface **008–010** contained or incorporated a number of features, of which the most significant were a group of three rectangular postholes aligned north-south across the centre of the trench (**011**, **012** and **013**). Posthole **011** was located 0.80m north of the building's south wall and measured approximately 0.2m x 0.2m by 0.5m deep (Plate 4). At the base was a fragment of horizontally laid saturated wood above a stone slab. It was filled with a grey-brown silty clay with occasional small stones towards the top (**003**); there was no evidence for wood above the basal timber and it can be assumed that any vertical post was removed before the infill process began.

- 6.7 Posthole **012** was located 1.70m north of **011**, in the centre of the trench. It measured 0.22m x 0.24m by 0.5m deep and, like posthole **011**, contained the remains of a timber plank at its base, resting on a stone slab (Plate 5). The lower 0.30m of the fill in the posthole comprised rotten timber with a series of voids above. The top section comprised small stones and iron fragments resting on what appeared to be horizontally set slate fragments (**004**). The presence of deliberately set slate in the

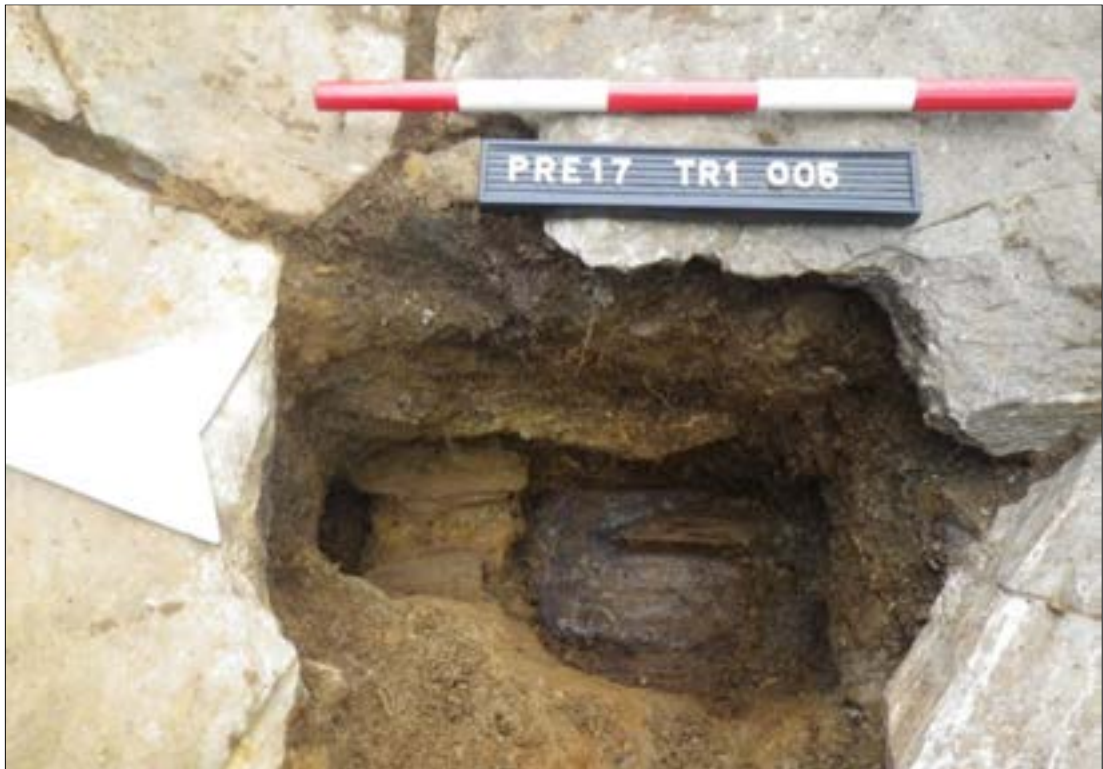
*Plate 6: posthole **013** after removal of fill **005**, with void for braced timber to left.*

- 6.8 The third posthole (**013**) was very similar to the other two, measuring 0.24m x 0.26m by 0.5m deep, and also had the remains of a basal timber resting on a stone slab (Plate 6). Posthole **013** was over-dug, and this revealed the fragmentary remains of two pieces of angled wood, presumably braces associated with the basal timber and the putative vertical post.

- 6.9 The fill of the posthole followed a similar sequence to that observed in **012**. The top section comprised a fill of clay, stone and iron fragments above a series of voids with wood towards the base. As with **012**, this might indicate the posthole was reused after the original timber upright was removed or that the post had rotted in situ.

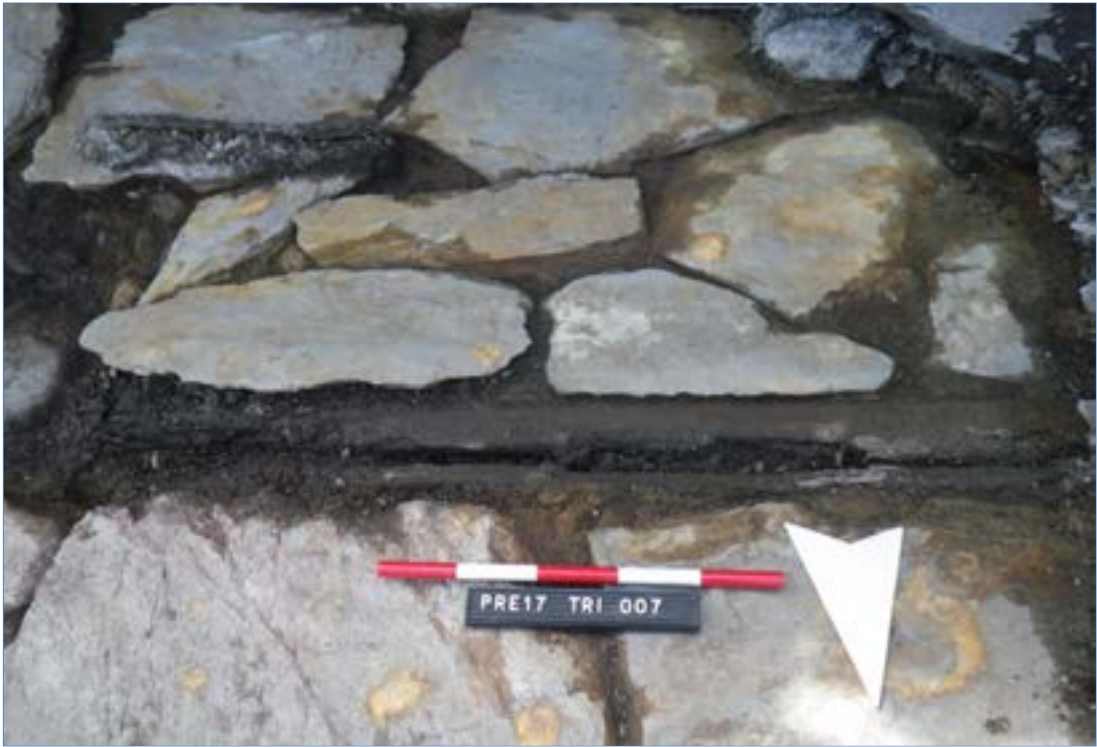
*Plate 7: timber 007.*

- 6.10 Dividing surface **008** and **009** was a horizontal timber (**007**; Plate 7), which had been set into a deliberate gap between the flagstones. The eastern end of the timber coincided with the northern side of posthole **011**, and to the west continued beyond the edge of the evaluation trench. It measured 0.16m wide by 1.5m long and had a slot or vertical depression running along its length, probably the result of decay rather than a deliberate feature.

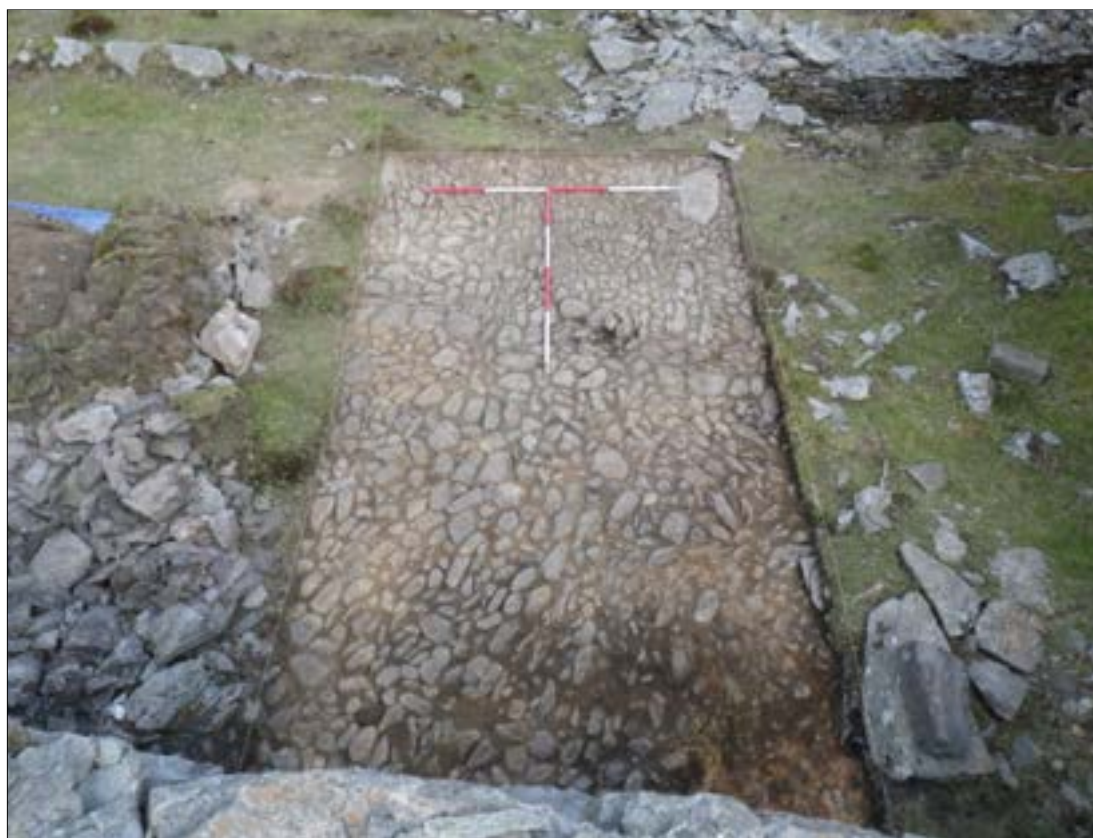
*Plate 8: Trench 2 from the west, showing the cobbled surface.*

- 6.17 The cobbles formed a uniformly level surface set in a matrix of soil, gravel and clay. The cobbles were water-rolled volcanic rock, suggesting they were sourced from one of the local becks. Most were laid with flat-face uppermost although some, particularly in the south-east sector of the trench, were set on edge. There was no discernible pattern or change across the surface of **103**, although the cobbles tended to be larger and set further apart in the northern and western sectors of the trench.

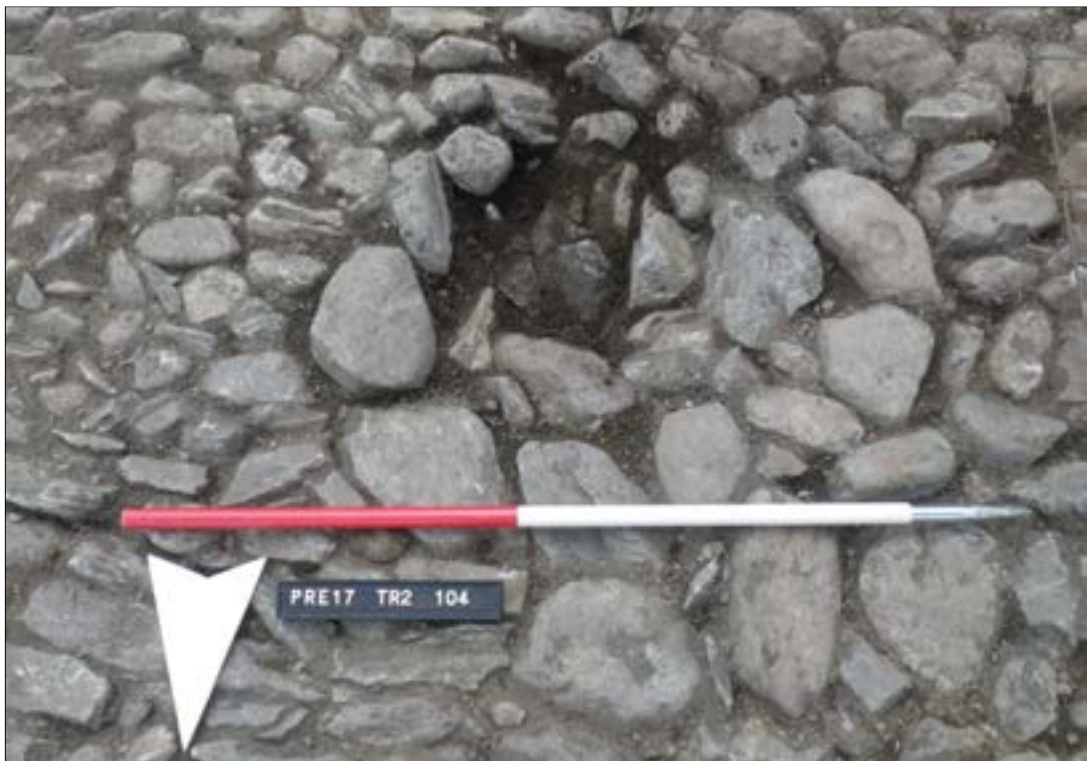
*Plate 9: feature **104**; a possible posthole.*

- 6.18 The only possible feature recorded within **103** was an irregular, sub-square hollow (**104**; Plate 9), measuring 0.27m x 0.30m by 0.16m deep (Plate 9). This was filled with a dark brown soil (**105**) containing some fragments of roofing slate. The sides and base of **104** were very irregular, and it could not be ascertained if this was a deliberate posthole or an area where cobbles had been removed or destroyed.

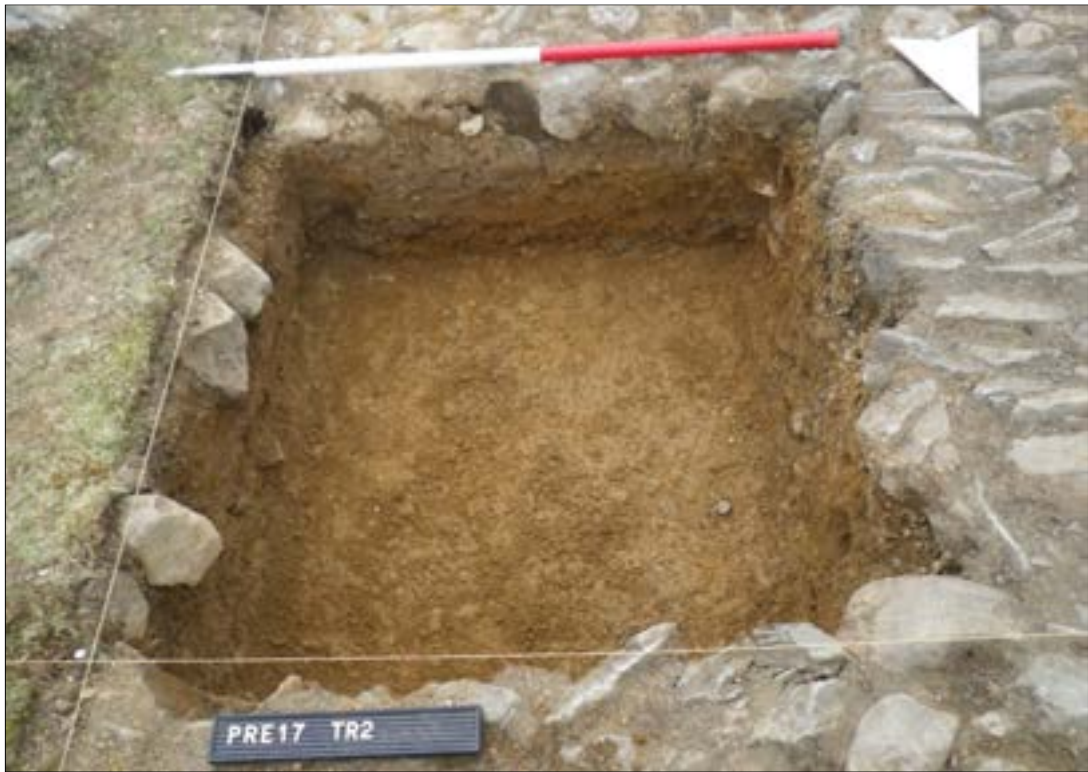
*Plate 10: Trench 2 sondage, view from north.*

- 6.19 A 1m x 1m by 0.35m deep sondage was excavated at the east end of the trench to investigate the sequence of construction beneath the cobbled surface **103** (Plate 10). This indicated that the cobbles had been laid on a layer of grey soil and stone (**106**) that sloped steeply down to the east. Below this, two further sloping deposits of brown soil and sand (**107**) and grey clay and soil (**108**) were observed. Layers **106–108** appear to be a series of dump deposits, presumably laid down as a level sub-surface

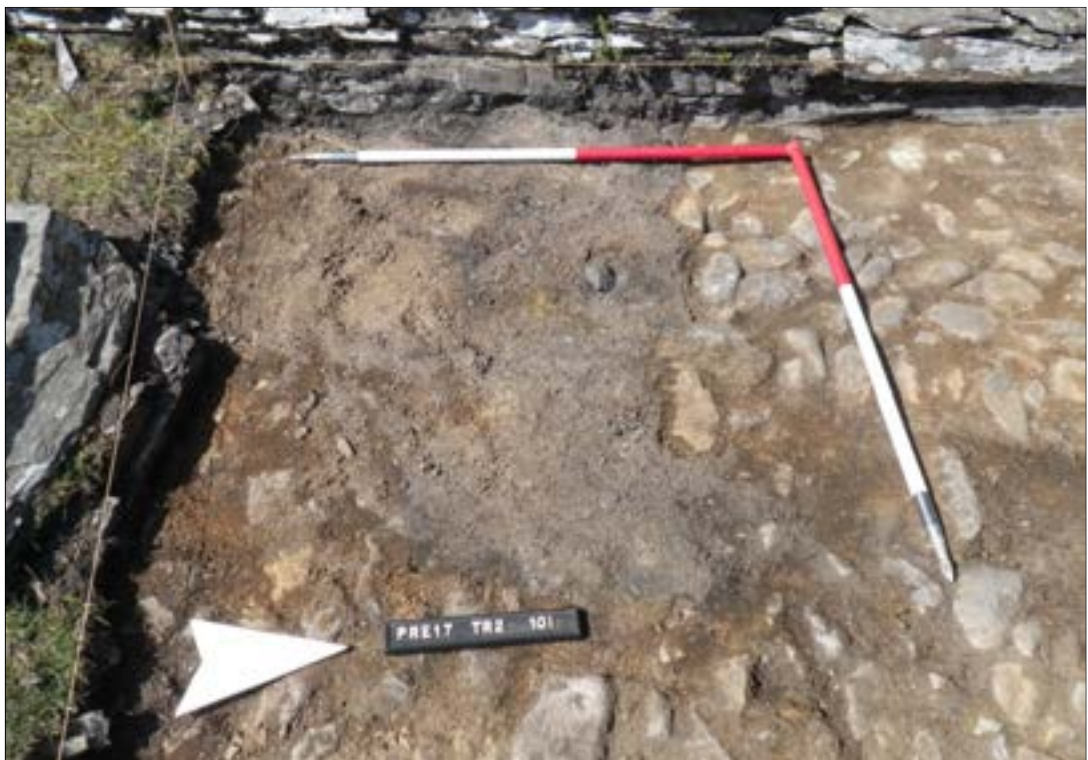
*Plate 11: ore processing waste (101) above cobbled surface.*

- 6.20 In the south-west corner of the trench the cobble surface was overlain by a thin laminated deposit of very fine sand and gravel (**102**), which was sealed by a 0.04m thick layer of fine brown gravel with quartz (**101**). Deposits **101** and **102** had the appearance of sand and gravel waste from mineral processing operations (Plate 11).
- 6.21 Elsewhere in the trench, surface **103** was generally sealed by top soil (**100**), which also lay above **101** and **102**. This was a black, loam-rich deposit, approximately 0.10m thick, that contained large (>0.20m long) fragments of slate and occasional stone blocks.
- 6.22 Scattered across the surface of the trench at ground level were a number of large pieces of tumbled masonry, some of which had been used relatively recently to form the surrounds for small, temporary camp fires.

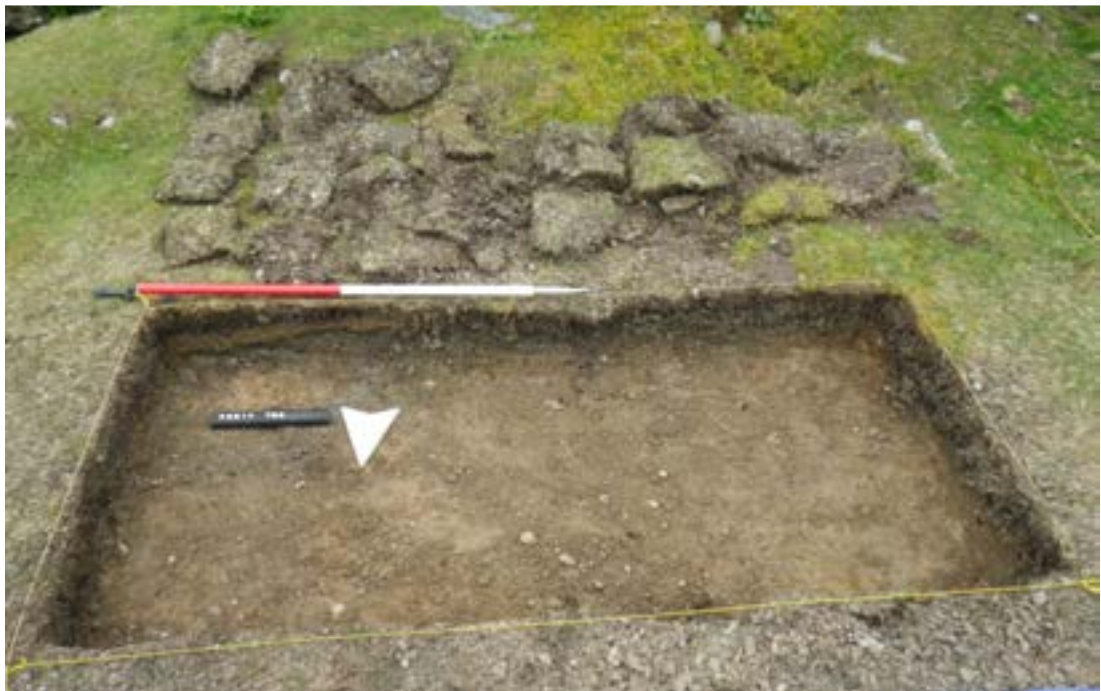
*Plate 12: Trench 3, view from north.*

- 6.23 Trench 3 measured 1m x 2m and was located roughly parallel with and 2m north of the north-facing wall of the crusher house wheel pit (Fig. 6; Plate 12). This area had been identified during the 2016 survey as the location of a possible working platform or timber structure (NAA 2016, 49). The trench was opened on the morning of the last working day and only the southern end was fully excavated.

- 6.24 The earliest deposit exposed was a clay surface, probably a natural hill wash deposit, which was observed in the eastern section of the trench at a depth of 0.25m. Above this, and extending the full length of the trench, was a layer of grey clay (205), possibly a natural subsoil. This had a maximum depth towards the centre of the excavation of approximately 0.20m.
- 6.25 To the east, deposit 205 was sealed by a sequence of comparatively thin (0.6m–0.8m thick) mineral-stained gravel layers (202–204) that sloped to the east. To the west, deposit 205 was overlain by a 0.10m thick layer of brown soil with small stones and gravel (206). The relationship between 206 and layers 202, 203 and 204 could not be established.
- 6.26 No features or other forms of structural evidence were observed within Trench 3.

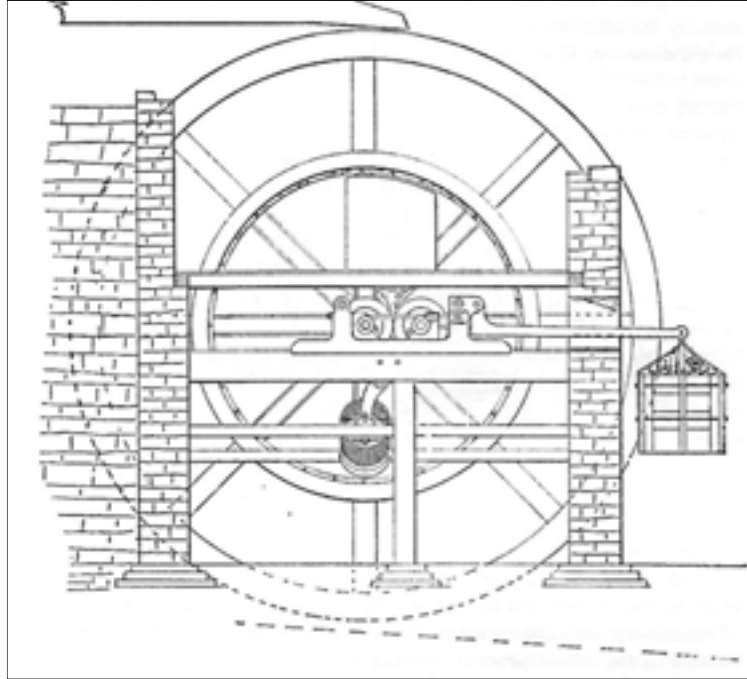
*Plate 13: ore crusher (after Davies 1902).*

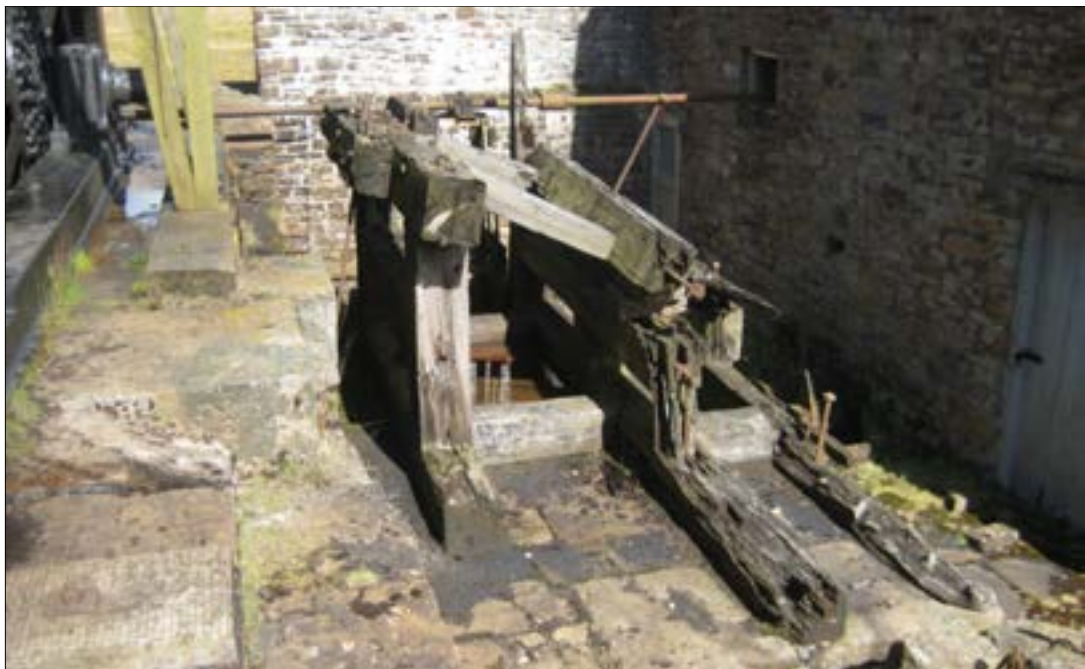
*Plate 14: ore crusher supports at Killhope mine, Co. Durham.*

example is at Killhope lead mine in Weardale, County Durham, where much of the wooden framework for a set of single rollers is still in place in an open area between the water wheel and the associated jig house. At Killhope, a free-standing timber support structure sits on a base framework of edge-set beams that are secured with iron bolts to a flagstone surface (Plate 14). There is no suggestion of a sub-floor structure at Killhope.

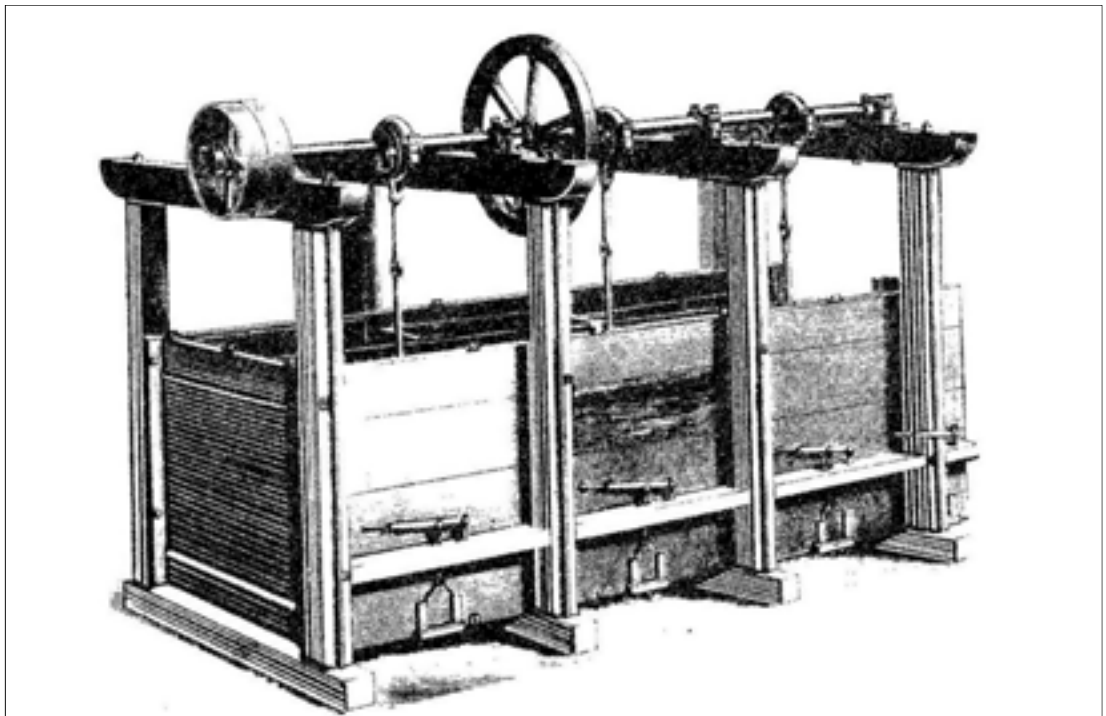
*Plate 15: mechanical jigs (after Hunt 1887).*

- 8.10 The results of the evaluation suggest that the building was probably a jig house but have provided no further information about how the jigs were powered. Mechanical jigs were in common use by the 1860s, and it is more than likely that the Penny Rigg jigs were powered by a water wheel. There is no compelling evidence for a water wheel attached to the jig house and it is most likely that the jigs were powered through extended shafts and gearing by the crusher house water wheel. The second water wheel, which is listed on the 1875 sales inventory of the mill, remains elusive (NAA 2016, 56) but could well have been located on the lower terrace south-east of the jig house, where it operated buddles and a set of stamps. The absence of copper

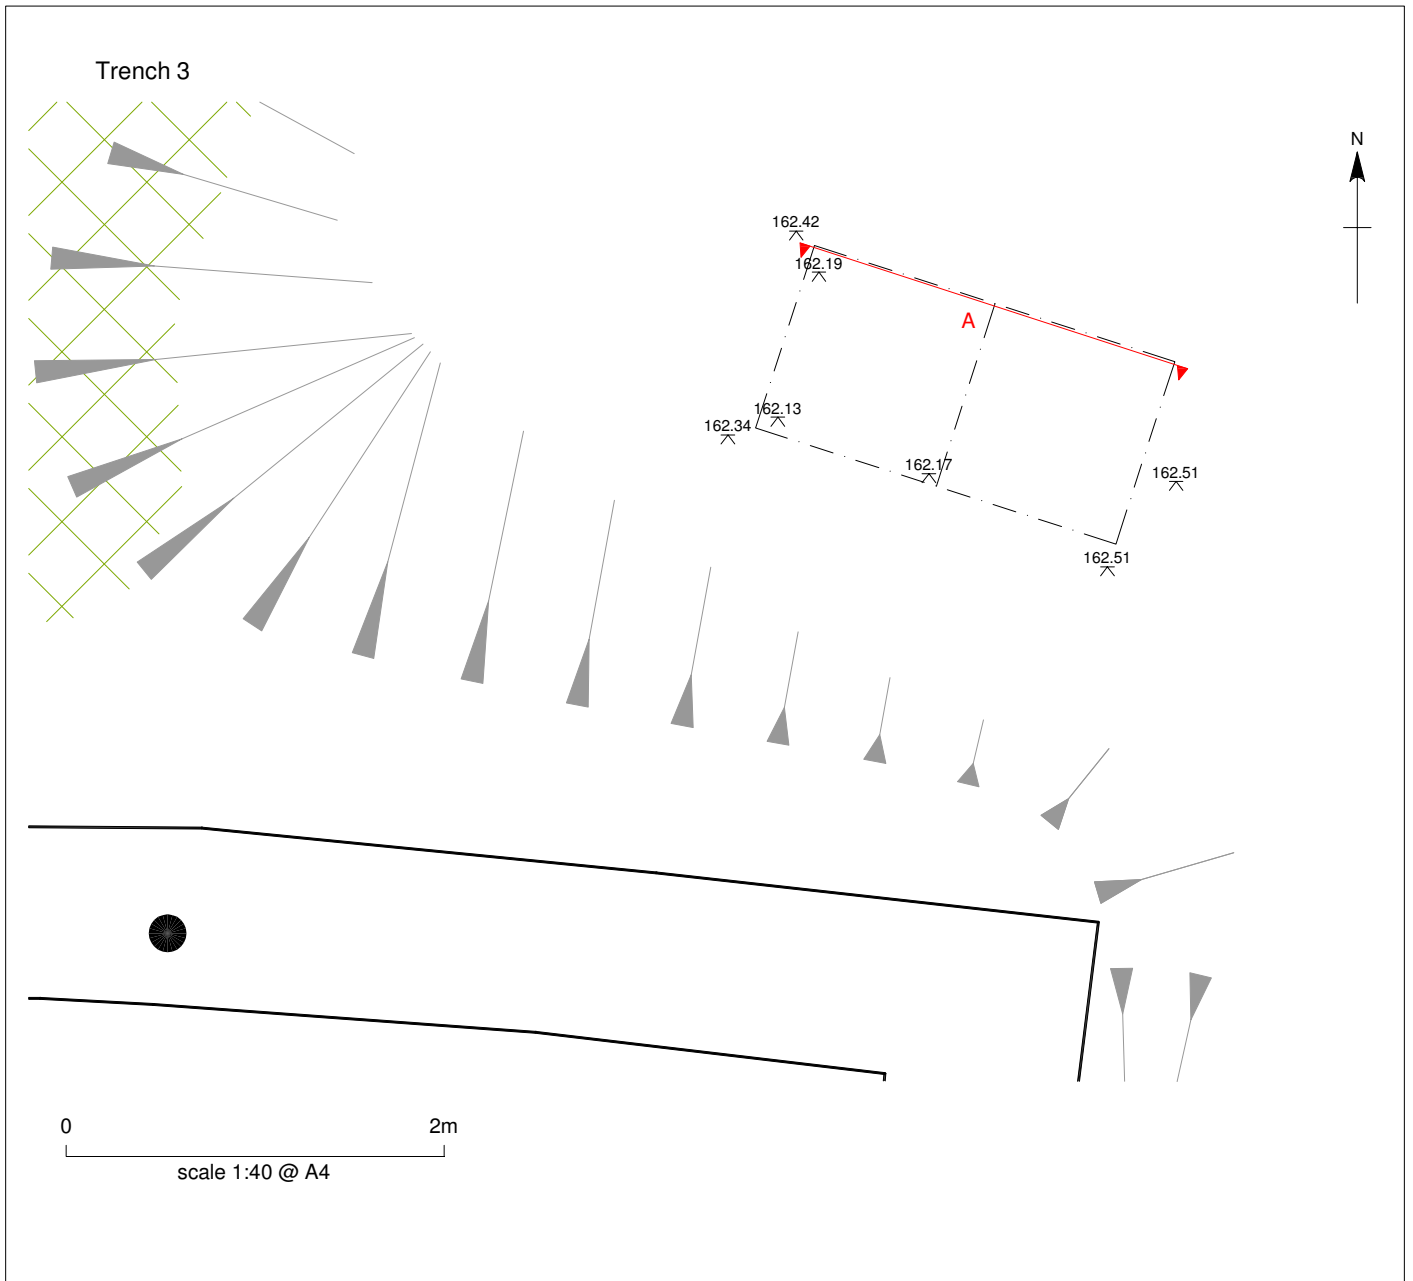
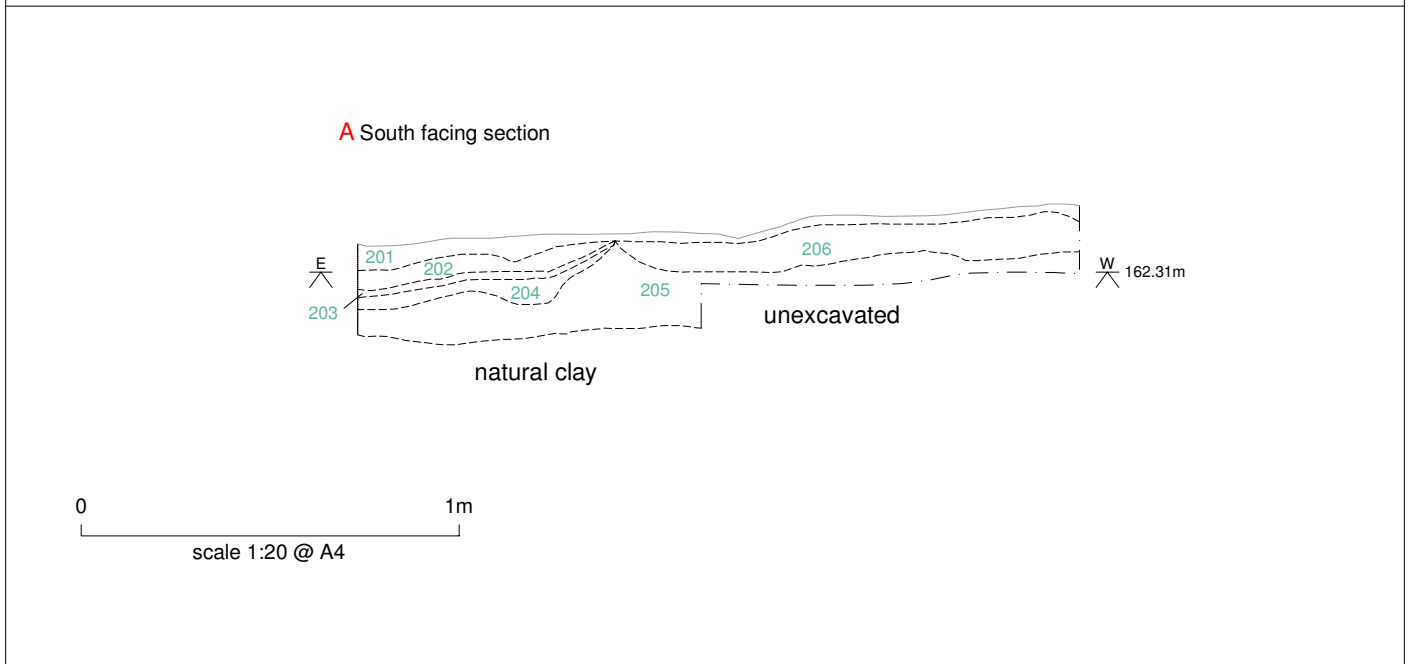
©NAA 2017 Penny Rigg copper mill Community Excavation, Cumbria: Trench 3 plan and section Figure 6

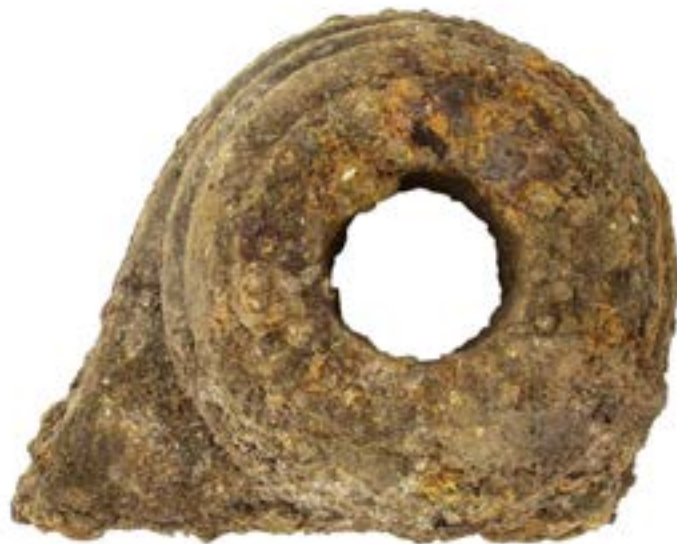
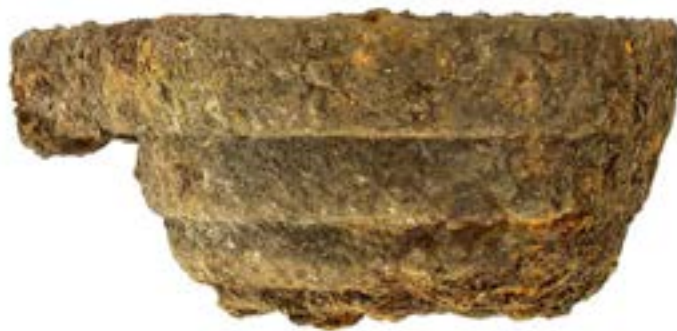
Figure 7: incomplete cast iron beehive-shaped fitting

41. **Glass vessel.** Single colourless translucent glass vessel sherd of similar type to those in Trench 1 Context 002. Modern.
42. **Iron concretion.** Three iron concretion fragments. 67g.
43. **Iron fitting.** Incomplete cast iron beehive-shaped fitting, possibly broken. Circular fragment: largest D: 63mm, hole D: 22mm, H: 34mm. 646g. Figure 7.
44. **Iron nails.** Eighteen small square sectioned nails and nail fragments (no complete heads). Most complete: L: 40mm, shank: 4x4mm. 74g.
45. **Iron nail.** Large square sectioned nails with incomplete heads. Most complete: L: 89mm, shank: 8mm x 8mm. 111g.

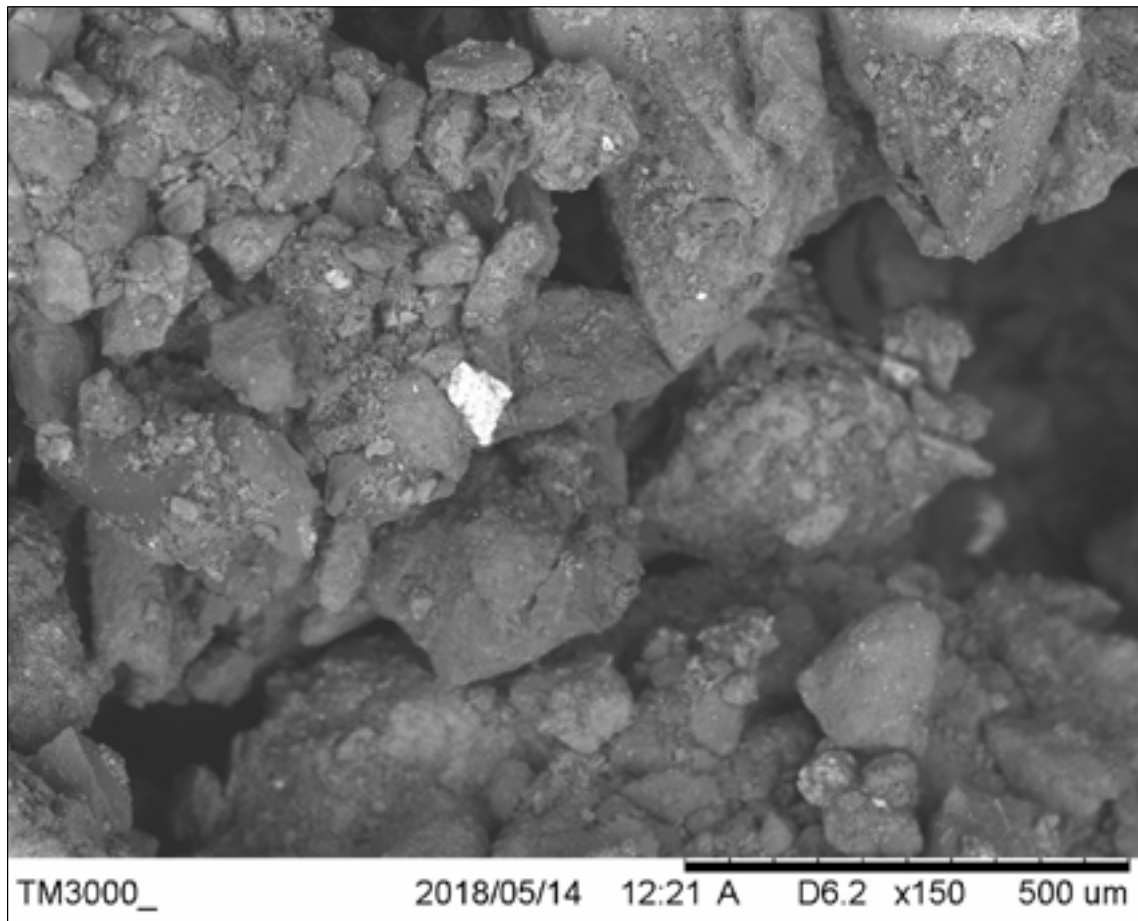
Figure 8

*Penny Rigg copper mill Community Excavation, Cumbria: Back-Scattered SEM image of PRE17 showing bright grain roughly 100 microns in size. Analysis by Energy dispersive x-ray spectrometry (EDS) showed the body to be composed mostly of barium. All bright bodies in the image were analysed and none showed significant copper content. (Image courtesy of Durham Archaeomaterials Research Centre)*

The soil and the coarse fraction were examined in a Hitachi TM3000 SEM fitted with a SwiftED3000 EDS (Fig. 8). The soil was not homogenised at this stage, so discrete copper bodies and minerals could be assessed if found. In total, 1.5g of soil and 1g of coarse fraction were analysed. The accelerating voltage of the SEM was set to 15kV and the probe current was set to 700pA. The samples were investigated in Back-scattered Electron (BSE) mode. The bulk compositional analysis was generated by the SwiftED software using standardless matrix corrections and is semi-quantitative. The results can be found in Figure 9 and Table E1.

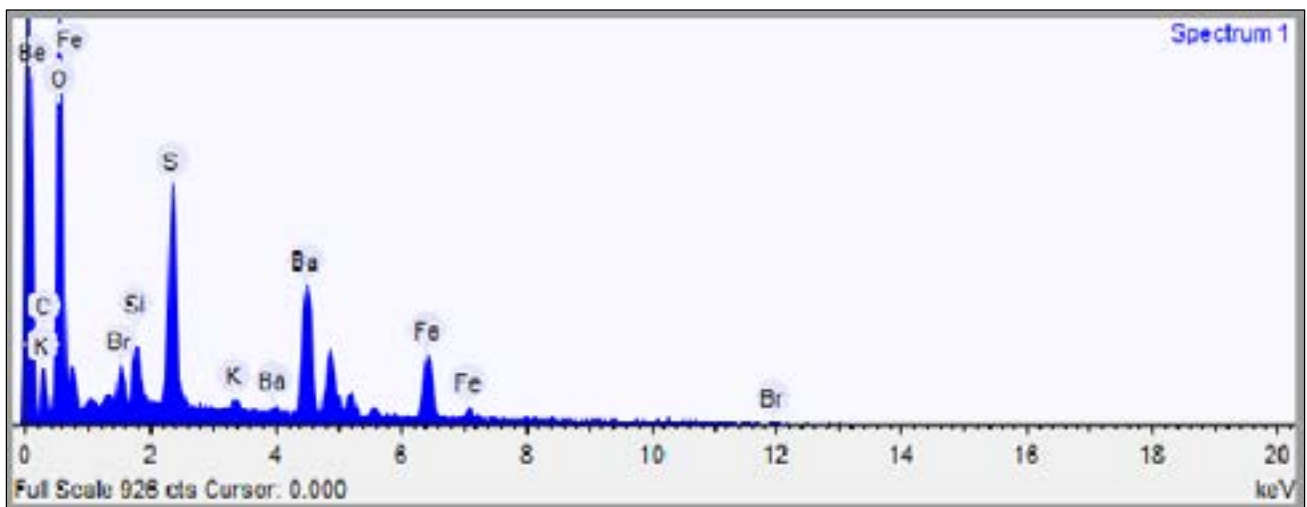
*Penny Rigg copper mill Community Excavation, Cumbria: EDS spectrum of barium-rich grain. (Image courtesy of Durham Archaeomaterials Research Centre)*
