PENNY RIGG COPPER MILL,

ARCHAEOLOGICAL  
COMMUNITY LANDSCAPE  
AND BUILDING SURVEY

PENNY RIGG COPPER MILL,  
TILBERTHWAITE, CONISTON,  
CUMBRIA

NAA 16/145  
November 2016  
(Issued January 2017)

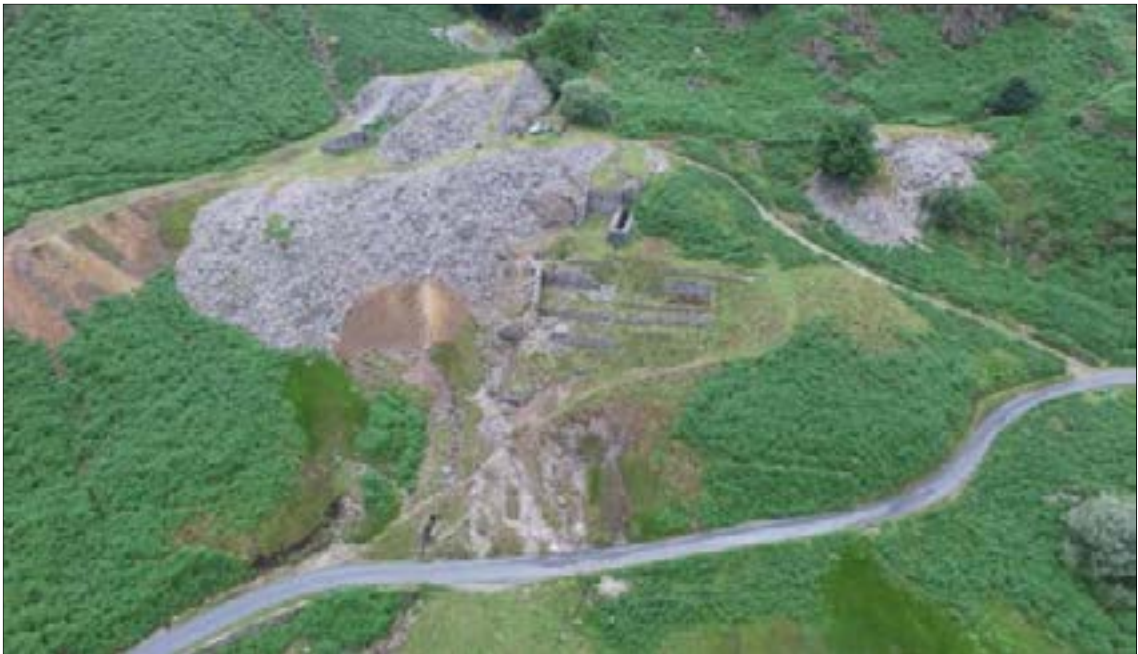
*Plate 1: the Penny Rigg copper mill site looking west; photograph taken by aerial drone. Note the rid tips associated with the later slate quarry*

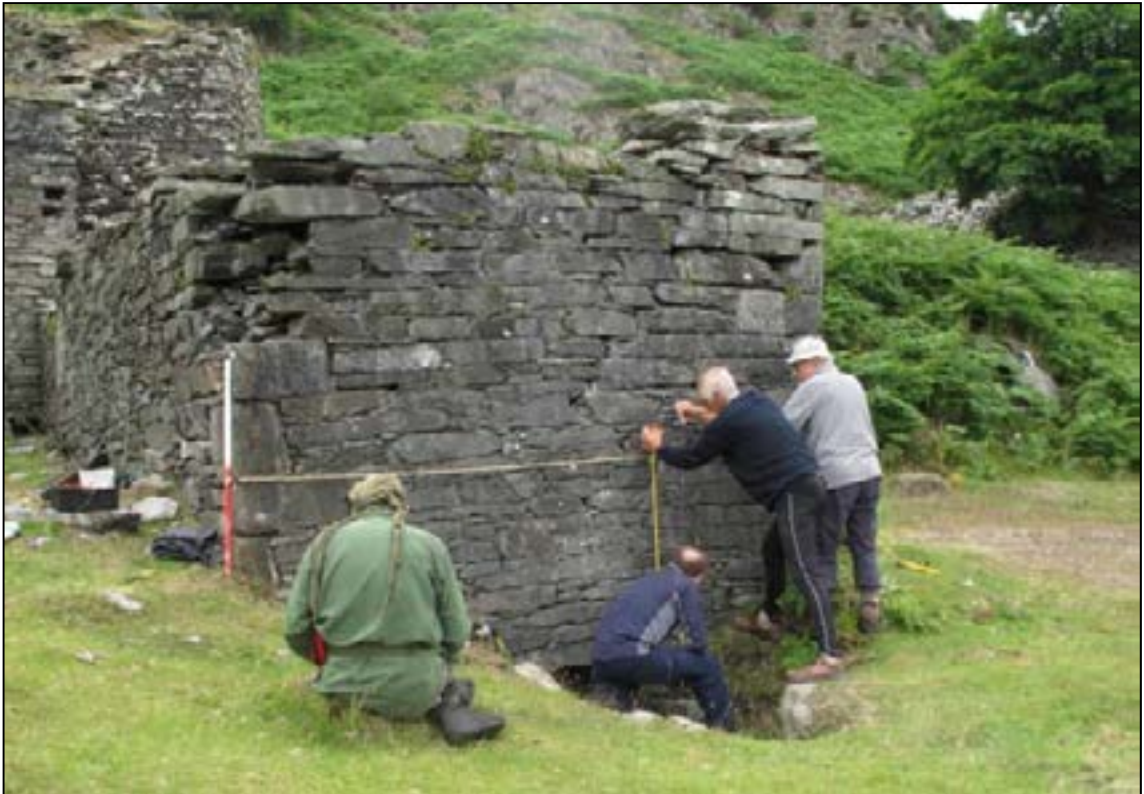
*Plate 4: traditional building recording techniques – volunteers using tape and offset to record the east wall of the wheel pit*

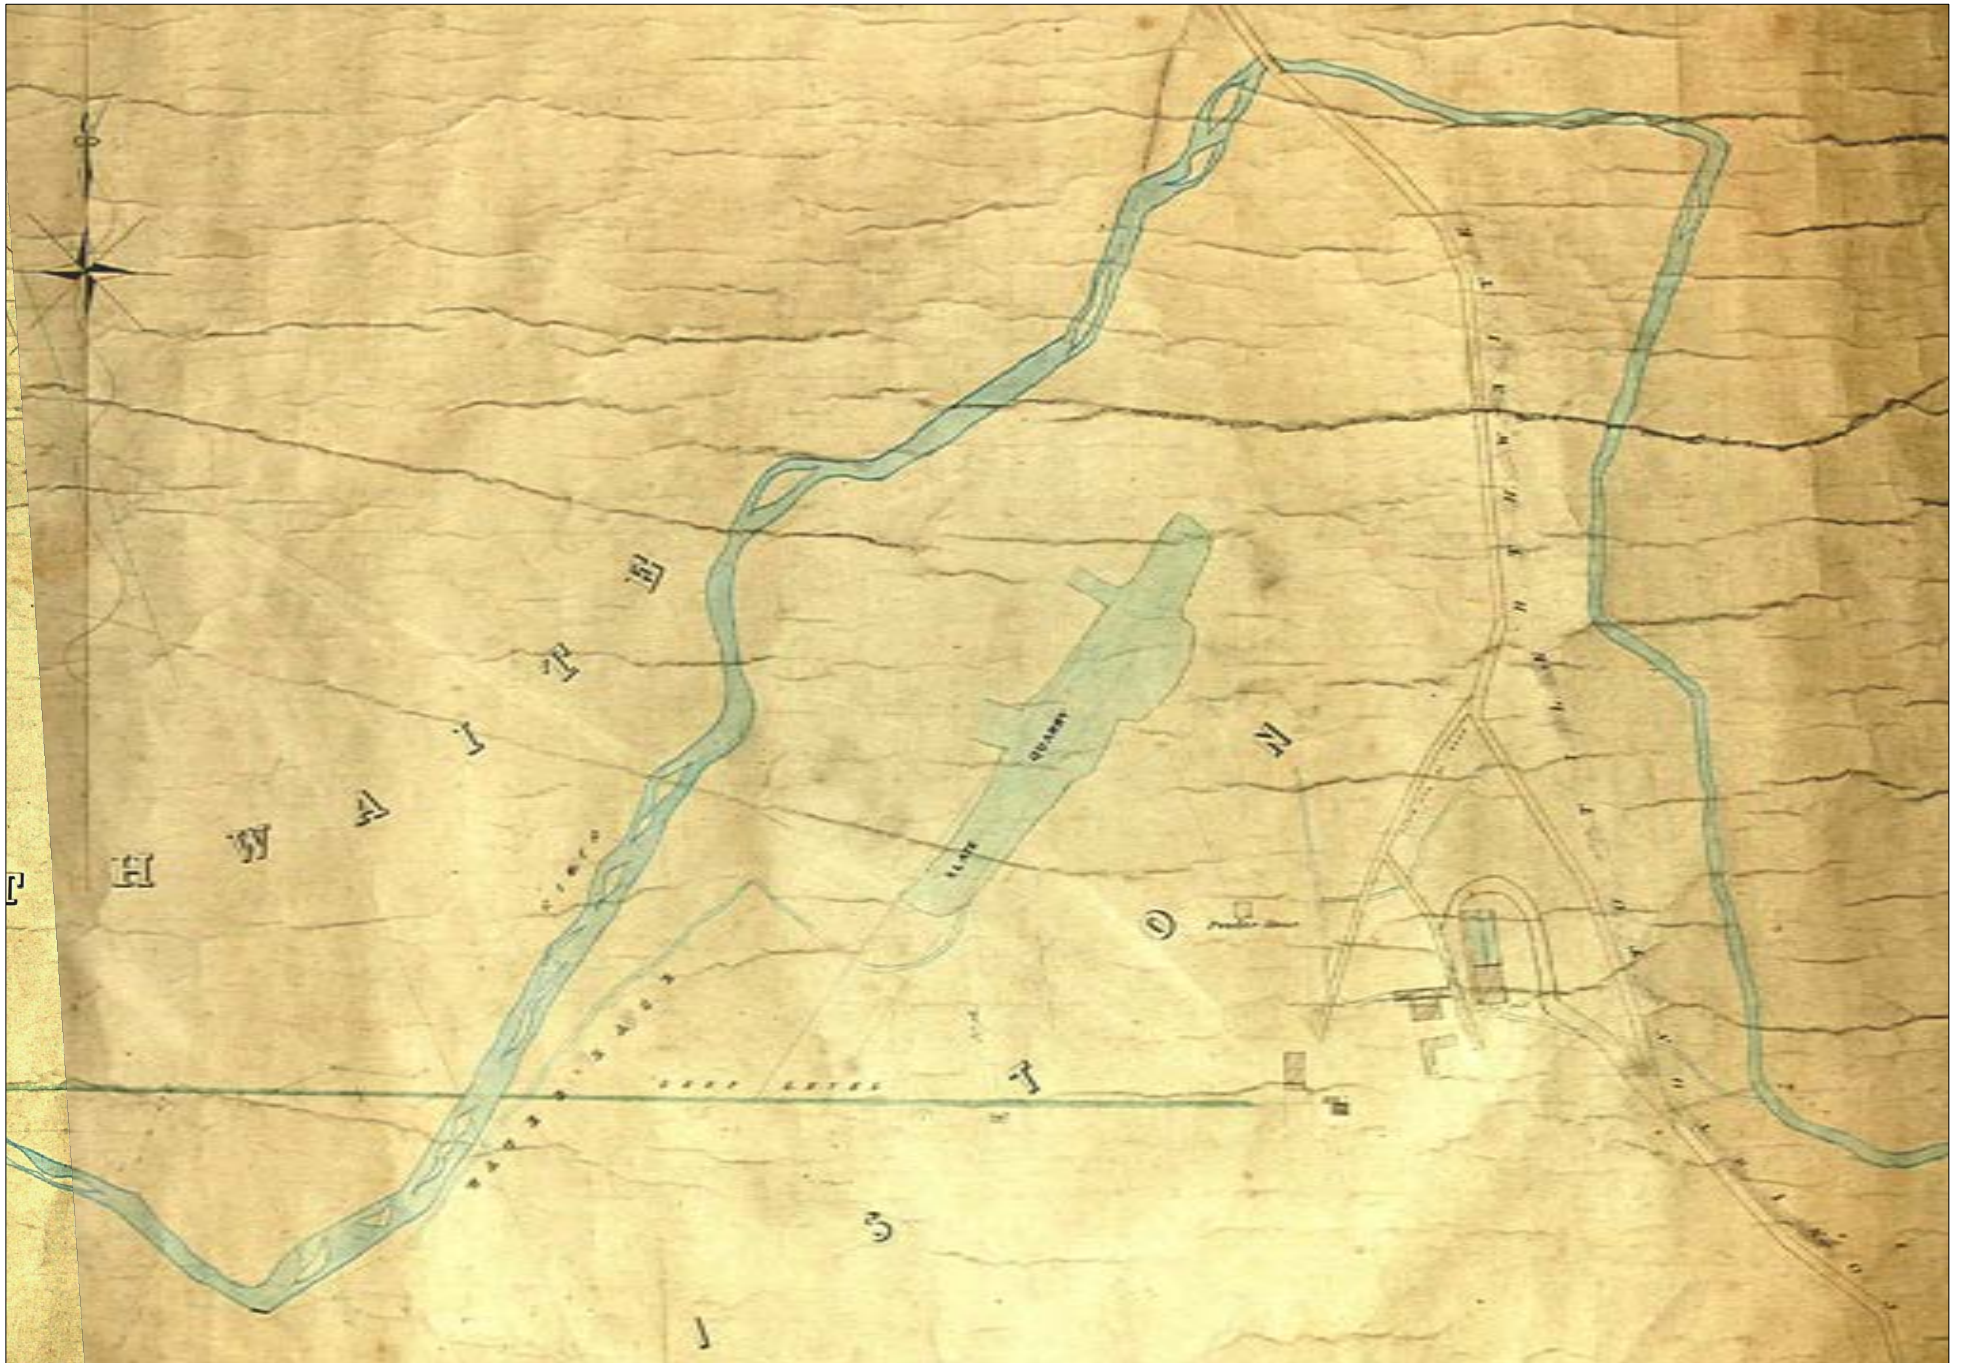
*Figure 7*

*Penny Rigg copper mill, Cumbria: detail from the Lampton plan c.1869*

- 4.24 The completed mill complex is shown on the Lampton Estate map, prepared c. 1869 (CATMHS archive, no ref) (Fig. 7), the layout of which is much as it appears today. The only exception is the L-shaped structure to the south of the crusher, which is now largely buried beneath a later rid tip (813), although a small section of paved floor still survives

- 4.25 The Lampton map suggests that water to power the large mill wheel was diverted from Tilberthwaite Gill and conveyed along a curving leat to Penny Rigg (Horse Crag) quarry (Figs 7, 8). A small dam is shown controlling the flow into the race from the gill at approximately NY 30283, 00642. The diverted water flooded the quarry, where all production had ceased a number of years earlier, effectively creating a reservoir. Water was carried along the old quarry adit, mentioned by Corry, and fed into the mill leat (Corry 1825, 528). The location of the quarry on the higher ground to the north of the mill would have ensured a suitable head of water was maintained at all times.

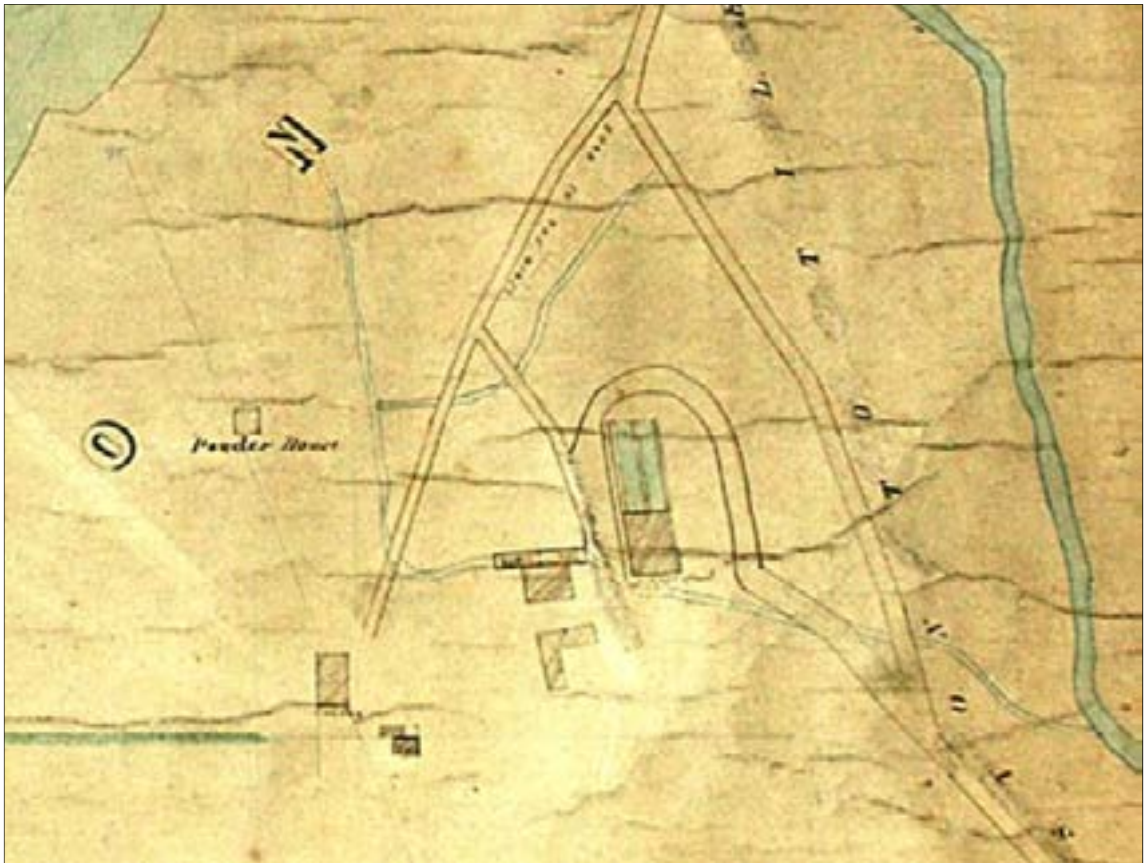
*Figure 8: extract from the Lampton map, c. 1869, showing the dressing mill complex (CATMHS archive – no ref – image supplied by I. Matheson)*

*in situ* (423). The plan also shows a small rectangular structure to the east of the level entrance, which may be an ore hopper (Fig. 8).

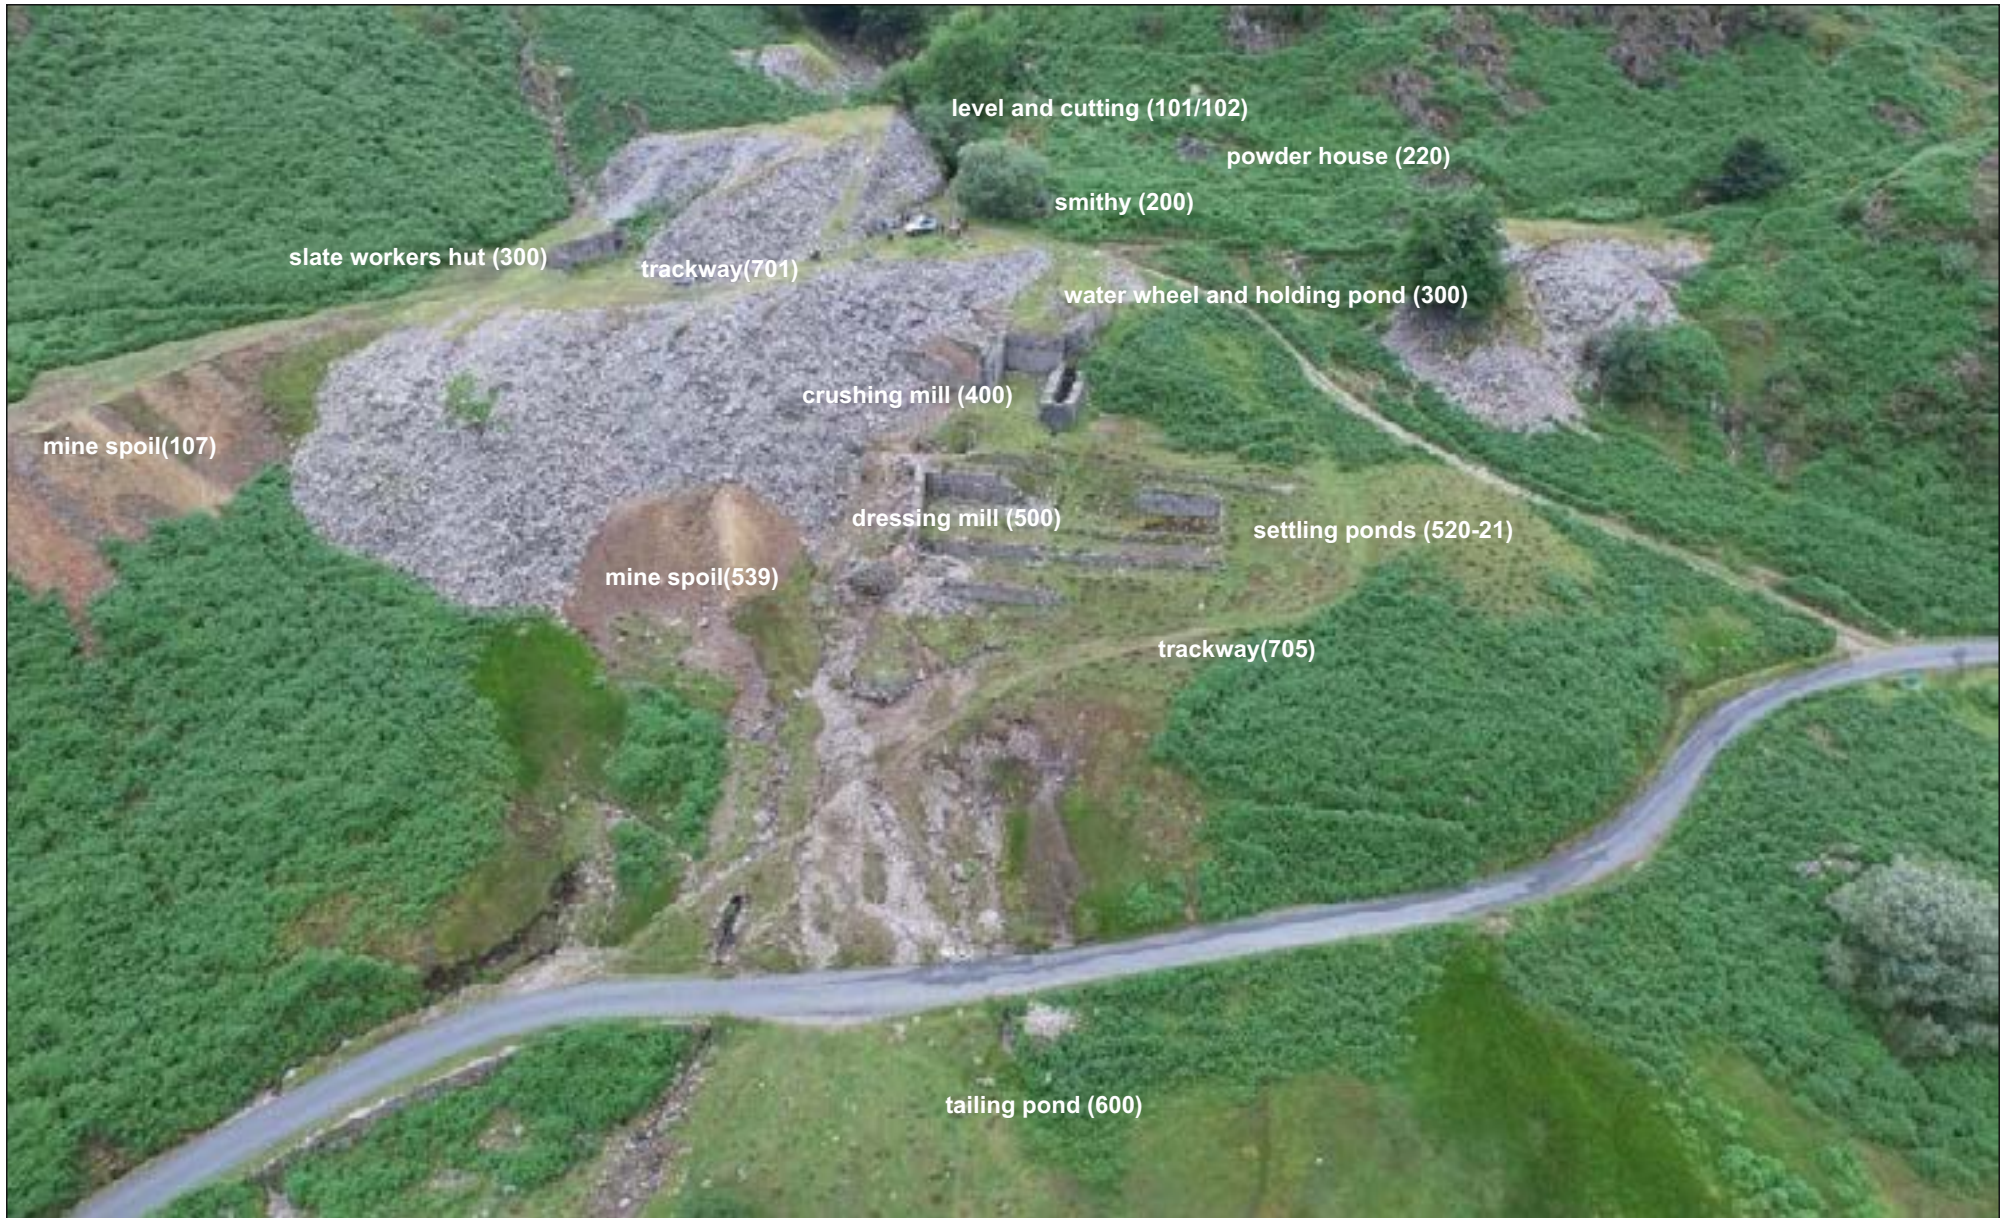
*Penny Rigg mill complex, looking west, annotated with key structures and features*

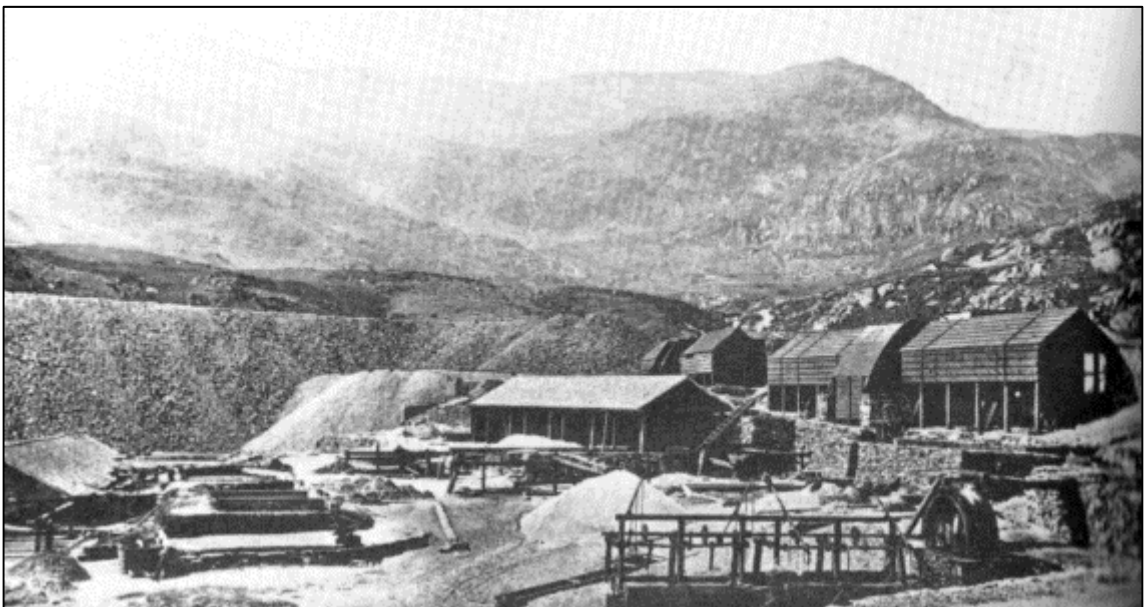
*Plate 5: a late 19th-century view of the Bonsor Lower Mill at Coniston copper mines showing the extensive use of timber in the mill buildings. In the foreground is a set of unenclosed water powered jigs and to the left are open settling ponds. Taken from Holland 1986, 174*

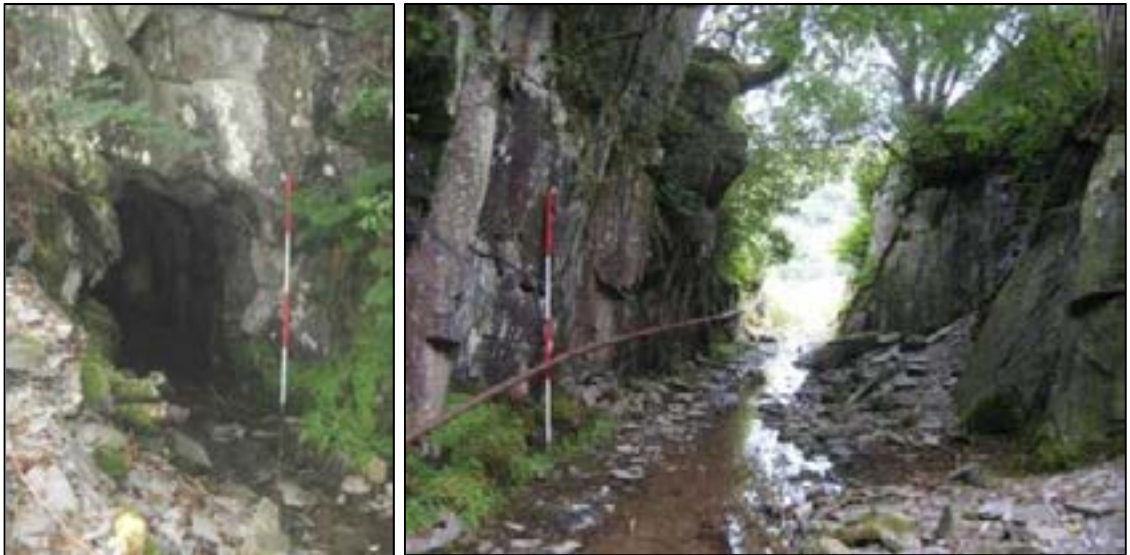
*Plates 6, 7: (left) portal to Horse Crag Level (101) and (right) associated cutting (102), note water continues to drain out of the adit*

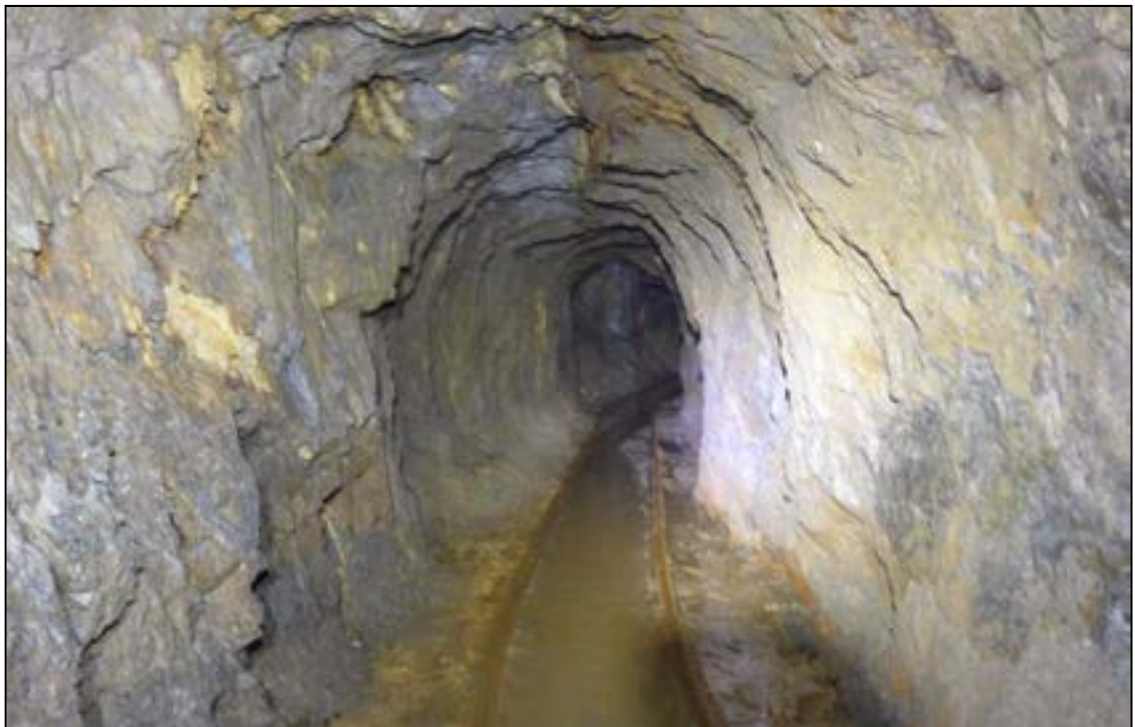
*Plate 8: interior of Horse Crag Level, photograph (c) W. Allison*

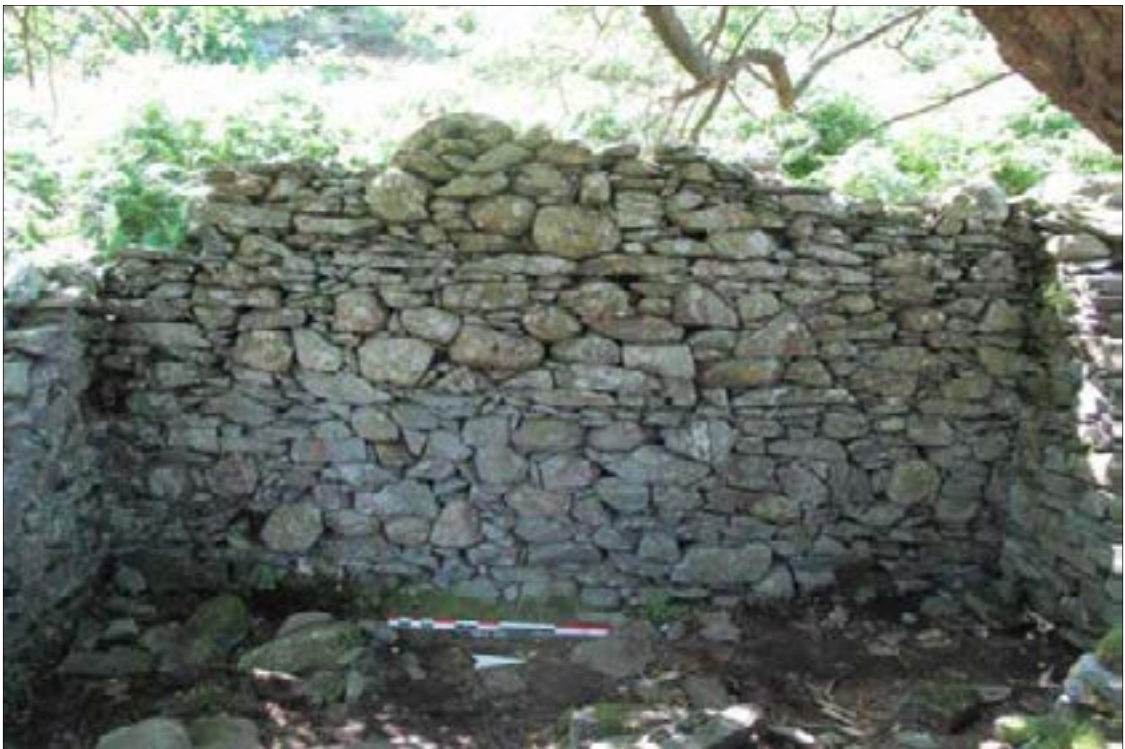
*Plate 9: east-facing elevation of smithy back wall (205) showing the levelling of the wall at intervals with smaller flat pieces of slate*

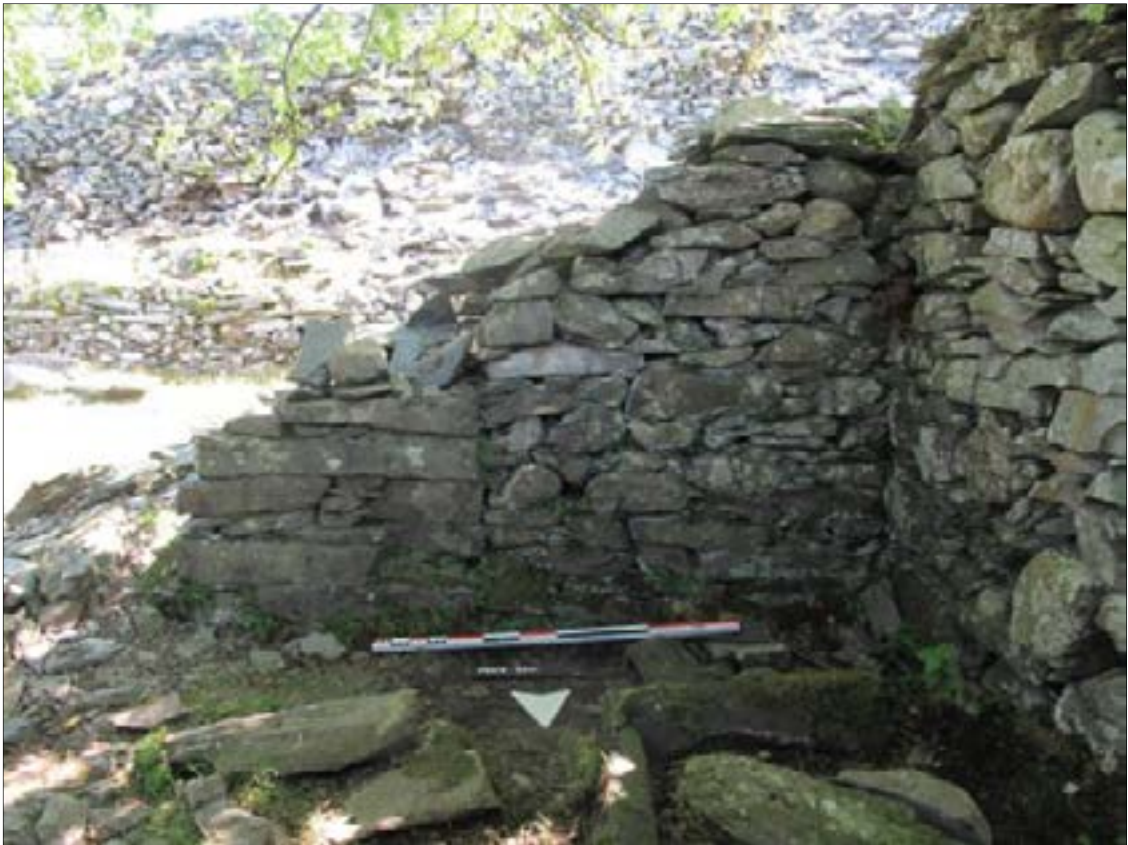
*Plate 10: internal north elevation of wall (202), showing blocked door (203) to the left*

- 5.18 The building features evidence of both its original use (209), (210), (211) and modification over time (203), (204). The south wall of smithy (202) survives to a maximum height of 1.40m internally, towards the rear of the building. The height of the wall decreases towards the front. This wall includes evidence for what is believed to be a

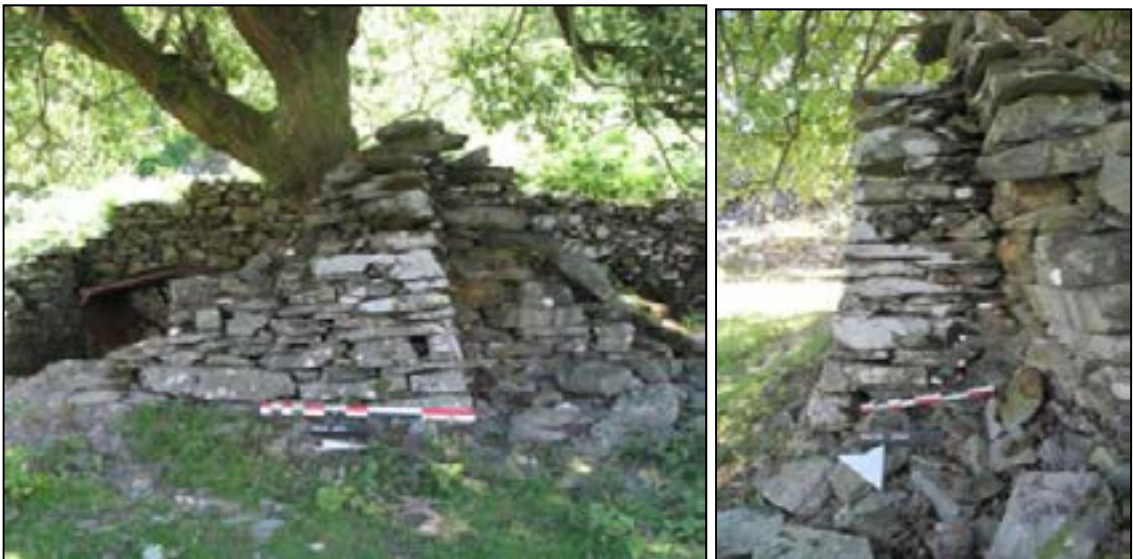
*Plates 11, 12: (left) east-facing elevation of the buttress (208), (right) north-facing elevation of the buttress (208)*

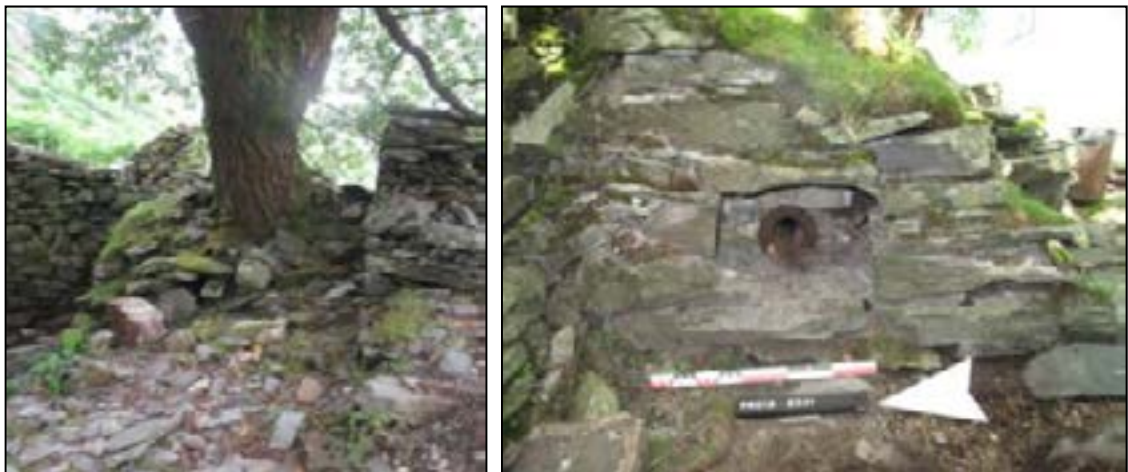
*Plates 13, 14: (left) hearth (209), facing north, (right) west-facing elevation of hearth (209) showing bellows hole (210) and metal inlet pipe (211)*

209	<p>Hearth. This has a large tree growing out of the middle of it which has caused a lot of damage making it difficult to see the hearth's original form. The bellows hole and metal inlet pipe (210, 211) survive at its W end.</p> <p>The hearth is roughly 2.10m by 1.40m and it survives to a maximum height of 1m. The W elevation is roughly keyed into the north wall (206) and is made up of random coursed roughly rectangular blocks.</p>	<p><b>High</b> – good historical and evidential value as demonstrates the function of the building, although badly damaged by the tree.</p> <p>Its form may be better understood once rubble is cleared.</p>	N wall (206) E wall (207) Buttress (208) Bellows hole (210) Metal inlet pipe (211)	High High High High High	c. 1850

Context No.	Description	Significance	Associated with	Contribution to Significance	Date	Photo
210	Bellows hole. Roughly square opening within the western end of the hearth (209) measuring 0.30 by 0.30m at its widest points. The aperture is approximately 0.15m deep.	<b>High</b> – good historical and evidential value as contributes to our understanding of how the building functioned.	N wall (206) Hearth (209) Metal inlet pipe (211)	High High High	c. 1850

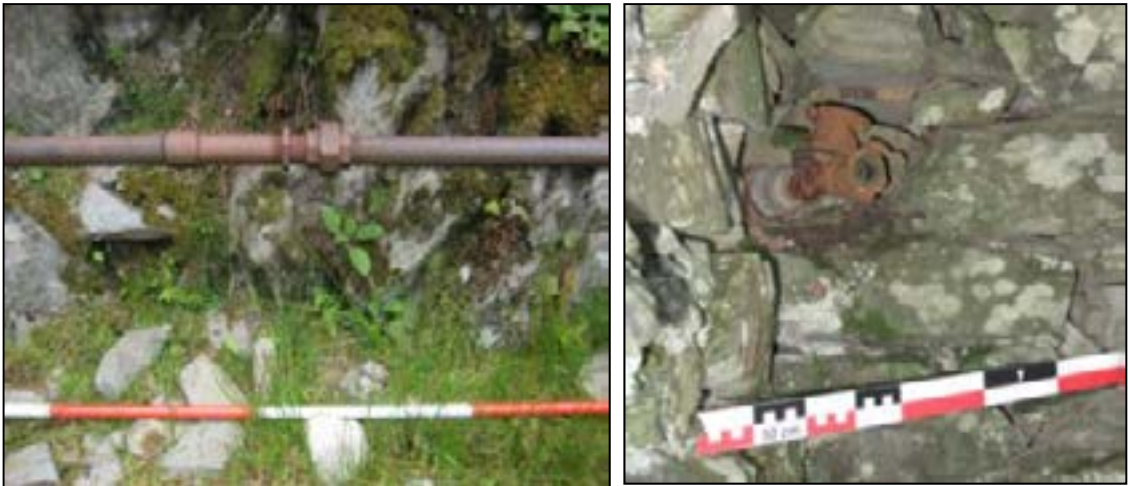
**Plates 15,16:** (left) compressed air pipe (105), (right) compressed air pipe valve (204) in the smithy

- 5.24 In the south-west corner of the smithy is a valve (204), which is connected to a compressed air pipe (105) (Plate 15). The iron compressor pipe, 64mm (2½in) in diameter is attached by iron brackets to the north wall of Horse Crag Level and the north side of the entrance cutting. It runs north-east along the surface from the east end of the cutting towards the south-west corner of the smithy. The presence of the valve (204) (Plate 16) and the compressor pipe (105) demonstrate the changing use of the building and the changing methods for working the mine.

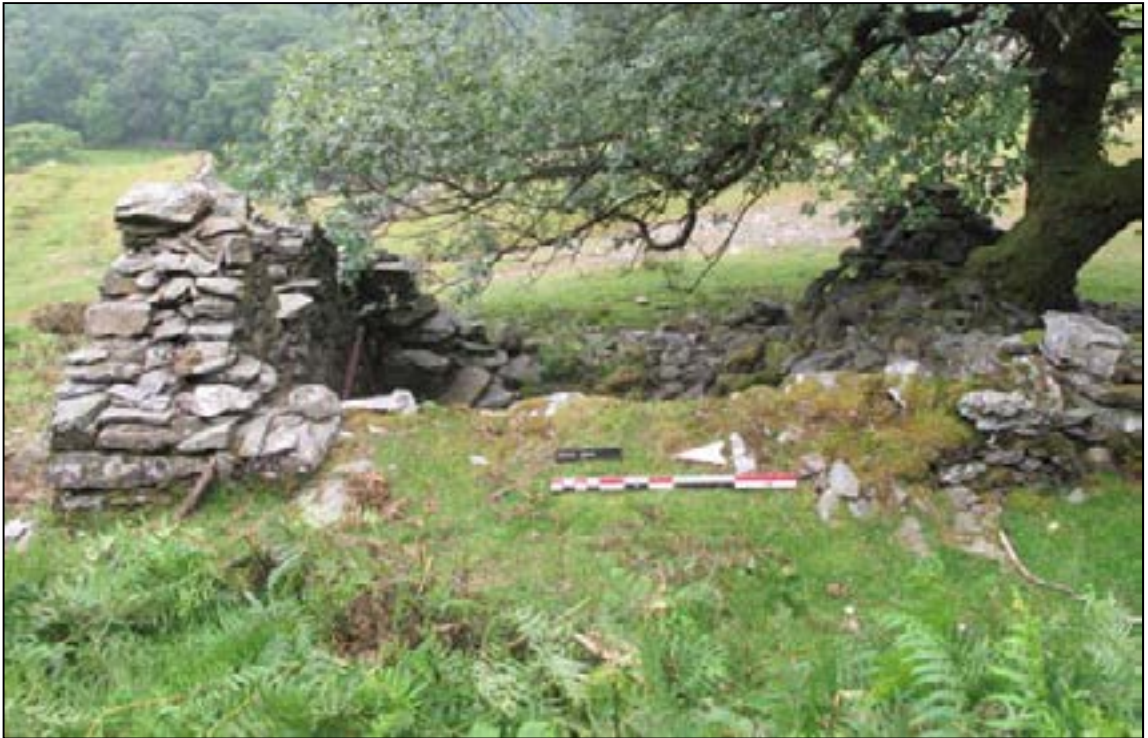
*Plate 17: remains of the smithy (201), looking east*

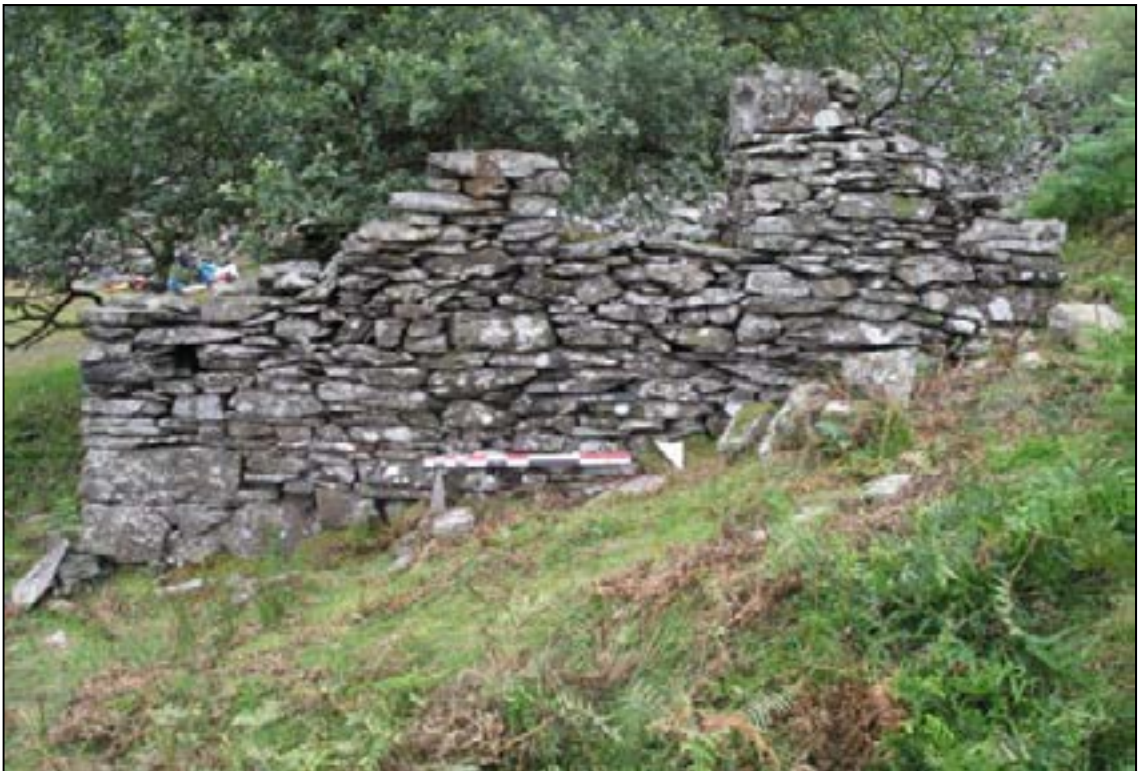
*Plate 18: north-facing gable wall of smithy (201), looking south*

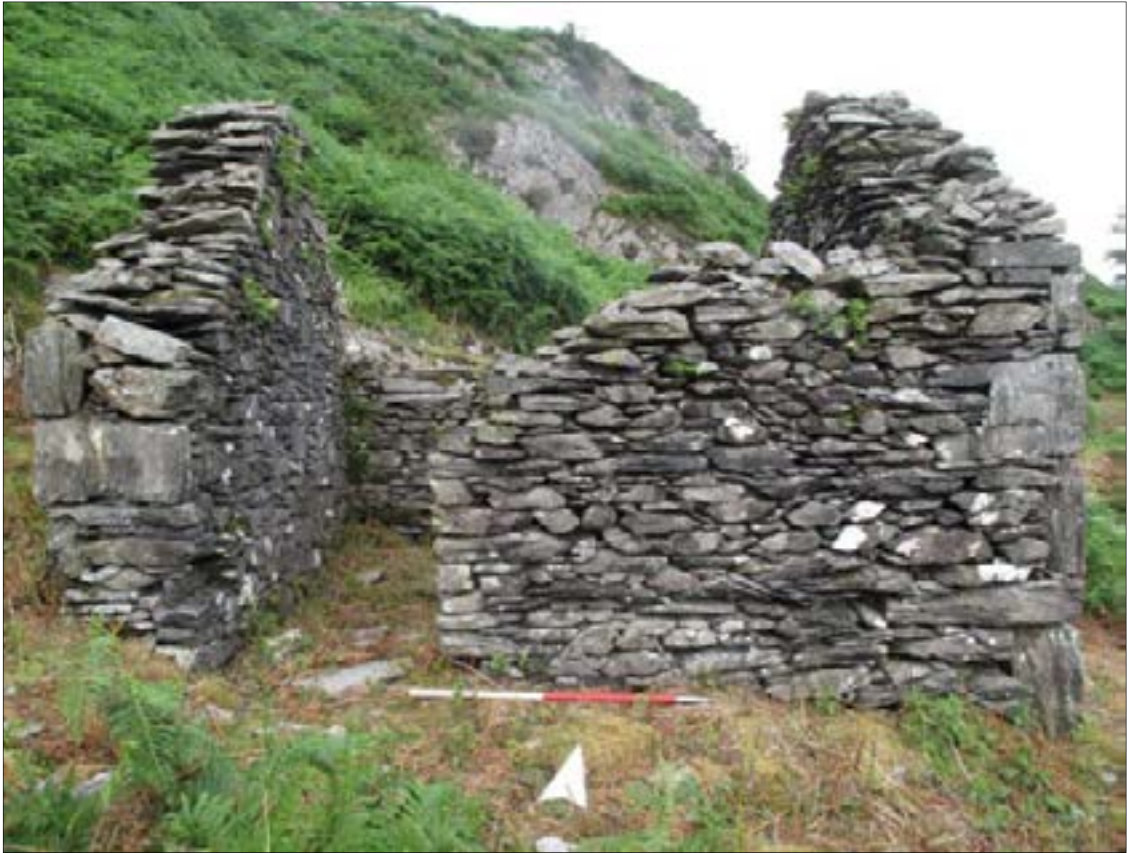
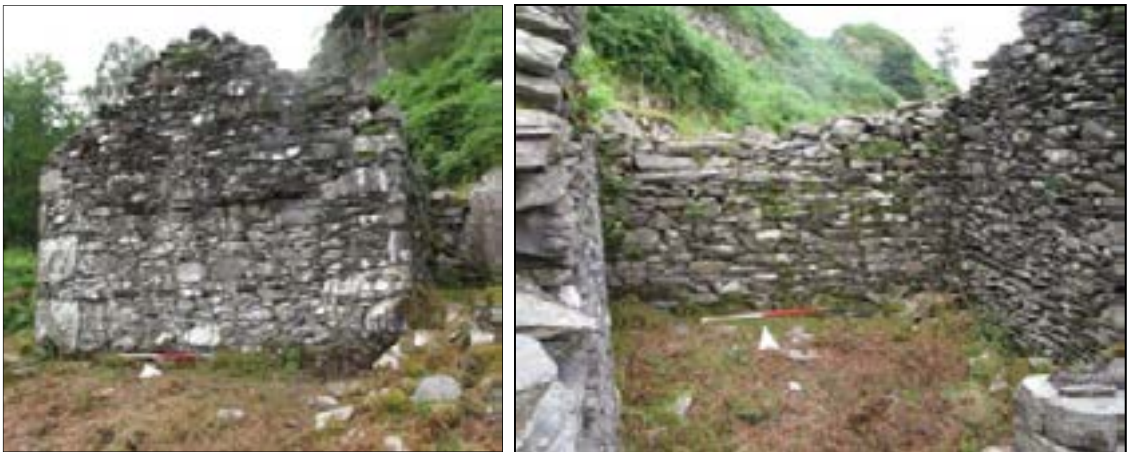
*Plates 19, 20, 21: (above) powder house (220) south-facing elevation and door opening (222), (below left) east-facing gable end and (below right) interior*

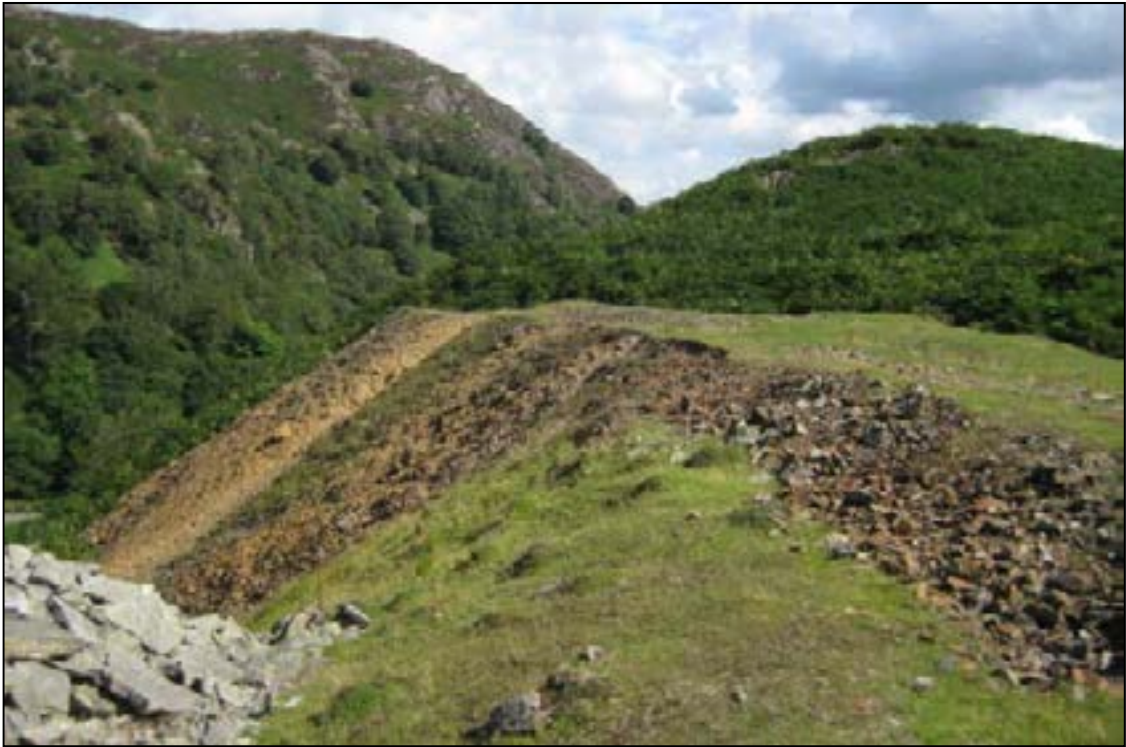
- 5.33 The broad terrace to the east (front) of the entrance cutting to the mine is the product of later slate quarrying, in particular the working of the closehead quarry in the early 20th century. A number of features associated with the mine and copper mill must have been buried by the quarry working and resultant rid tips. Other than the buildings described above, the only other surviving original feature in this area is spoil tip 107. This has the distinctive orange-brown colour of the mineralised rock and the remains of parallel tip lines at its south-east end (Plate 22). The north section of the tip lies under slate spoil tip (813) and its original extent is unknown.

*Plate 22: the distinctive orange-brown mineralised rock of spoil tip 107, associated with the working of the mine and partially buried beneath the later slate rid tip (813)*

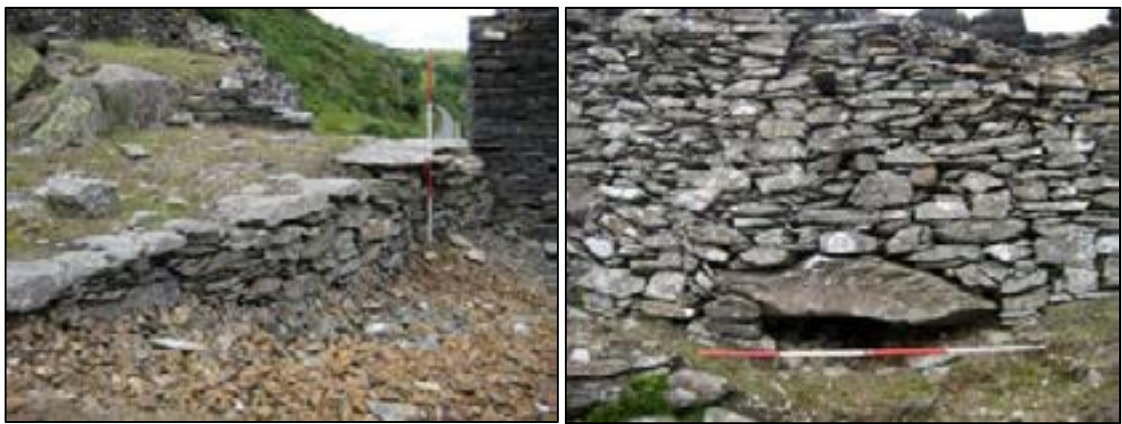
*Plates 23, 24: (left) short section of retaining wall (419), covered by later ridge tip at its south end; this may be associated with the mill sorting area and culvert beneath track (420) (right), potentially carrying waste from the ore cleaning operations*

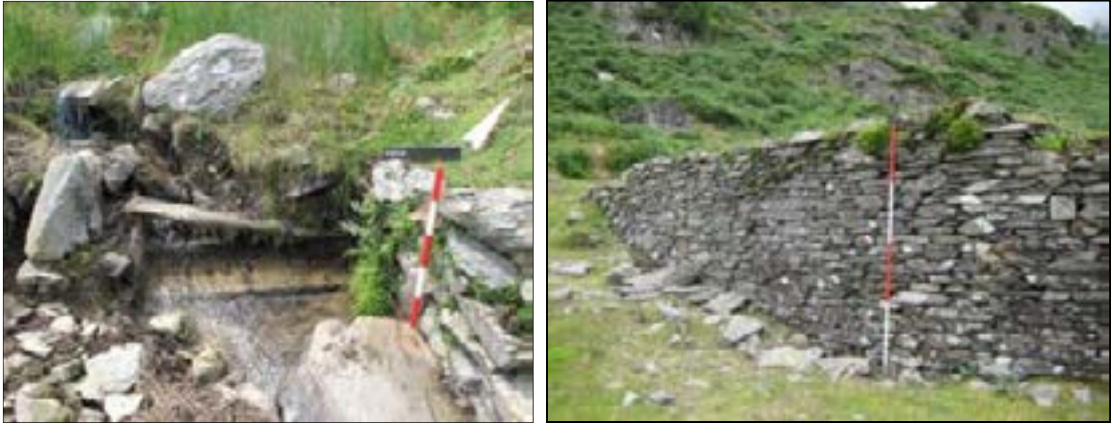
- 5.40 Approximately 17m south of culvert (319) is an overflow channel (318) cut into the east bank of the leat. This contains the remains of a timber box-drain and some wooden uprights, probably associated with a sluice gate (Plate 25). The overflow was used to control the flow of water to the holding pond and waterwheel with any surplus diverted in a channel down the hillside to Yewdale Beck. At the south end, the leat –

*Plates 25, 26: (left) box-drain in leat (318) and (right) south wall of the holding pond (313); note collapse of east wall just visible on the left side of photo*

- 5.41 The holding pond (310) survives intact except for the east end of wall (312) where some of the facing stone at the top has collapsed. Constructed against the natural slope, the oval, raised pond is supported by two massive retaining walls (311), (313) (Plate 26) with expanded sides. The pond itself is now drained and turf-covered, but originally was probably clay-capped (Plate 28). Two small rectangular holes in the face of the north wall (311) are either putlog holes for scaffolding or weep holes to allow the interior of the structure to drain. One curious feature is a change of building style at the west end of the south side wall where the regular rubble construction of wall (313) is replaced by a

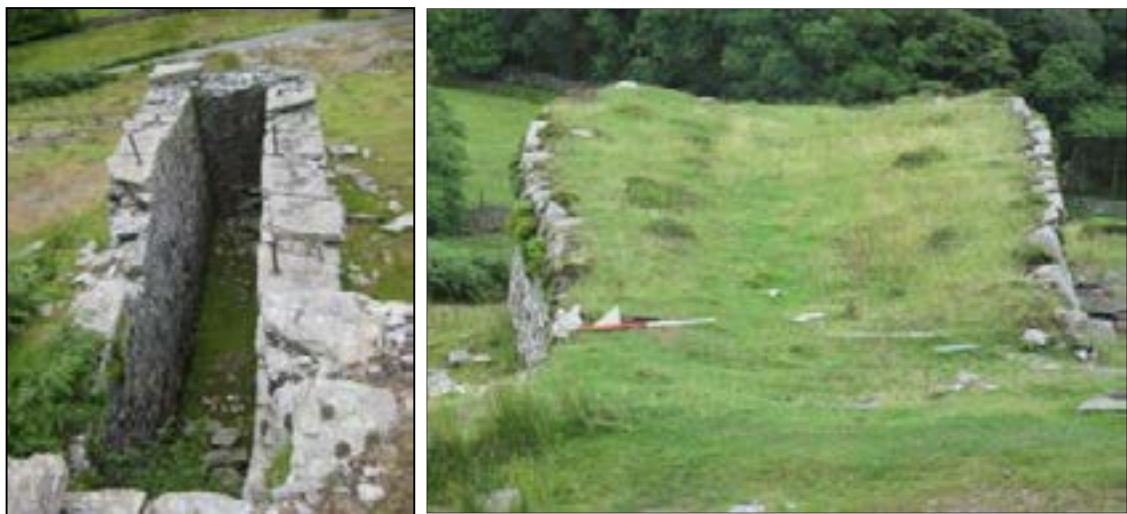
*Plates 27, 28: (left) remains of the Penny Rigg wheel pit, with bolts for the horizontal wheel supports still in situ, and (right) turfed-over remains of the holding pond (310)*

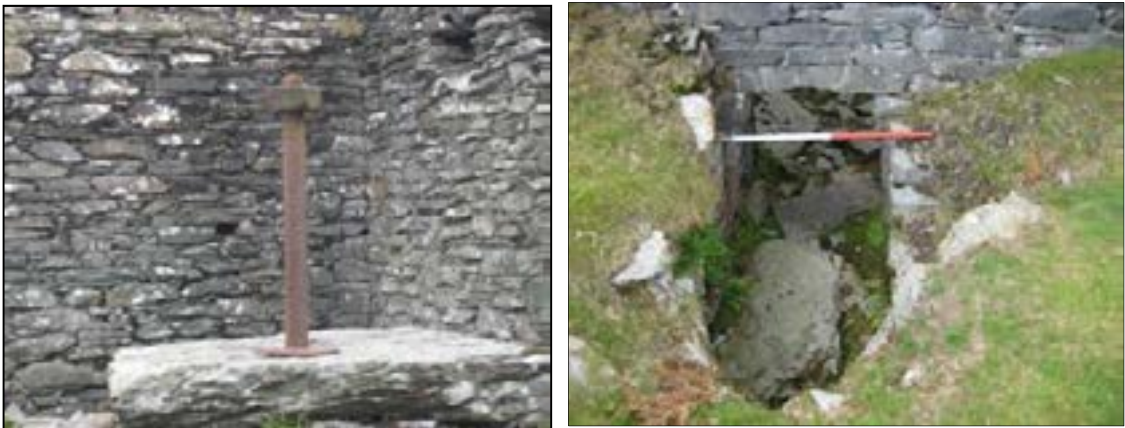
**Plates 29, 30:** (left) detail of one of the holding bolts at the top of the wheel pit (320) and (right) vent of race at the base of wheel pit (303)

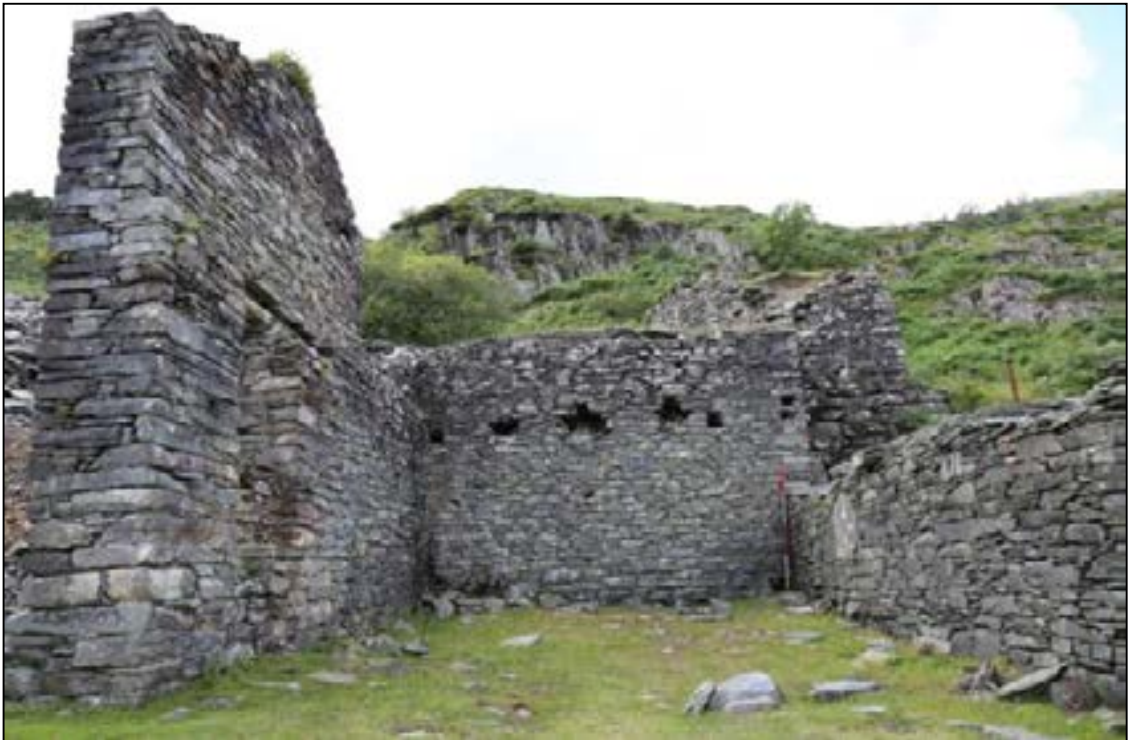
- 5.47 Set below the wall head of the east-facing wall (401) are a set of five rectangular joist holes (402), which correspond with a horizontal recess (408) on the north-facing wall and must relate to a timber floor spanning the interior of the building (Plate 31). This would have been accessed via entrance (409) in the south-west corner of the building, which connects with external track way (416) (Plate 33). There is, however, no surviving evidence of floor supports on the east and north sides of the building, although presumably these would have comprised a series of braced timber uprights. It is possible that the ground level void (405), at the north end of wall (401), was for one end of a horizontal sleeper beam holding vertical support timbers. Similarly, voids (403) on wall (401) may have held horizontal members relating to the north side of the same putative wooden structure. This structure must also have supported the north side of the crusher house gable roof. Recesses for roof trusses can be seen in the gable end wall (407), presumably connected with a matching timber gable to the north.

*Plate 31: east-facing wall of the crusher house (401), with first floor joist holes (402). The ground floor void (405) can be seen at the base of the vertical ranging rod*
