PENNY RIGG COPPER MILL,

ARCHAEOLOGICAL  
COMMUNITY LANDSCAPE  
AND BUILDING SURVEY

PENNY RIGG COPPER MILL,  
TILBERTHWAITE, CONISTON,  
CUMBRIA

NAA 16/145  
November 2016  
(Issued January 2017)

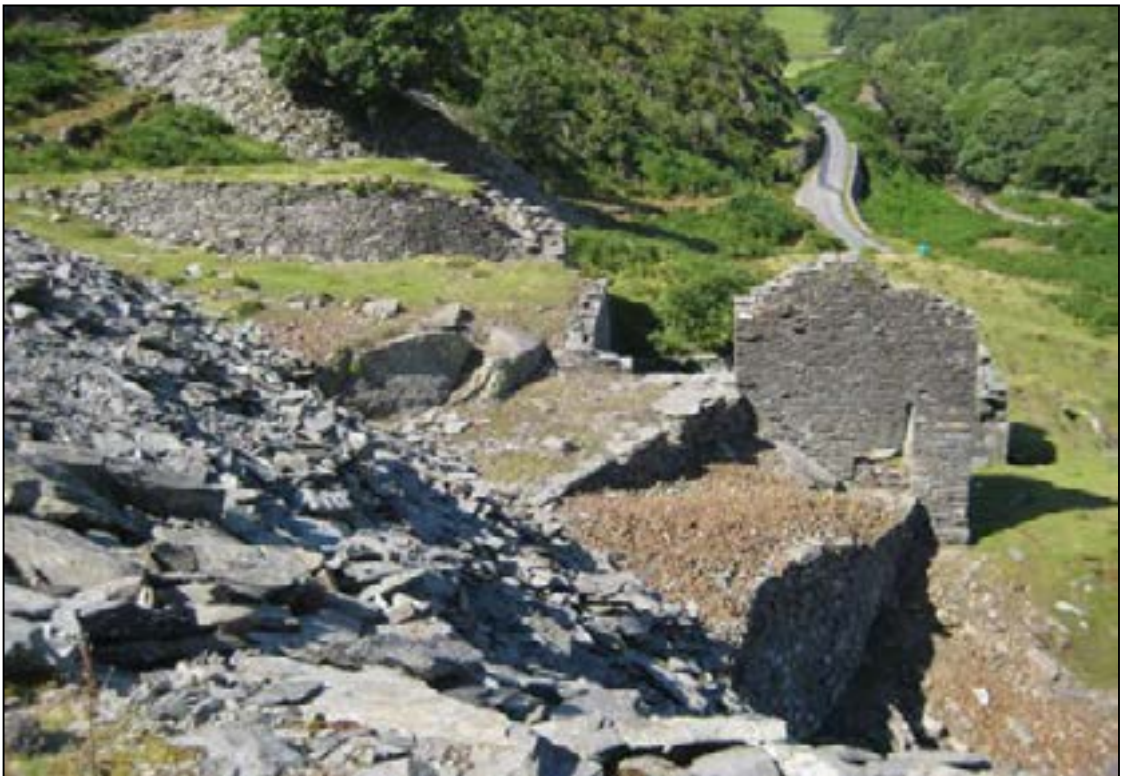
*Plate 32: view of the southern gable of the crusher house showing the rectangular opening (410) and associated track way (414). The three retaining walls (417/418) and (415) are also visible*

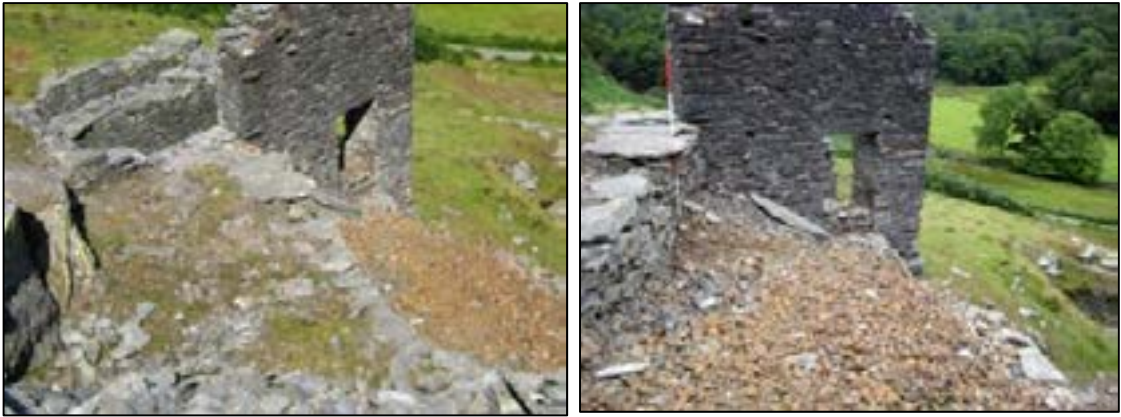
*Plates 33, 34: tracks above the crusher for delivering ore: (left) upper track (416) delivering material via opening (409) and (right) the lower track (414) associated with the lower level opening (410)*

414	Inclined ramp or track above retaining wall (415) and leading to opening (410) in S face of wall (407). Surface covered in broken mineral. S end obscured by slate tips (813) but may originally have been associated with ore hoppers on terrace below.	<b>High</b> – of considerable evidential value because of its association with the movement of ore into the building and its potential to interpret processes within the crusher house.	Crusher house (400) Wall (407) Opening (410) Wall (415)	High High High High	c. 1860

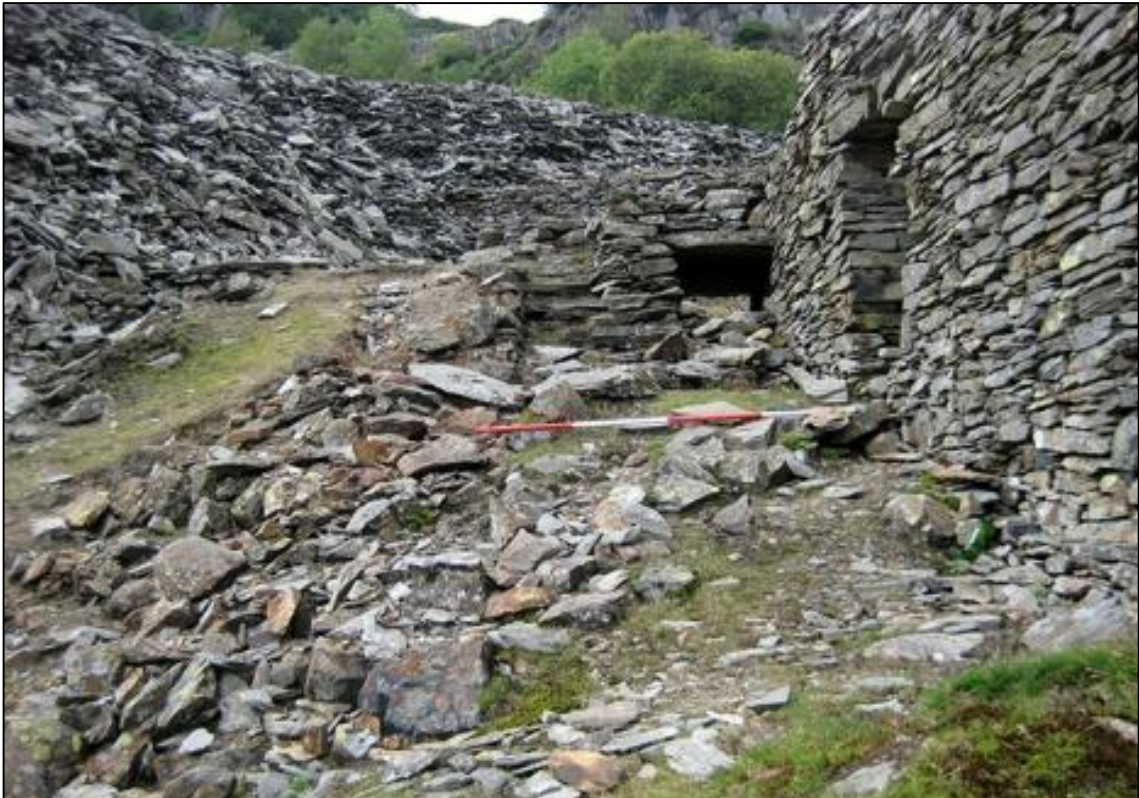
*Plate 35: looking west along the exterior of the south wall (507) of the dressing mill. The rectangular platform in this location (approximately the same width as the ranging rod) may be the backfilled remains of a smaller wheel pit associated with the mill*

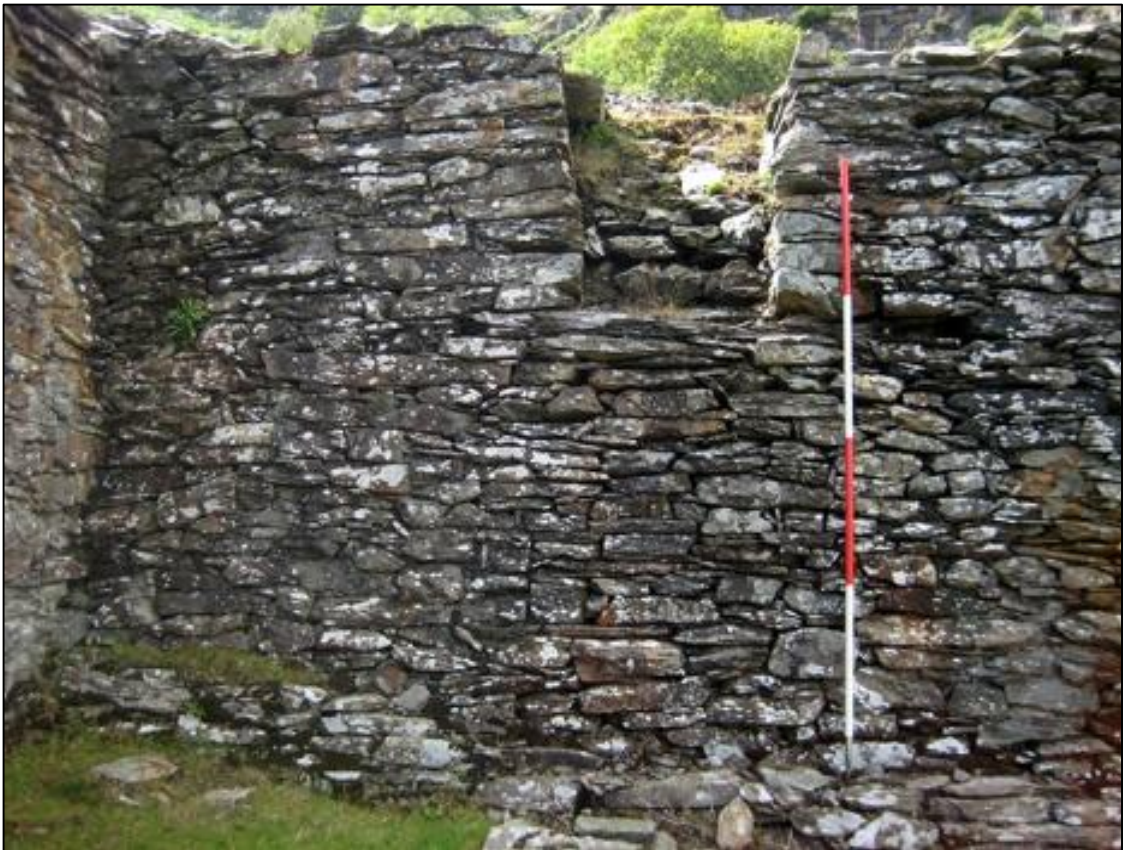
*Plates 36: angled recess (504) in wall (501); one of two chutes for tipping crushed ore from the crusher into the dressing mill*

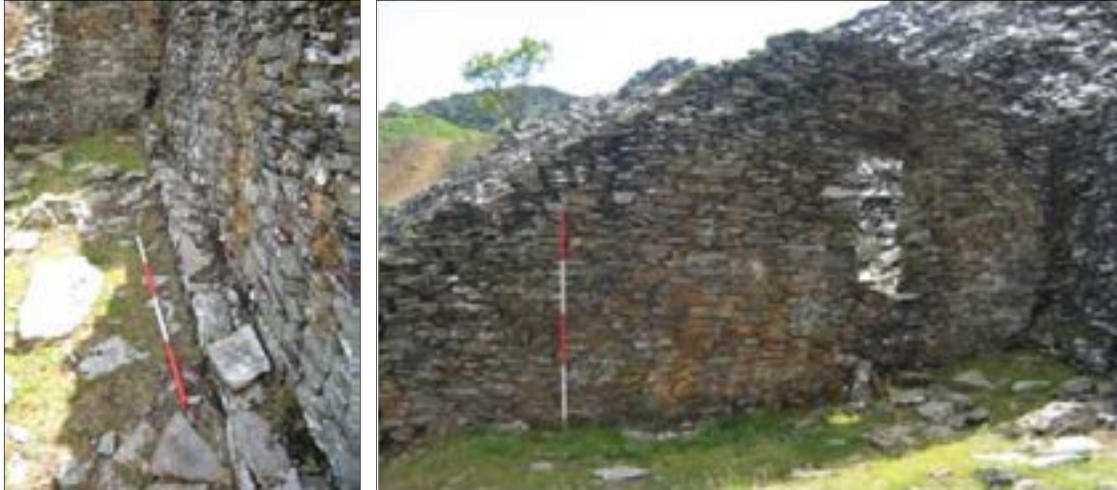
*Plates 37, 38: (left) stone plinth (503) for carrying the launder channelling water to the settling ponds, and (right) north-facing elevation of south wall (507)*

507	S wall of mill building. Coursed random rubble construction with rectangular opening (510) towards W section of wall. The profile of the wall shows a double roof line with a gable apex above opening (510) and a valley feature to the E. The E end of the wall is absent but there is a vertical face suggesting an E door or window; a later wall (515) butts against the E end of (507). At the E end wall (507) sits above a wider foundation or settling course (509).	<b>High</b> – good evidential value as part of structural layout of dressing mill. Also provides unique information on the constructional form and detail of the mill roof.	Mill (500) Wall (509) Wall (515) Opening (510)	High High High High	c. 1860

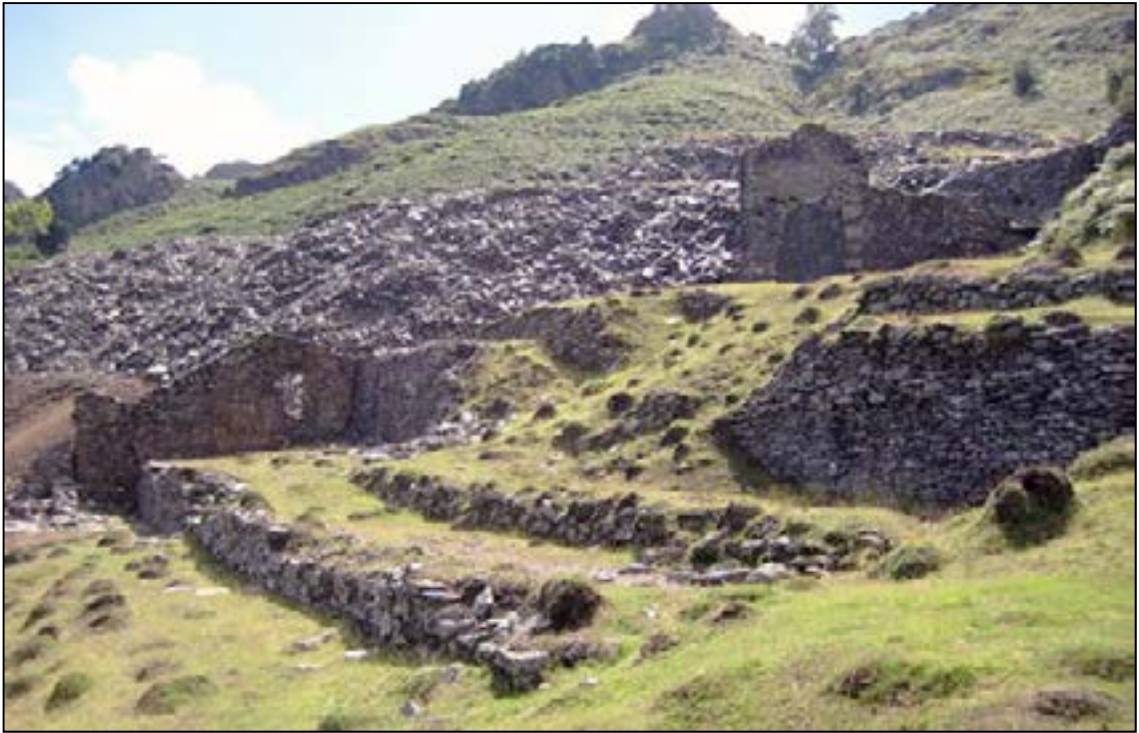
*Plate 39: view of dressing mill and crusher looking south-west and settling ponds in the foreground*

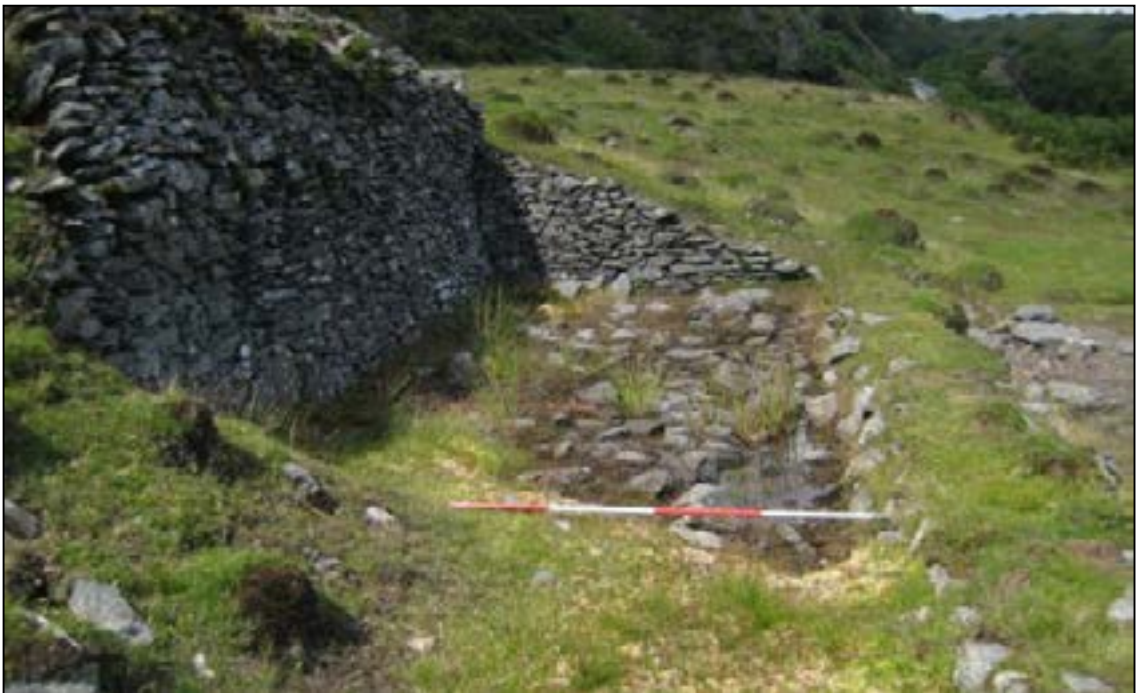
*Plate 40: western settling pond (520), one of two to the north of the dressing mill. Water still pools in the base of the feature*

- 5.64 The two Penny Rigg settling ponds are at different heights and connected by a drain (522) at the north end. The upper (west) pond (520) measures c. 12.00m by 3.75m and the lower (east) pond (521) measures 17.00m by 3.15m; both are now drained. The ponds

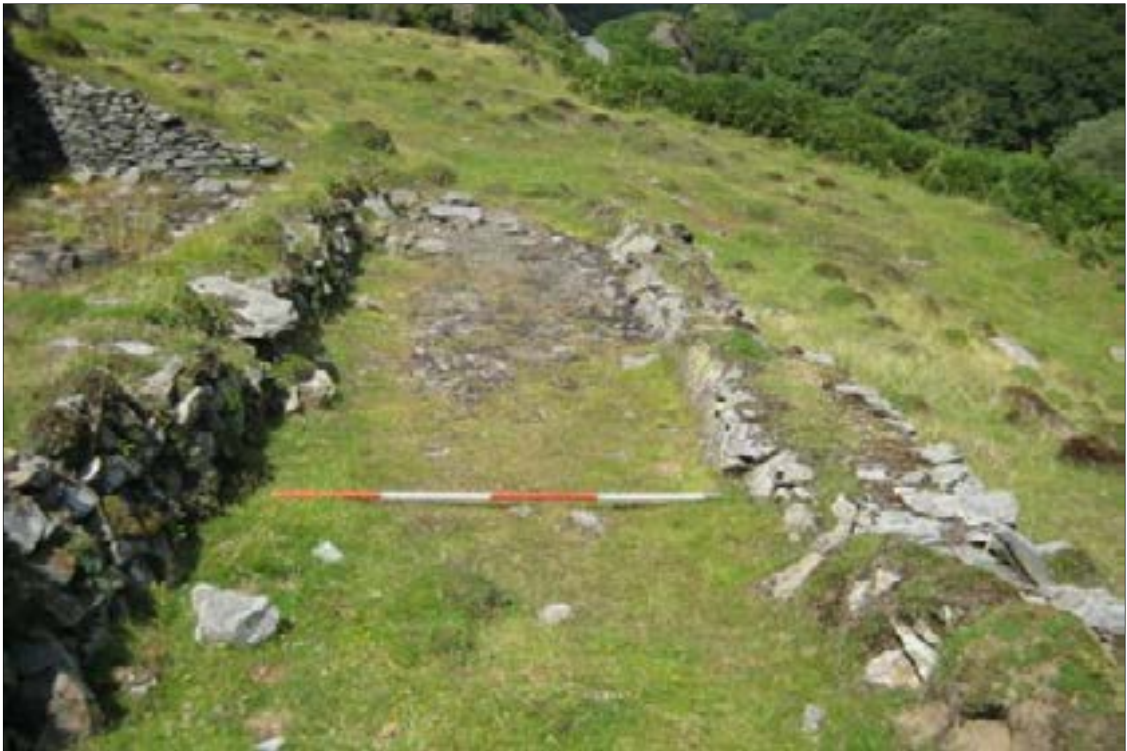
**Plate 41:** eastern settling pond (521) and associated stone-faced banks (516), (517)

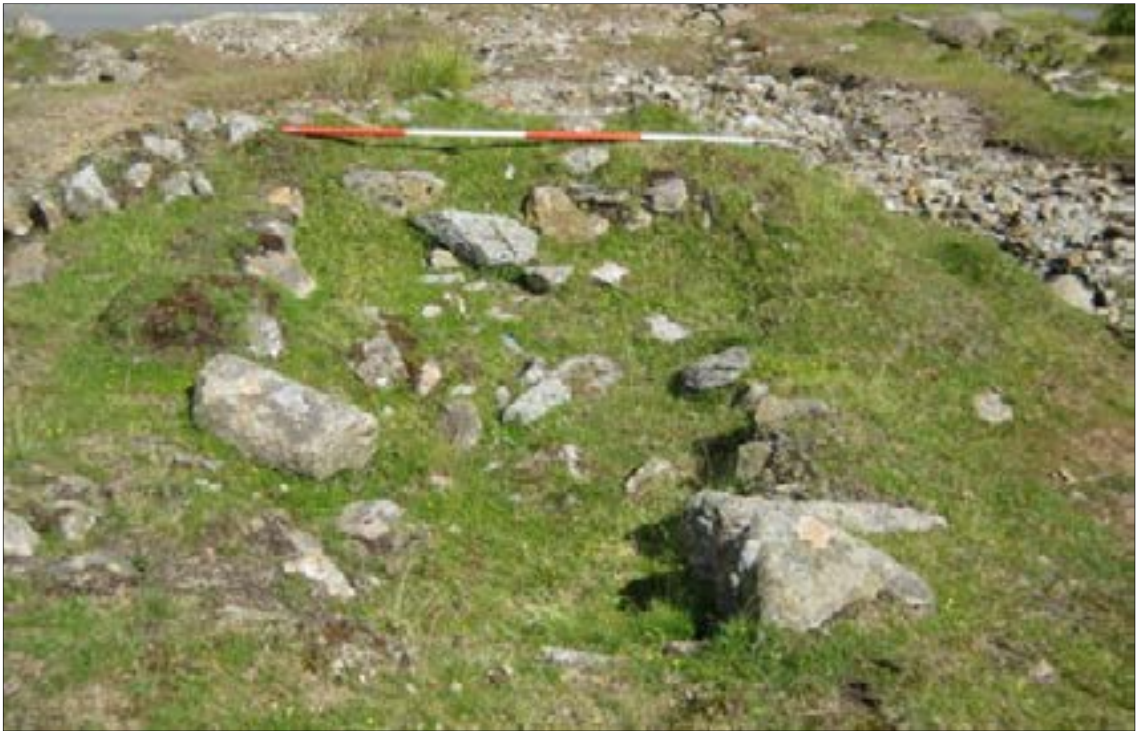
*Plate 42: rectangular depression (528) associated with buddle. Stepped stone sides remain visible*

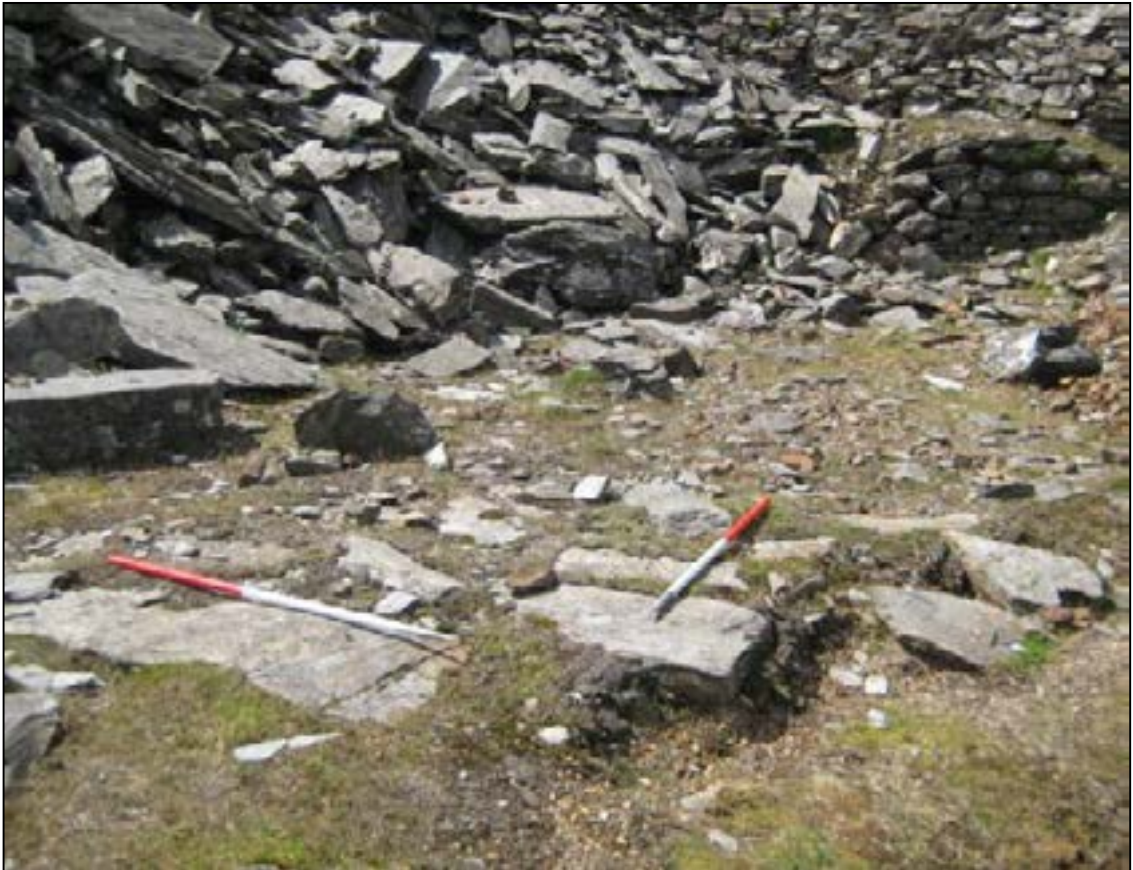
- 5.72 The paved surface is located to the south-west of the crusher house on a level area adjacent to tank (425). It comprises a series of large stone slabs (423), but the full extent of the feature cannot be established because it is covered by the later rid tip (813). The north edge of the feature appears to correspond with the large L-shaped, roofed structure depicted on the 19th-century Lampton map (Fig. 8). There are no signs of wall footings surrounding the paved area, which suggests that the structure, or at least this section of it, was of timber frame construction. Retaining walls (427), (428) may be part of the same building.

*Plate 43: large stone slabs to the south-west of the crusher and possibly associated with the L-shaped structure shown on the Lampton Estate map*

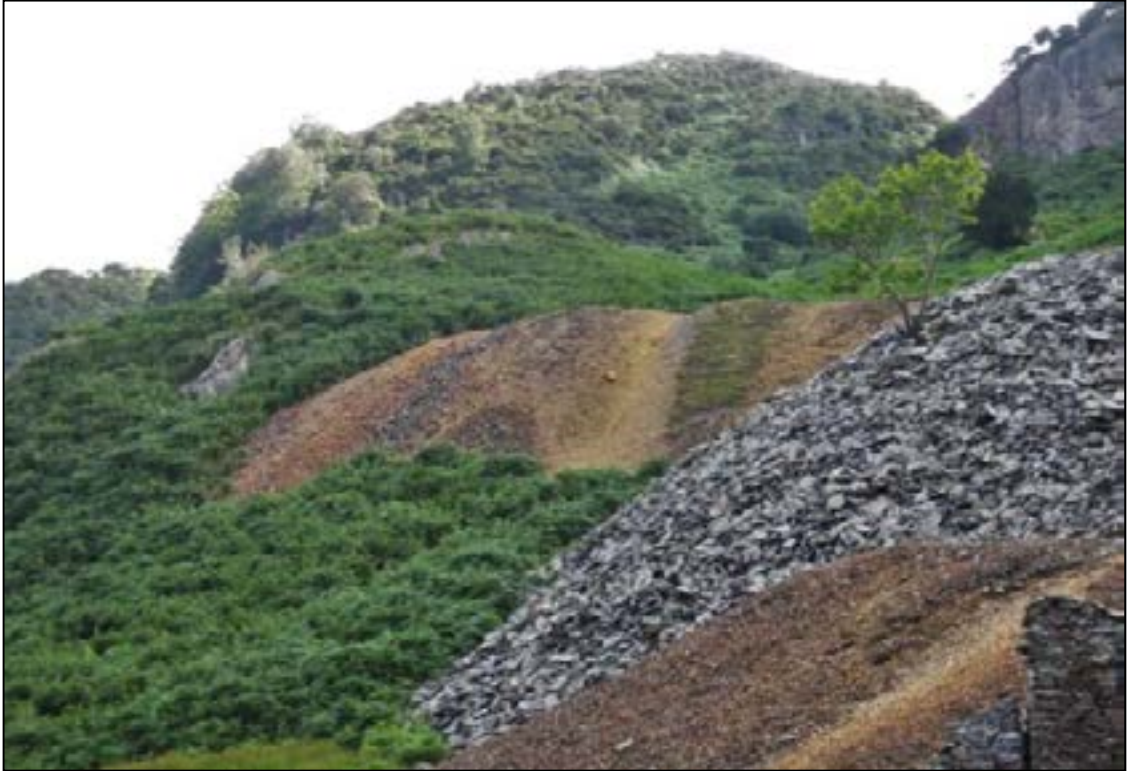
north end of the site, tip (107). Waste from hand-sorting, and possibly from crushing, formed a second spoil tip (539) lower down the hillside. Both of the tips have been partly buried under later slate spoil, which obscures their original form and size.

*Plate 44: mining tips – in the foreground, waste from hand-sorting and crushing (539), and in the background, tip (107), associated with primary sorting*

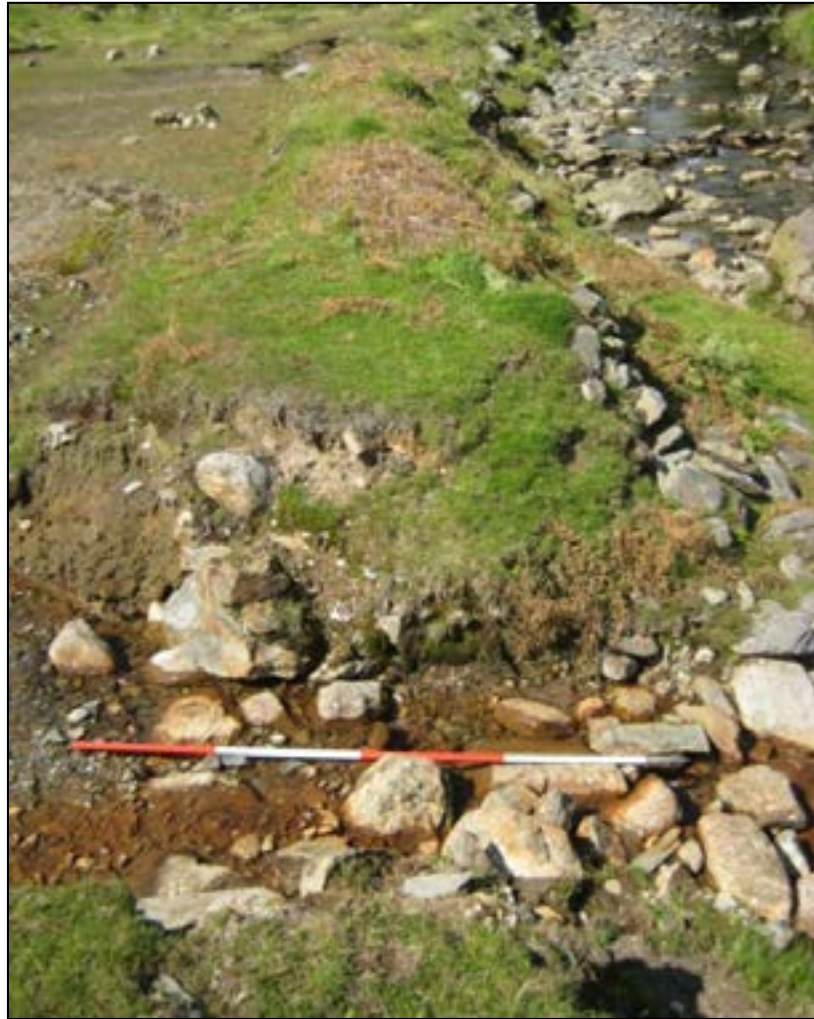
- 5.75 Evidence of the tailing pond comprises a series of earthwork banks (600) identified between the modern road and Yewdale Beck. A large earth bank or levée (601) separates the pond from the beck, with stone revetting on the west side and a double stone face on the east- or beck-facing side (Plate 45). Flood damage has truncated the bank in two sections revealing parallel boulder foundation footings with an internal fill of earth, turf and occasional river cobbles.

*Plate 45: earth bank or levée (601) separating the tailing pond from Yewdale Beck*

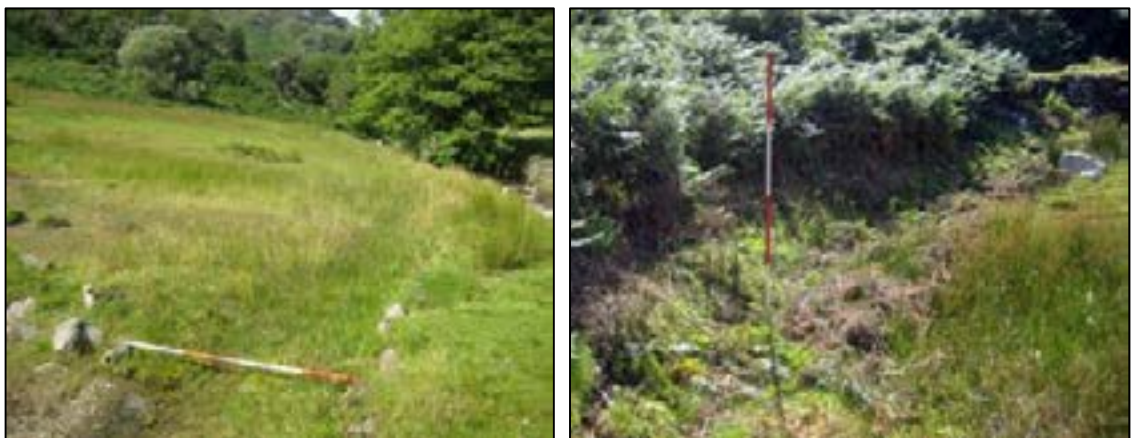
*Plates 46, 47: (left) gap (607) at east end of bank (604), possibly associated with a sluice or overflow, and (right) low, discontinuous retaining wall forming curved S-section of tailings pond (602)*

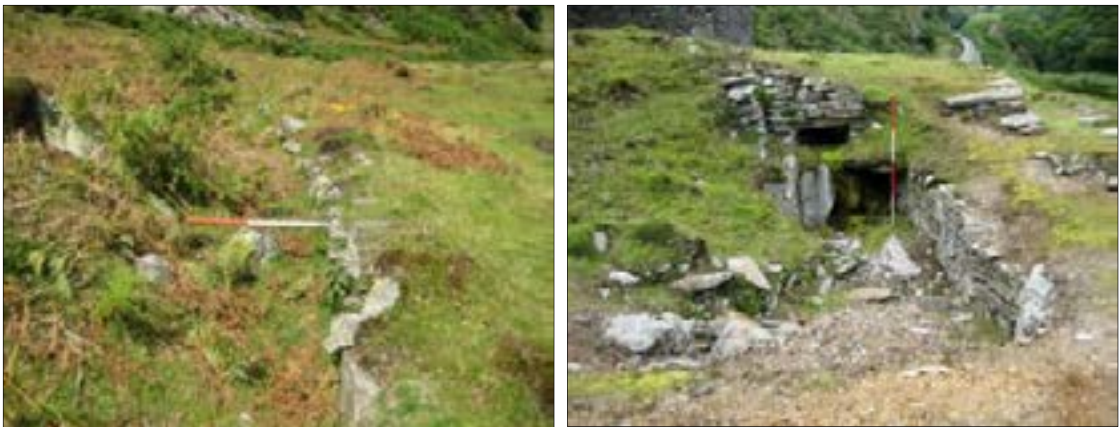
*Plates 48, 49: (right) leat (308/309) running down to Yewdale Beck, and (left) culvert (424)*

- 5.80 Depending on need, outflow water from the crusher wheel pit was carried into one of two culverts. Surplus water not needed elsewhere in the mill complex was then taken north via culvert (306) to leat (308/309) (Plate 48). This discharged directly into the channel running down slope to Yewdale Beck. Outflow water that could be re-used was channelled south through culvert (424) into a small holding tank (425) (Plate 49) and then led east along the outer wall of the dressing mill where it may have powered a second waterwheel. From there, the water flowed down slope in a series of culverts to the tailings pond (600) and thence, via overflow channel (606), into Yewdale Beck. At

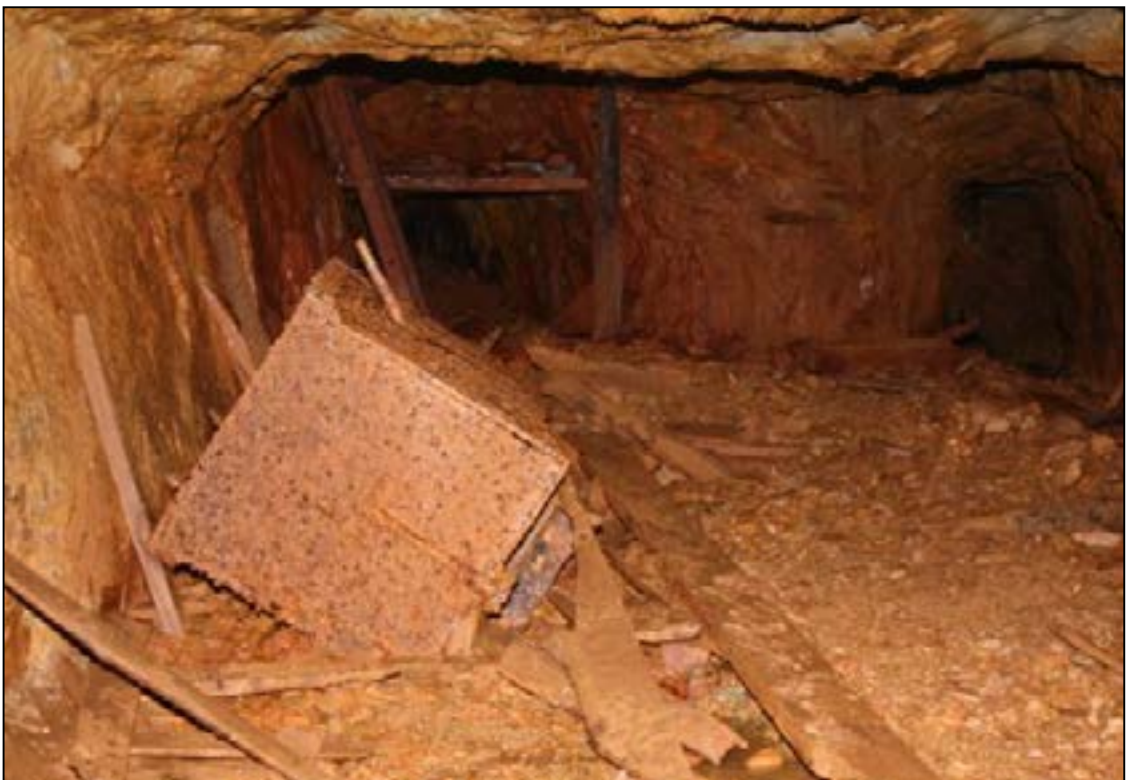
- 5.82 Movement of ore from the mine to the copper mill would have been by tubs running on iron rails, but most evidence for this has been obscured by later dumping and spreading of slate spoil. The only indication of a contemporary tramway at the surface is at the south end of copper tip (107) where three parallel tip lines with distinctive ‘finger’ outlines appear to have been formed by dumping waste from tubs running on temporary or moveable rails. However, there is a long section of tramway preserved within the level (Plate 50).

*Plate 50: mine tub surviving in situ in the Horse Crag Level. Photograph courtesy of Warren Allison*

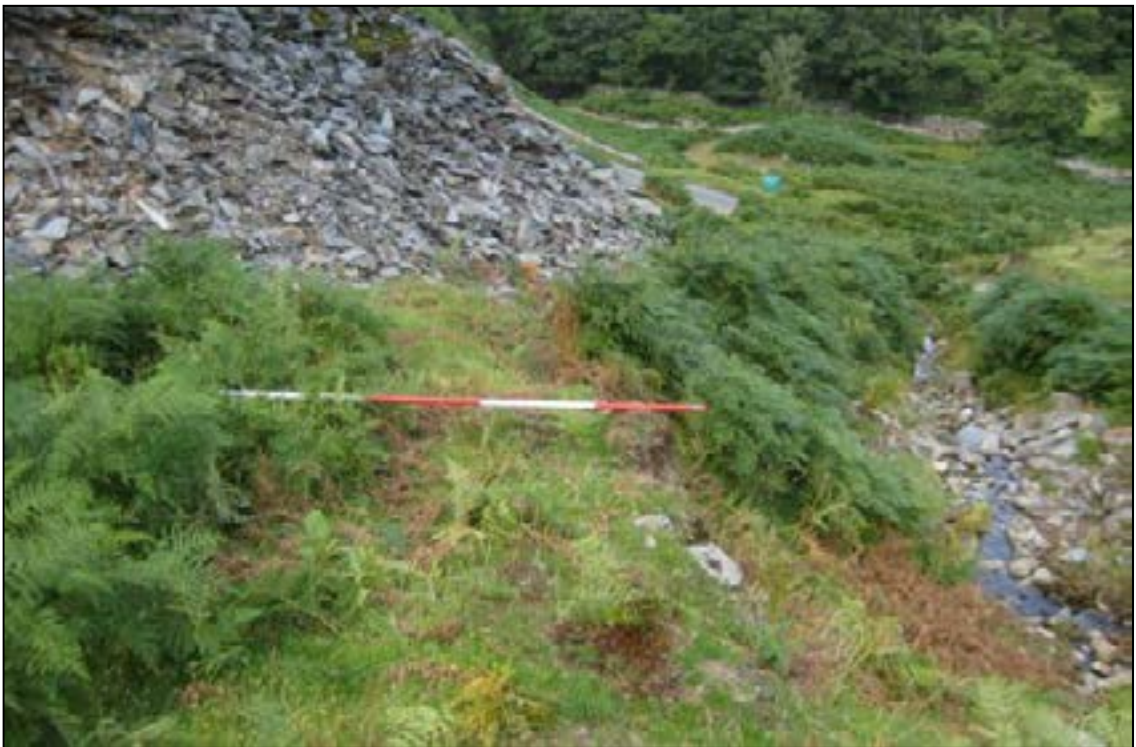
- 5.83 Two of the surviving tracks (701), (705) appear to be associated with the mine and copper mill. Track (701), now overgrown, partly covered by slate tip (814) (Plate 51) and cut to the south-west by later track (700), is shown on the First Edition Ordnance Survey 6-inch map of 1850 (Fig. 5) as linking the entrance to Horse Crag Level with the valley road. At this date, the copper mill had not been built, so it can be assumed that the track was constructed specifically to serve the mine. It is comparatively narrow (*c.* 2.00m wide) and one of the surviving sections includes a well-constructed stone-slab bridge (702). The bridge crosses the overflow watercourse from leat (317) and may be a slightly later feature, contemporary with the construction of the waterwheel at the crusher house.

*Plate 51: mine track (701), now overgrown and partially covered by waste from later quarrying*

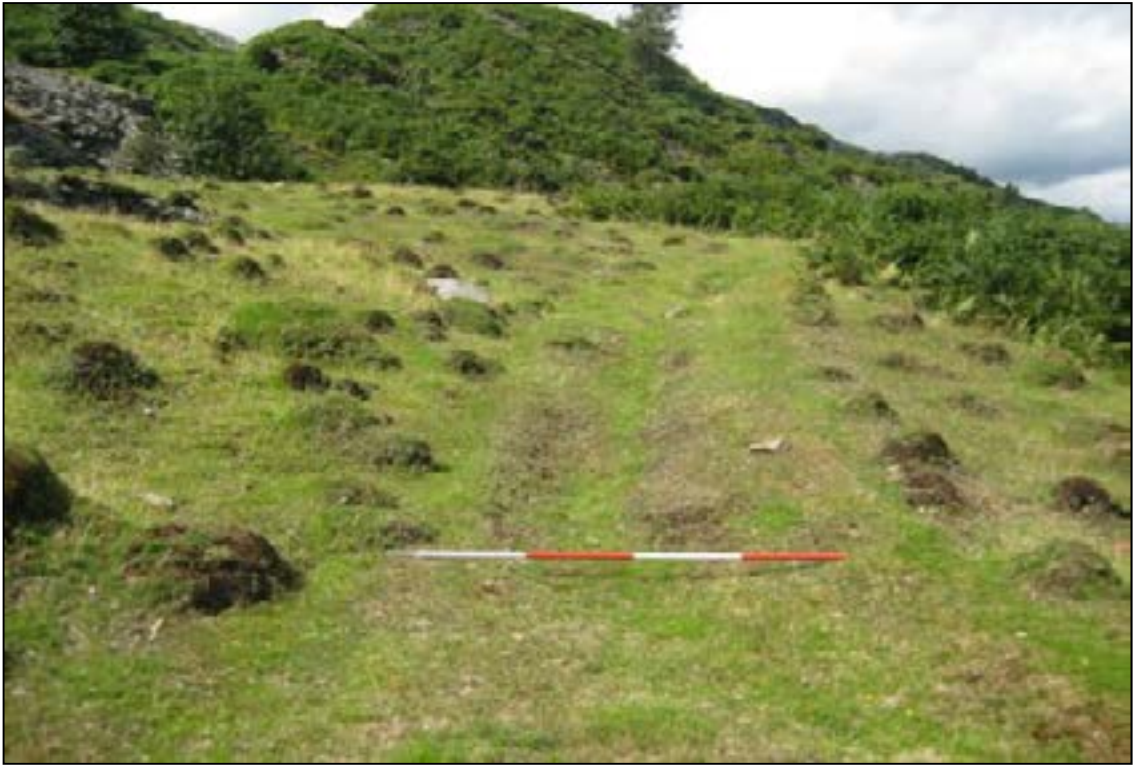
- 5.84 The Lampton map (Figs 7, 8), shows track (701) and depicts another track curving uphill from the valley road, passing the north end of the settling ponds and terminating at the crusher house. This track must have been constructed to access the mill complex and is thus probably contemporary with it. It survives as a broad grassed track (705) (Plate 52), which in its upper section is terraced into the hill slope. Feature (432), a narrow terrace connecting with and running above retaining wall (431), is probably an access track to the crusher house and may originally have been part of track (705). A similar track is likely to have run along the terrace below the settling ponds and provided access to the lower section of the dressing mill, but nothing survives.

**Plate 52:** *second of the original mine tracks (705), constructed to access the mill complex*

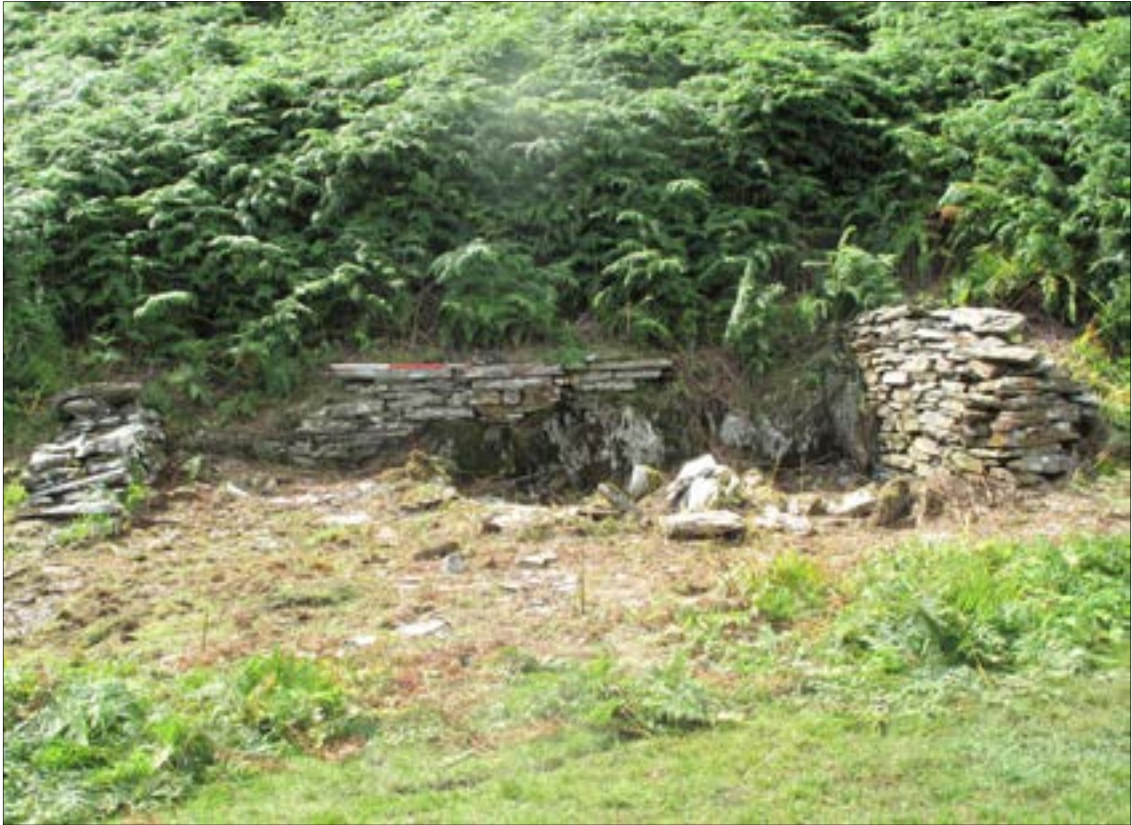
*Plate 53: east-facing open-fronted riving shed (800)*

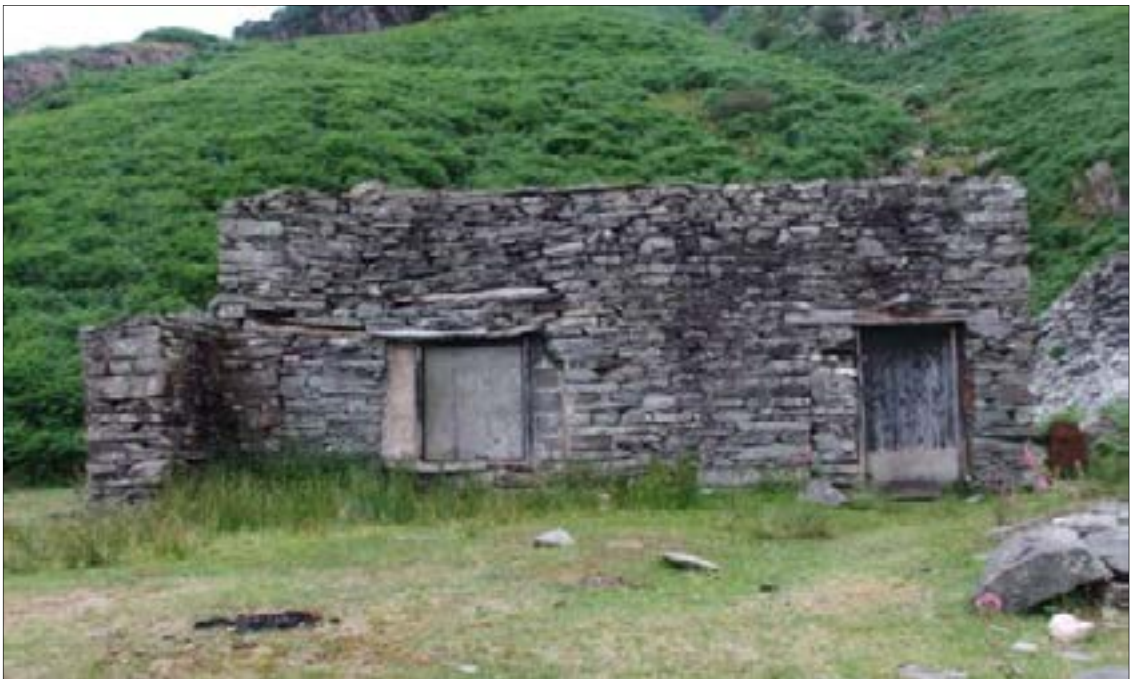
*Plate 54: north-east-facing elevation (front) of riving shed (812)*

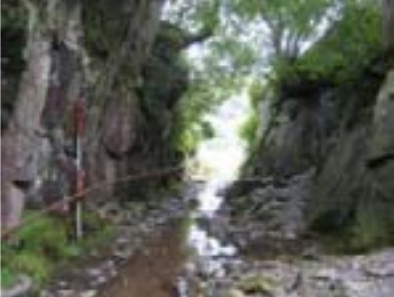
102	Horse Crag Level entrance cutting. Rock-cut trench, 5m deep x 3m wide, connecting Horse Crag Level portal with the surface installations of Penny Rigg mill. Retained slate spoil from Horse Crag quarry at NW end.	<b>High</b> – as above. Also demonstrates historical and sequential association between copper and slate working.	Level portal (101) Mine drain (103) Compressor pipe (105)	High High High	c. 1850

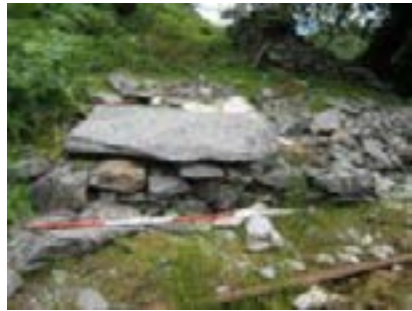
Context No.	Description	Significance	Associated with	Contribution to Significance	Date	Photo
103	Entrance to stone-slatted culvert taking water from Horse Crag Level and the entrance cutting (101-102). Drains N to leat (317).	<b>High</b> – good evidential and historical value as demonstrates methods of water control and use.	Mine level (101) Entrance cutting (102) Leat (317)	High High High	c. 1850	
104	Stone platform, 3m x 0.8m x 0.54m high. Rectangular slab above rough coursed retaining wall. Foundation course incorporates concrete breeze block suggesting recent construction and use.	<b>High</b> – good historical and evidential value as possibly one of the latest structures on site, demonstrating ongoing use of the mine and surrounding area into the late 20th century.	Mine level (101) Compressor pipe (105)	High High	Mid to late 20th century

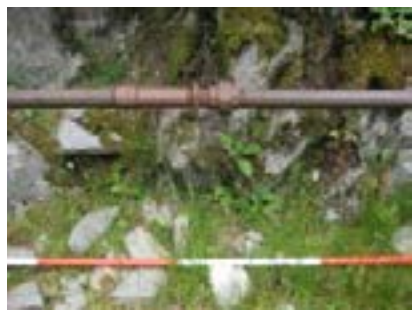
105	Iron compressor pipe, 64mm (2½in) diameter attached by iron brackets to N wall of Horse Crag Level and N side of the entrance cutting. Runs NE along surface from E end of cutting towards SW corner of smithy (201).	<b>High</b> – as above. Also of significance as provides a visual and physical association between the underground and surface workings.	Mine level (101) Entrance cutting (102) Smithy (201)	High High High	Mid to late 20th century

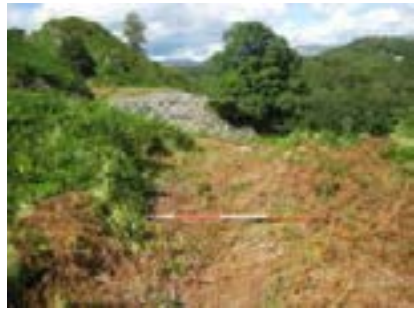
Context No.	Description	Significance	Associated with	Contribution to Significance	Date	Photo
106	Shallow linear gully, v-shaped profile, running SW-NE on terrace between top of the Horse Crag Level entrance cutting and track (703). No obvious function.	<b>Moderate/low</b> – lack of evidence for date and function reduces the significance of this feature. Further research might establish its association with other elements of the site and increase its relative significance.	Track (703)	Low	Unknown

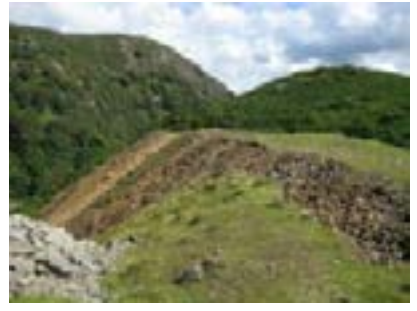
107	Flat-topped linear spoil tip composed of distinctive orange-brown mineralised rock. Three distinct tip lines at the S end of spoil tip indicate use of end- or side-tipping wagons, probably running on temporary rail tracks. Spoil derived from driving of Horse Crag Level and from initial surface sorting. Overlain to N by later slate spoil tip (811).	<b>High</b> – of considerable historical and evidential value as only area of spoil associated with driving of Horse Crag Level and primary separation of rock and ore. Association with slate spoil tips demonstrates chronological and sequential development on site.	Slate tip (811)	High	c. 1850

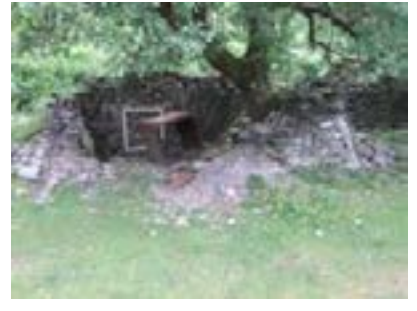
201 Group	<p>Smithy and office. The smithy to the south and was built first. The office to the north was added later, but how much later is not known. The west back wall (213) of the office butts up against the back wall (205) of the smithy.</p> <p>Both structures were built into the slope of the hillside. The whole area may have been dug out in one go rather than as two separate events.</p>	<p><b>High</b> – good historical and evidential value. The structures demonstrate several phases of use.</p> <p>Its value is also increased by its association with other features within the vicinity such as the Leat (317) which is directed underground in front of the buildings.</p>	<p>Mine Level (101)                      Entrance cutting (102)                      Culvert (103)                      Culvert (316)                      Leat (317)                      South wall of smithy (202)                      Blocked door (203)                      Valve for compressed air pipe (204)                      W wall of smithy (205)                      N wall of smithy (206)                      E wall of smithy (207)</p>	<p>High                      High                      High                      High                      High                      High                      High                      High                      High</p>	c. 1850

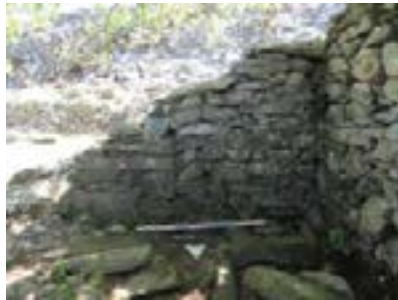
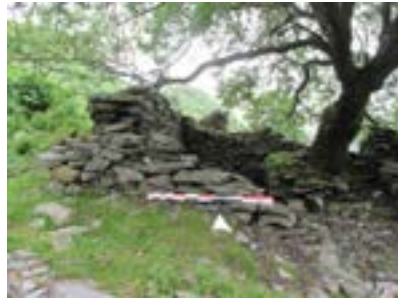
202	<p>S wall of Smithy. Coursed random rubble. Survives to a maximum height of 1.40m internally towards the back of the building. The height of the wall decreases towards the front. Includes evidence for what is believed to be a blocked doorway (203). The ground level is higher externally.</p>	<p><b>High</b> – good historical and evidential value as demonstrates the changing function and use of the building.</p>	<p>Blocked door (203)                      W back wall 205)</p>	<p>High                      High</p>	<p>c. 1850</p>

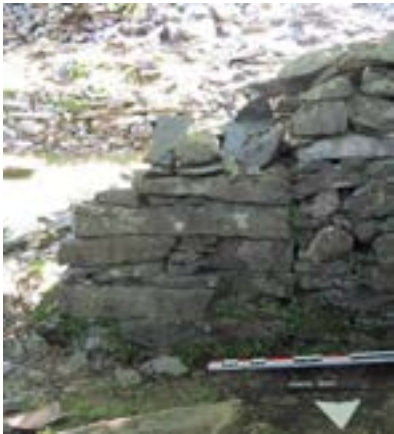
Context No.	Description	Significance	Associated with	Contribution to Significance	Date	Photo
203	<p>Blocked door c. 0.9m wide surviving to roughly 5 courses high. Obvious straight joint between the blocking and wall (202). The blocking consists of roughly rectangular blocks, in contrast to the coursed random rubble of wall (202).</p> <p>To the S is the entrance to the stone slabbed culvert (103), taking water from Horse Crag Level and the entrance cutting (101-102). The gap between the wall (202) and the culvert entrance would have been roughly 1.20m. At some point it may have been decided that it would be more convenient to put the entrance in the east wall of the building, which has a large open area in front of it.</p>	<p><b>High</b> – good historical and evidential value as demonstrates the changing function and use of the building and its relationship to the water management features within its vicinity. Thereby demonstrating chronological depth.</p>	<p>Mine Level (101) Entrance cutting (102) Culvert (103) Wall (202) Leat (317)</p>	<p>High High High High High</p>	Undated

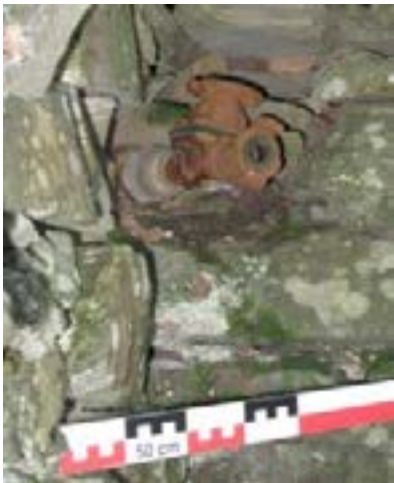
204	<p>Valve for compressed air pipe (105). Located in the SW corner of the room.</p>	<p><b>High</b> – good historical and evidential value as possibly one of the latest structures on site, demonstrating ongoing use of the mine and surrounding area into the late 20th century. Also of significance as provides a visual and physical association between the underground and surface workings. Also demonstrates the changing use of the smithy building.</p>	<p>Mine level (101) Entrance cutting (102) Compressor pipe (105) S wall (202) W back wall (205)</p>	<p>High High High High High</p>	Mid to late 20th century

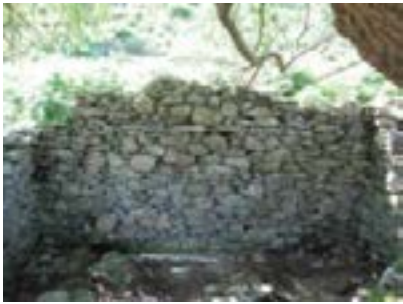
206	<p>N wall of Smithy, which also forms the dividing wall between the smithy and the office has been badly damaged in places by the presence of a tree. The back wall of the office (212) butts up against this wall.</p> <p>Survives to a maximum height of 1.9m internally towards the back of the building. The height of the wall decreases towards the hearth. The upper half of the wall consists of coursed random rubble and the lower half contains more even sized rectangular blocks of slate.</p> <p>The NE corner of the smithy, towards the base of the wall contains some large slab like pieces of slate forming quoins.</p> <p>The hearth (209) has been built into the NE corner of the smithy and may have been partially keyed into the</p>	<p><b>High</b> – good historical and evidential value, but badly damaged by the presence of the tree.</p>	<p>W back wall of smithy (205) E front wall (207) Hearth (209) W back wall of office (212)</p>	<p>High High High High</p>	c. 1850

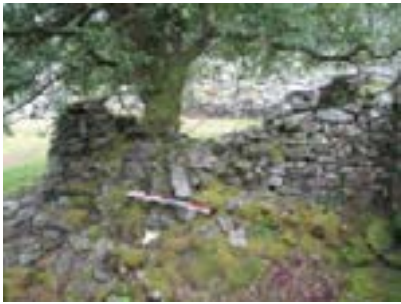
207	<p>E wall of Smithy. Coursed random rubble. This wall is in a very ruinous state. It survives to a maximum height of 1.6m either side of which it tails off towards the ground and the surrounding rubble. Its maximum length is no more than 3.00m.</p> <p>The N end of the wall where it survives for roughly 3 courses contains some large slab like pieces of slate forming quoins.</p> <p>The wall is visibly leaning outwards, which may have been a problem even before it fell into a ruinous state and could explain why the buttress (208) was built in front of it. This wall may have needed more support because of the location of the hearth (209) within the building.</p>	<b>High</b> – good historical and evidential value, but badly damaged.	Buttress (208) Hearth (209)	High High	c. 1850

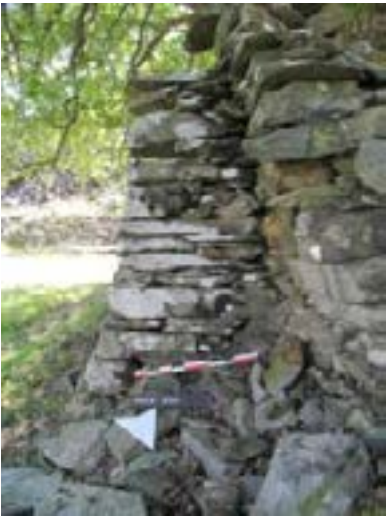
209	<p>Hearth. This has a large tree growing out of the middle of it which has caused a lot of damage making it difficult to see the hearth's original form. The bellows hole and metal inlet pipe (210, 211) survive at its W end.</p> <p>The hearth is roughly 2.10m by 1.40m and it survives to a maximum height of 1m. The W elevation is roughly keyed into the north wall (206) and is made up of random coursed roughly rectangular blocks.</p>	<p><b>High</b> – good historical and evidential value as demonstrates the function of the building, although badly damaged by the tree.</p> <p>Its form may be better understood once rubble is cleared.</p>	N wall (206) E wall (207) Buttress (208) Bellows hole (210) Metal inlet pipe (211)	High High High High High	c. 1850

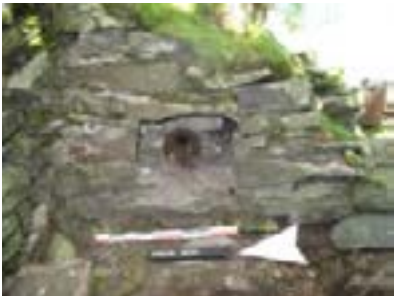
Context No.	Description	Significance	Associated with	Contribution to Significance	Date	Photo
210	Bellows hole. Roughly square opening within the western end of the hearth (209) measuring 0.30 by 0.30m at its widest points. The aperture is approximately 0.15m deep.	<b>High</b> – good historical and evidential value as contributes to our understanding of how the building functioned.	N wall (206) Hearth (209) Metal inlet pipe (211)	High High High	c. 1850

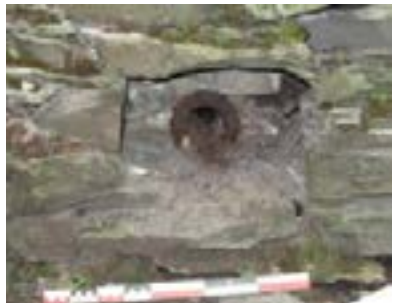
211	Metal inlet pipe, 0.15m in diameter and made of iron. The pipe extends into the hearth for a distance of approximately 0.60m at which point it meets the trunk of the tree.	<b>High</b> – good historical and evidential value as contributes to our understanding of how the building functioned.	Hearth (209) Bellows hole (210)	High High	c. 1850

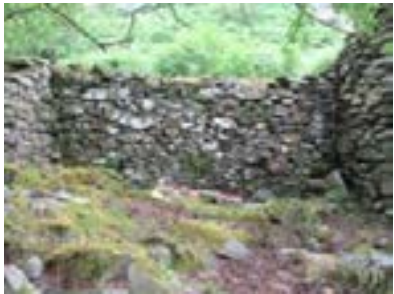
212	W back wall of office. Coursed random rubble wall surviving to roughly 1.80m in height internally and 0.45m at its highest point externally as it is built into the side of the hill.  This wall butts up against the back wall of the smithy (205). It is not keyed in. This therefore suggests that the office was built after the smithy. The exact date is unknown. The way in which this wall has been built is noticeably different to the back wall of the smithy (205).	<b>High</b> – good historical and evidential value shows a good example of wall building techniques, various styles of which are present across the site. It shows how the building was extended to create the office	W back wall of smithy (205) N wall of smithy (206) N wall of office (213)	High  High High	c. 1850
