PENNY RIGG COPPER MILL,

ARCHAEOLOGICAL  
COMMUNITY LANDSCAPE  
AND BUILDING SURVEY

PENNY RIGG COPPER MILL,  
TILBERTHWAITE, CONISTON,  
CUMBRIA

NAA 16/145  
November 2016  
(Issued January 2017)

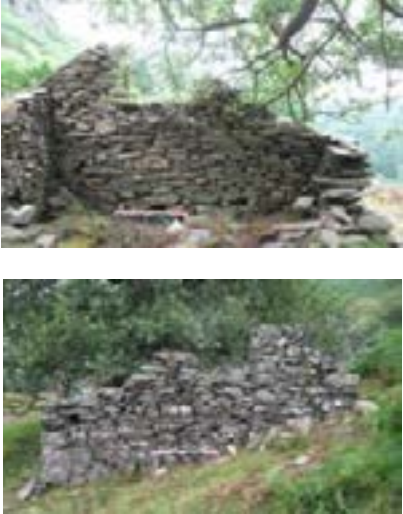
Context No.	Description	Significance	Associated with	Contribution to Significance	Date	Photo
213	<p>N wall of office, gable end, tapering towards what would have been the apex of the roof. This helps to confirm that the building was a single storey. There is a single window opening (214) and rough dressed quoins at both corners.</p> <p>Coursed random rubble wall surviving to roughly 2.6m at its highest point internally and 1.8m at its highest point externally as it is built into the side of the hill. Building style similar to the west back wall (212).</p> <p>There is a large square block of stone on the W edge of the window where the top of the window may have been and it is suggested that this may have supported a roof beam.</p>	<p><b>High</b> – good historical and evidential value as contributes to our understanding of how the building functioned.</p>	<p>W back wall of office (212) Window (214) E wall (215)</p>	<p>High High High</p>	c. 1850

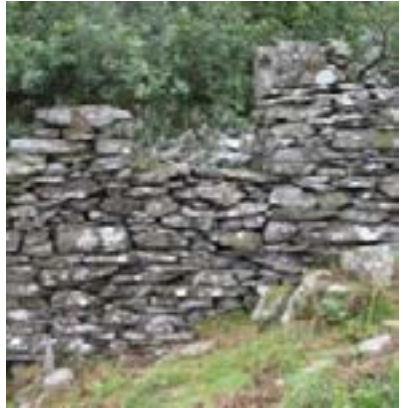
214	<p>Window within the N wall (213) of the office, approximately 0.90m wide.</p> <p>The stones forming the windowsill are keyed into the wall. The window is 1.80m above the ground internally and approximately 1m above the ground externally.</p>	<p><b>High</b> – good historical and evidential value as contributes to our understanding of how the building functioned.</p>	N wall (213)	High	c. 1850

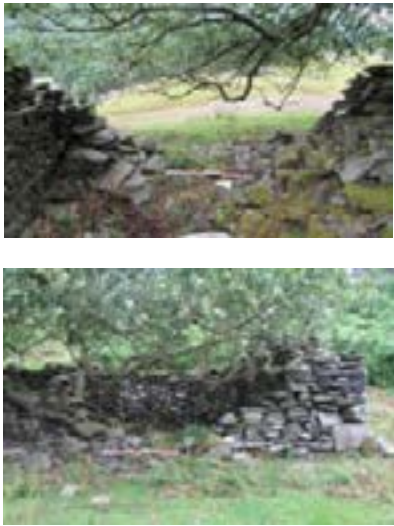
Context No.	Description	Significance	Associated with	Contribution to Significance	Date	Photo
215	<p>E wall of office. Coursed random rubble wall surviving to roughly 1.20m high and 2.00m in length. Rough dressed quoins at the corners, which are larger at the base of the wall.</p> <p>Very little survives and there is no clear evidence for where the door may have been. No evidence for the front wall having been keyed into the front of the smithy.</p>	<b>Medium</b> – Very little survives and there is no clear evidence for where the door may have been.	North wall (213)	High	c. 1850

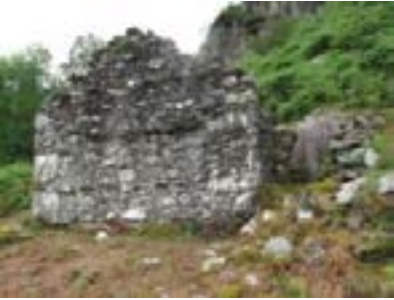
220 Group	Powder house and attached small annex. Single-storey, single-cell square structure with a single door opening and no windows. Constructed of coursed random rubble, with roughly dressed quoins and protruding through-stones. Partially built into the hillside.	<b>High</b> – of considerable evidential value because of its association with the mining process, provides a visual association between the underground and surface workings and how it fits in to the overall process and landscape. Also, good example of another type of wall construction.	S wall (221) Door (222) W wall (223) Through-stones (224) N wall (225) E wall (226) Through-stones (227) W wall (228) N wall (229) Track (703)	High High High High High High High High High	c. 1850

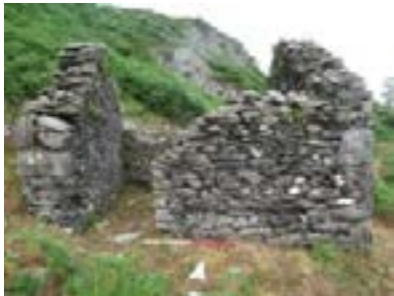
Context No.	Description	Significance	Associated with	Contribution to Significance	Date	Photo
221	S wall of powder house. Coursed random rubble wall with rough dressed quoins at both corners. Mostly survives to full height. Contains one door (222) at the W end of the wall. The wall building style is similar to that observed for the W (back) wall of the smithy (205). At roughly half-metre intervals the random rubble courses are levelled out by using smaller flatter pieces of slate.	<b>High</b> – as above.	Door (222) W wall (223) E wall (226)	High High High	c. 1850

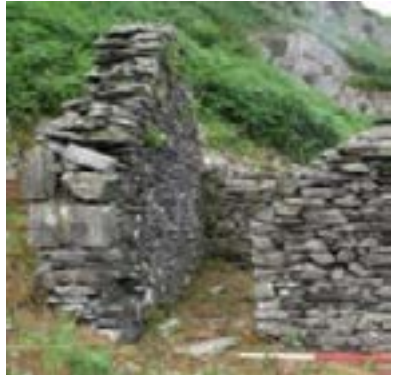
222	Door aperture into the powder house. Approximately 0.90m wide. There are two gaps within the wall to the west of the door, which may indicate where the door was hung.	<b>High</b> – as above.	S wall (221) W wall (223)	High High	c. 1850

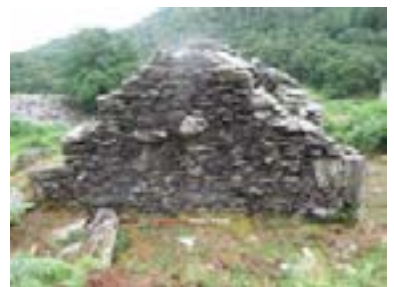
223	W wall of powder house which survives to full height. Rough dressed quoins at both corners. The wall also contains rows of protruding through-stones (224) at three levels.	<b>High</b> – as above.	S wall (221) Through-stones (224) North wall (225)	High High High	c. 1850

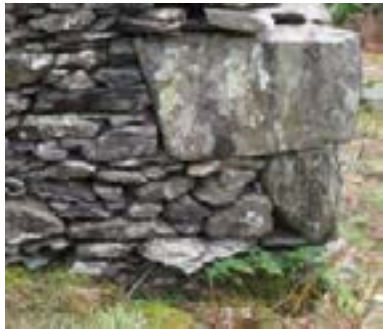
Context No.	Description	Significance	Associated with	Contribution to Significance	Date	Photo
224	Protruding through-stones. The W wall (223) contains rows of protruding through-stones at three levels. The stones are flat to the wall on the internal elevation, but protrude from the external elevation.	<b>High</b> – as above. The protruding through-stones are not seen on any of the other structures on site.	W wall (223)	High	c. 1850

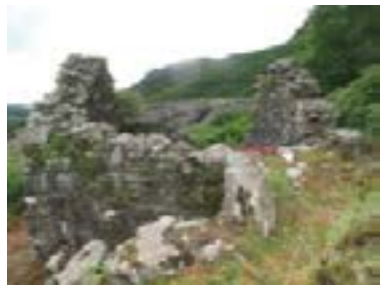
225	N wall of powder house. Coursed random rubble wall with rough dressed quoins at the NE corner. Mostly survives to full height.	<b>High</b> – as above.	W wall (223) E wall (226) W wall (228)	High High High	c. 1850

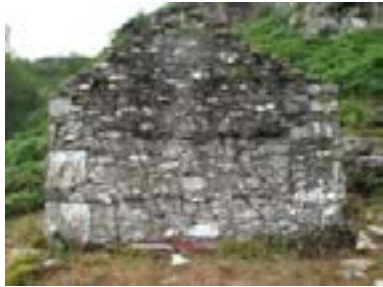
226	East wall of powder house which survives to full height. Coursed random rubble wall with rough dressed quoins at both corners. Some large square slabs have been used on end to make them look bigger from the front than they actually are. The wall also contains rows of protruding through-stones (227) at three levels.	<b>High</b> – as above.	S wall (221) N wall (225) Through-stones (227)	High High High	c. 1850

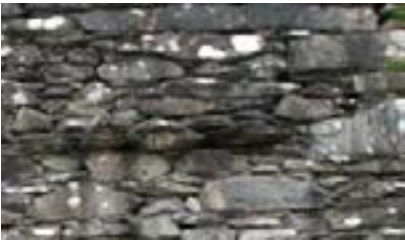
Context No.	Description	Significance	Associated with	Contribution to Significance	Date	Photo
227	Protruding through-stones. The east wall (226) contains rows of protruding through-stones at three levels. The stones are flat to the wall on the internal elevation, but protrude from the external elevation.	<b>High</b> – as above. The protruding through-stones are not seen on any of the other structures on site.	E wall (226)	High	c. 1850

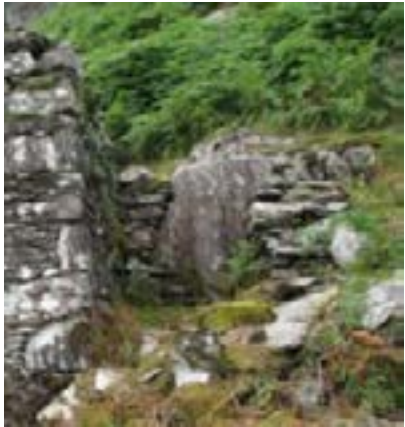
228	W wall of small outside annex. The majority of the wall is created by the presence of bedrock. The gap between the bedrock and the N wall (225) of the powder house (220) has been filled with coursed random rubble.  Survives to a height of roughly 1.30m. It may not have been much taller than this.	<b>High</b> – as above.	N wall (225) N wall (229)	High High	c. 1850

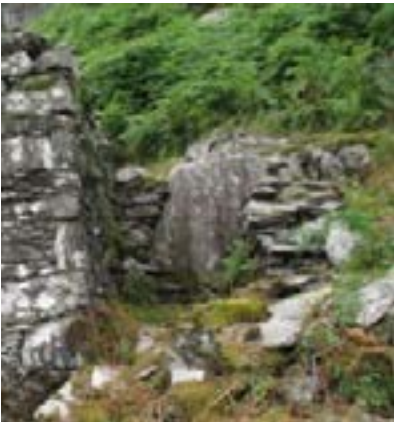
Context No.	Description	Significance	Associated with	Contribution to Significance	Date	Photo
229	N wall of small outside annex. Coursed random rubble wall, surviving to a height of roughly 1m and 1.70m long. This wall was built against bedrock and into the hillside.	<b>High</b> – as above.	W wall (228)	High	c. 1850

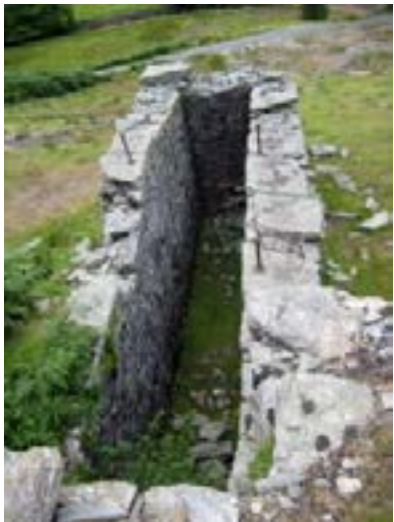
300 Group	Waterwheel pit or housing. Raised, rectangular structure, constructed for 32 feet (9.75m) wheel which powered crushing machinery in the adjacent building (400). An open leat (317) brought water to a holding pond (310-14) above the wheel pit.	<b>High</b> – well preserved and only surviving on-site example of a waterwheel pit. Value increased by its structural, group and visual association with associated features such as water supply system and crusher house which allow interpretation of full process of water-powered ore crushing.	Leat (316-19) Holding pond (310 G) Crusher house (400 G)	High High High	c. 1860

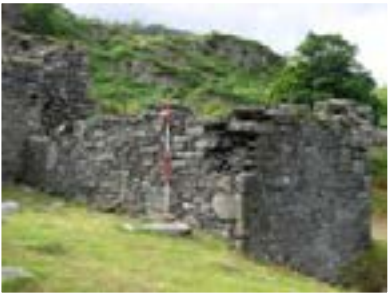
Context No.	Description	Significance	Associated with	Contribution to Significance	Date	Photo
301	S wall of wheel pit (300). Random rubble coursing, incorporating a number of exceptionally large blocks. Rough dressed quoins at SE corner. Overlain to W by crusher house wall (401).	<b>High</b> – as above	N wall of crusher house (401)	High	c. 1860

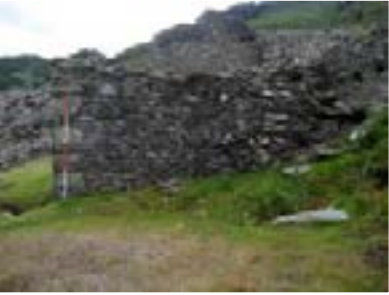
302	N wall of wheel pit (300). Random rubble coursing with rough dressed quoins at NE corner. Terraced into slope at W end. Overlain to W by holding pond wall (312).	<b>High</b> – as above	Holding pond E wall (312)	High	c. 1860

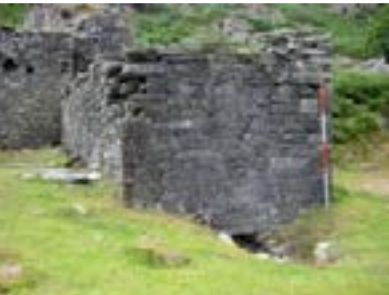
303	E or end wall of wheel pit (300). Random rubble coursing with roughly dressed quoins. Outfall opening at base of wall (304).	<b>High</b> – as above. Also provides evidence for integrated water control.	Outfall tank (304) Culvert (306) Culvert (424)	High High High	c. 1860

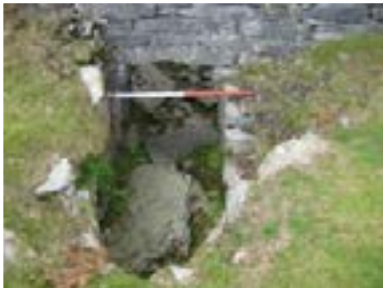
Context No.	Description	Significance	Associated with	Contribution to Significance	Date	Photo
304	Outfall tank for wheel pit (300). Rectangular sub-surface opening with stone lintel at base of wall (303). Connects with two culverts, (306) and (416), leading N and S respectively.	<b>High</b> – good evidential value as helps explain the use and control of water supply systems at the site.	Wheel pit (300) Culvert (306) Culvert (416)	High High High	c. 1860

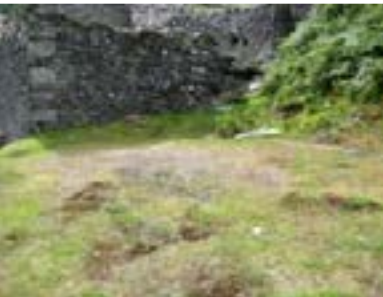
305	Possible activity area or building platform. Rectangular area, 4.60m x 9.60m, partially terraced against slope to W where there are also traces of a low retaining wall. There is an area of crushed mineral spoil in the centre of the platform.	<b>High</b> – good historical and evidential value as may provide archaeological evidence for additional structures and/or activities associated with ore treatment. Potential for below ground survival of archaeological features and deposits.	Wheel pit (300)	High

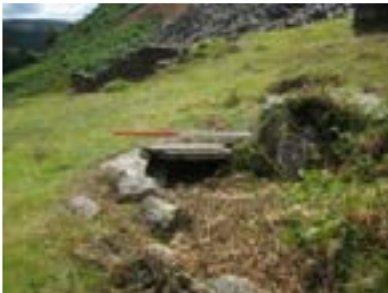
Context No.	Description	Significance	Associated with	Contribution to Significance	Date	Photo
307	Culvert opening. Stone-slabbed opening, 0.7m wide x 0.5m high, at N end of culvert (306). Leads into leat (308). Carried surplus outflow from wheel pit (300).	<b>High</b> – as above	Wheel pit (300) Culvert (306) Leat (308)	High High High	c. 1860

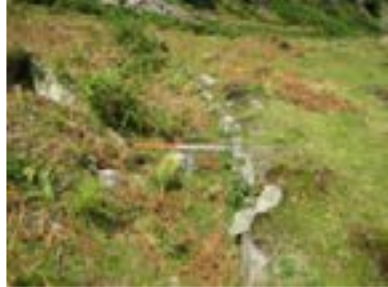
308	Leat. Open leat, cut into natural slope to W with linear upcast bank to E. Low stone wall along E side of leat. Carried surplus outflow from wheel pit (300). Obscured to N by line of track (705).	<b>High</b> – as above. Association with track (705) helps establish sequence of use and abandonment between features on site and provides additional sequential and chronological evidence.	Culvert (306-07) Track (705)	High High	c. 1860

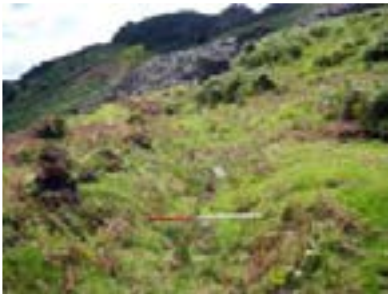
309	Leat. N continuation of leat (308). Survives as a V-profile linear gully with upcast mound to E. Disturbed to S by track (705) and to N by track (700). Would have continued N of track (700) but route cannot be identified. Carried surplus outflow from wheel pit (300).	<b>High</b> – as above. In addition, Association with track (700) increases chronological and historical significance.	Track (700) Track (705)	High High	c. 1860

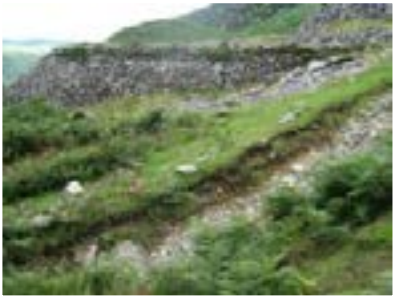
Context No.	Description	Significance	Associated with	Contribution to Significance	Date	Photo
310 Group	Holding pond for wheel pit (300). Rectangular stone walled structure built against the slope to the W and butting against and raised above wheel pit (300) to E.	<b>High</b> – considerable evidential significance as fundamental to understanding and interpretation of use and control of water supply on site. Also important group value in relation to waterwheel pit and crusher house.	Leat (316-19) Wheel pit (300) Crusher house (400)	High High High

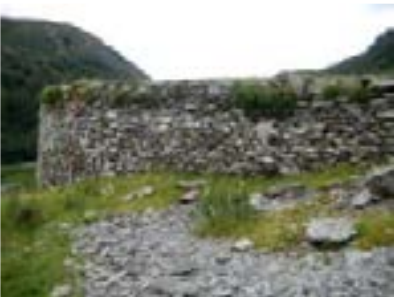
311	Wall of coursed random rubble retaining the N side of the holding pond. Constructed against the natural slope, the battered wall rises in height to the E reaching a maximum height of 2.5m. The E end curves inwards.	<b>High</b> – as above	Holding pond (310)	High	c. 1860

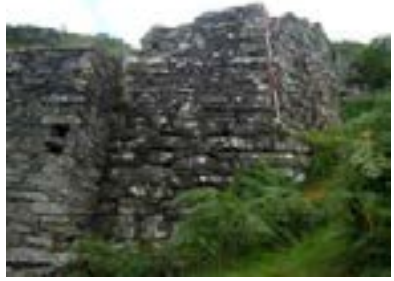
312	Battered wall of coursed random rubble retaining the E end side of the holding pond. Constructed above wheel pit (300) and overlain to S by crushing house wall (401).	<b>High</b> – as above. Also significant in demonstrating relative construction phases with the wheel pit and crusher house.	Wheel pit (300) Holding pond (310) S wall crusher house (401)	High High High	c. 1860

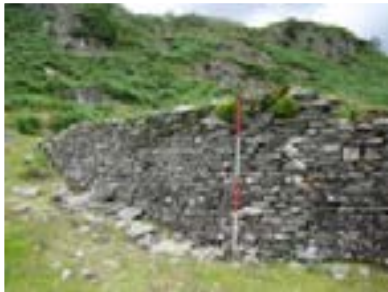
Context No.	Description	Significance	Associated with	Contribution to Significance	Date	Photo
313	Wall of coursed random rubble retaining the S side of the holding pond. Constructed against the natural slope, the battered wall rises in height to the E where it curves inwards to join with end wall (312).	<b>High</b> – as (311) above.	Holding pond (310)	High	c. 1860

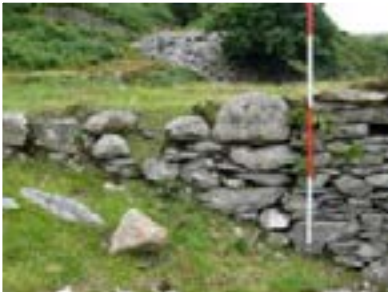
314	Short retaining wall forming SW end of holding pond (300). Random rubble and boulder construction it keys with and forms W continuation of wall (313).	<b>High</b> – as above.	Holding pond (310)	High	c. 1860

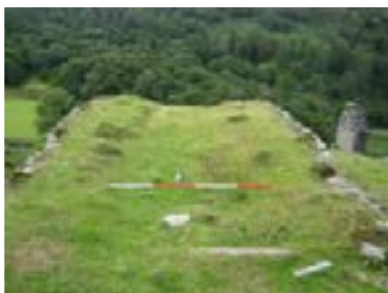
315	Turf covered linear channel, slightly oval in plan, within raised platform supported by walls (311-314), Forms the outline of the holding pond. E end disturbed.	<b>High</b> – as above.	Holding pond (310)	High	c. 1860

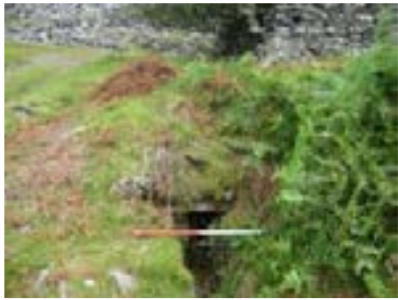
Context No.	Description	Significance	Associated with	Contribution to Significance	Date	Photo
316	Culvert entrance. Stone-slabbed, 0.65m wide X 0.4m high. N end of culvert (103) channelling water from Horse Crag Level (101) into leat (317).	<b>High</b> – of high evidential value in demonstrating the use and control of water on site.	Mine drain (103) Leat (317-319) Holding pond (310)	High High High	c. 1860

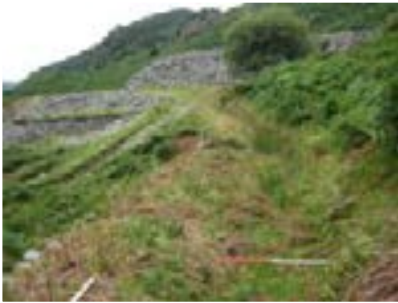
317	Leat. Cut into slope to W with upcast bank to E; bank and E side of leat retained by discontinuous stone wall. Originally carried water to wheel pit holding pond (310) but association with (310) has been disturbed/destroyed by construction of track (700). The S end recently re-engineered by CATMHS to take water draining N from Horse Crag Level to leat outflow (318).	<b>High</b> – as above.	Leat (316, 318-319)	High	c. 1860

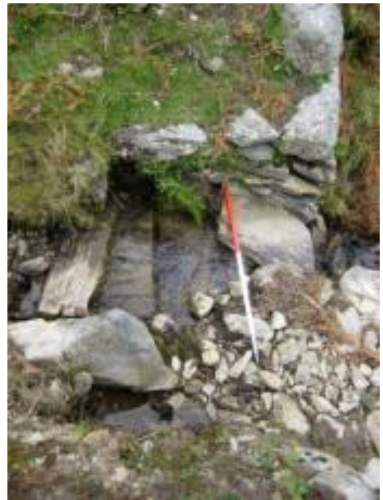
Context No.	Description	Significance	Associated with	Contribution to Significance	Date	Photo
318	Outflow to leat (317). Opening, 1.5m wide x 2.7m long, on E side of leat (317). Coursed stone wall survives to N but S side destroyed. Contains remains of timber box culvert. Overflow water runs E down slope to join Yewdale Beck.	<b>High</b> – as above.	Leat (317)	High	c. 1860

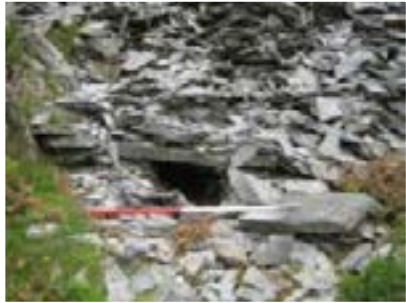
319	Culvert entrance. Stone-slabbed culvert, 0.5m wide x 0.3m wide, forming N end of leat (317). Overlain by spoil from slate tip (814).	<b>High</b> – as above. Also significant in demonstrating chronological relationship between copper mill and slate quarry features and thereby adding chronological depth.	Leat (317) Slate tip (814)	High High	c. 1860 or possibly contemporary with tip (814).

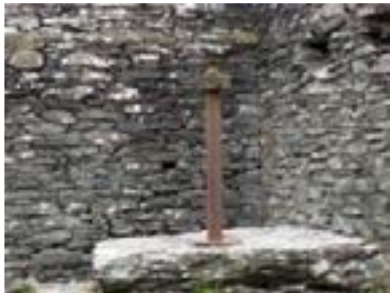
400 Group	Crusher house. Rectangular structure abutting wheel pit (300) with open front to E and gabled wall to N. Contained roller crusher and stamps for ore breaking .	<b>High</b> – considerable historic and evidential value because of the condition and extent of the surviving remains and the potential for interpreting and understanding the operation of water-powered ore crushing. Significant group value in association with the leat system, wheel pit and holding pond. Few crusher houses survive elsewhere in this state of preservation so of regional and national importance.	Leat (317) Holding pond (310) Wheel pit (300)	High High High	c. 1860

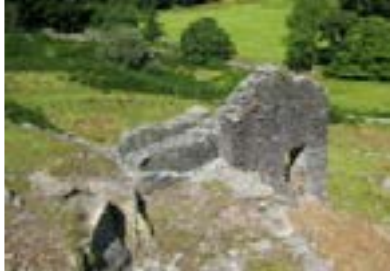
401	E wall of crusher house, coursed random rubble, constructed against slope to W. Ties in with wall (406) to S and overlies waterwheel pit wall (301) and N end of holding pond (312).	<b>High</b> – joist holes and timber slots within wall provide important evidence for understanding of internal timber elements and the position of associated crusher machinery.	Joist/timber slots (402-405) Wall (406) Wall (301) Wall (312)	High High High	c. 1860

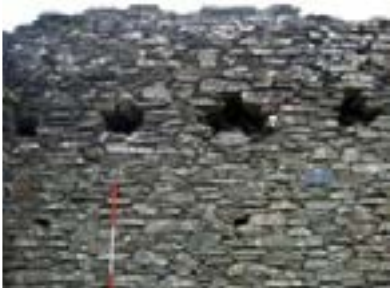
Context No.	Description	Significance	Associated with	Contribution to Significance	Date	Photo
402	Joist holes in E wall of crusher house (401). Line of five joist holes; central three damaged but joist holes at S and N ends retain rectangular profile. Held timber joists supporting high level or mezzanine floor, S line of which is marked by a recess (407) on adjoining wall (406); material for crushing was brought to this floor through opening (408) in wall (406) for delivery to the crushing rollers housed below.	<b>High</b> – as above.	Wall (401) Joist/timber slots (403-405) Recess (407)	High High  High	c. 1860

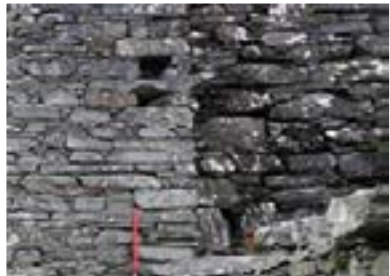
403	Two joist or timber holes set vertically one above the other at N end of wall (401). Function unknown but may have been associated with timber supports for the crushing rollers.	<b>High</b> – as above.	Wall (401) Joist/timber slots (402, 404-405)	High High	c. 1860

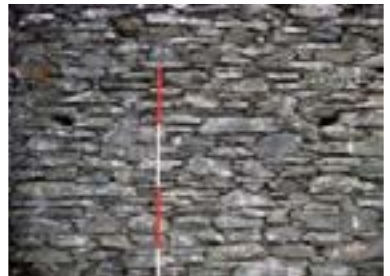
404	Two timber slots at S end of wall (401). Function unknown but may have been associated with timber structure associated with crushing rollers.	<b>High</b> – as above.	Wall (401) Joist/timber slots (402-403, 405)	High High	c. 1860

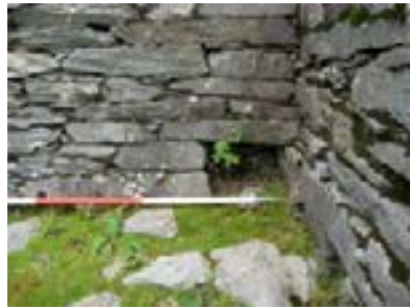
Context No.	Description	Significance	Associated with	Contribution to Significance	Date	Photo
405	Small rectangular ground level opening at N end of wall (401) and incorporating part of waterwheel pit wall (301). May have held structural timber associated with the crushing rollers or, alternatively, served as a weep-hole allowing drainage from the slope to the W.	<b>High</b> – as above.	Wall (401) Joist/timber slots (402-04) Wall (301)	High High High	c. 1860

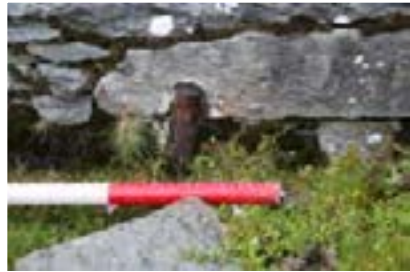
406	Two iron rods, possibly re-used drill rods or jumpers, set in ground in front of base course of wall (401).	<b>Medium</b> – of uncertain function but deliberate association with crusher house wall adds to the group value of the structure.	E wall crusher house (401)	Medium	c. 1860

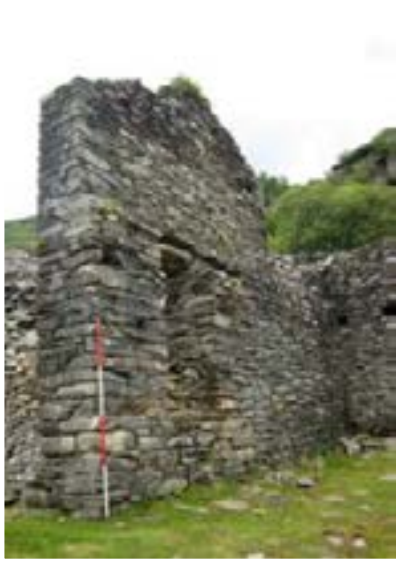
Context No.	Description	Significance	Associated with	Contribution to Significance	Date	Photo
407	The S wall of the crusher house, coursed random rubble construction with good use of through-stones at free standing E end. Gabled top, offset to the E, with a rectangular opening (410) below and a high-level opening (409) to the W. Joins with wall (401). Retaining walls and inclined tracks (414, 416, 417, 418) butt against the outer or S face.	<b>High</b> – openings, joist holes and timber slots within wall provide important evidence for understanding of internal timber elements and the position of associated crusher machinery.	Crusher house (400) Retaining walls and inclined tracks (414, 416-418)	High  High	c. 1860

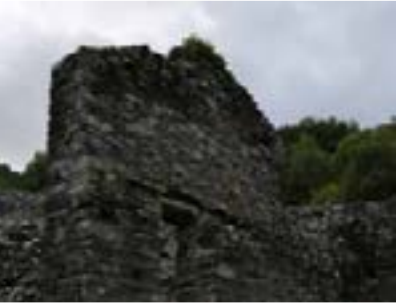
408	Recess to carry high level or mezzanine floor associated with joist holes (402) in adjacent wall (401).	<b>High</b> – as above	Crusher house (400) Wall (407)	High High	c. 1860

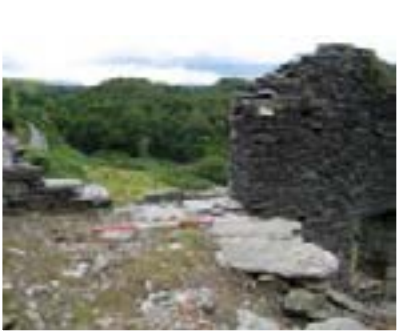
Context No.	Description	Significance	Associated with	Contribution to Significance	Date	Photo
409	High level opening to W of gable in wall (407). Material from inclined track (416) was carried through this opening onto the floor above the roller crushers.	<b>High</b> – of considerable evidential value because of its association with the movement of ore into the building and its potential to interpret processes within the crusher house.	Crusher house (400) Wall (407) Track (416)	High  High High	c. 1860

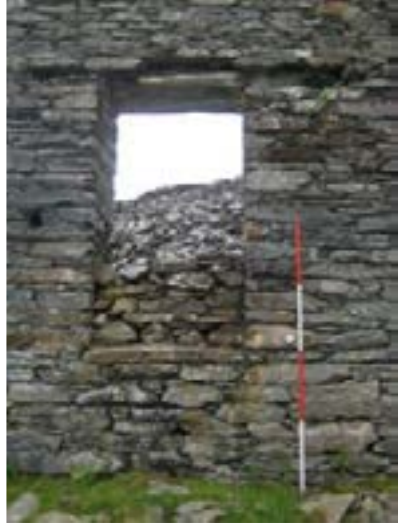
410	Rectangular opening or doorway in wall (407); infilled at base by wall (413). Opening associated with inclined track (414). Possibly used for delivery of ore bearing rock for secondary crushing.	<b>High</b> – as above	Crusher house (400G) Wall (407) Track (414)	High High High	c. 1860

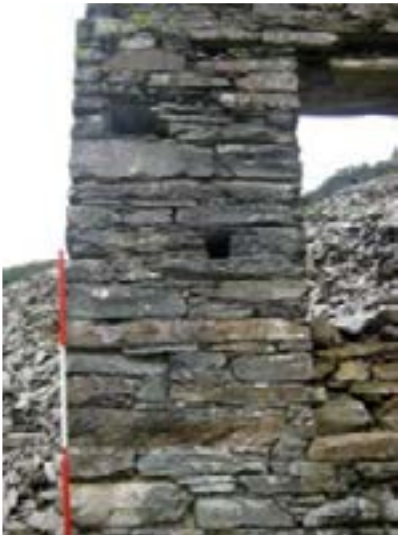
Context No.	Description	Significance	Associated with	Contribution to Significance	Date	Photo
411	Two joist holes on internal face of wall (407) to E of opening (410). Possibly associated with timber framework or structure on the E face of the crusher house.	<b>High</b> –joist holes and timber slots within wall provide important evidence for understanding of internal timber elements and the position of associated crusher machinery.	Crusher house (400) Wall (407)	High High	c. 1860

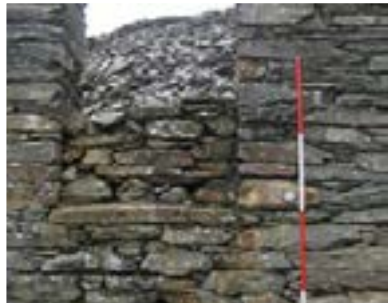
Context No.	Description	Significance	Associated with	Contribution to Significance	Date	Photo
413	Low dry stone wall built across and infilling the lower part of opening (410). Presumably, a secondary or later feature added after inclined ramp (414) had gone out of use.	<b>Medium</b> – of evidential and chronological value because it relates to a later use/adaption of the structure and thereby demonstrates chronological depth.	Crusher house (400) Wall (407) Opening (410)	High High Medium	undated

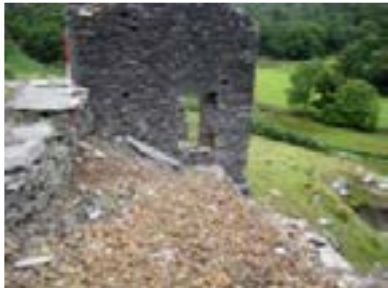
414	Inclined ramp or track above retaining wall (415) and leading to opening (410) in S face of wall (407). Surface covered in broken mineral. S end obscured by slate tips (813) but may originally have been associated with ore hoppers on terrace below.	<b>High</b> – of considerable evidential value because of its association with the movement of ore into the building and its potential to interpret processes within the crusher house.	Crusher house (400) Wall (407) Opening (410) Wall (415)	High High High High	c. 1860

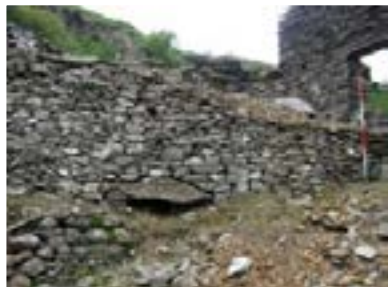
415	Random rubble retaining wall below ramp (414). Abutts wall (407) and to S overlain by slate tip (813). Opening of culvert (420) at base of wall.	<b>High</b> – of considerable evidential because of its role as important structural element within the site as a whole.	Crusher house (400) Track (414) Culvert (420)	High High High	c. 1860

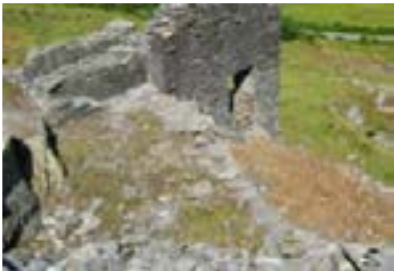
Context No.	Description	Significance	Associated with	Contribution to Significance	Date	Photo
416	Inclined ramp above retaining wall (417-418) leading to opening (409) in crusher house building. Large edging slabs on E side. Probably designed as a track to take material to top floor of crusher house. S part of ramp overlain by slate tip (813). W section of ramp defined by bedrock outcrop with shot-holes.	<b>High</b> – of considerable evidential value because of its association with the movement of ore into the building and its potential to interpret processes within the crusher house.	Crusher house (400) Wall (407) Opening (409) Retaining walls (417-418)	High High High High	c. 1860

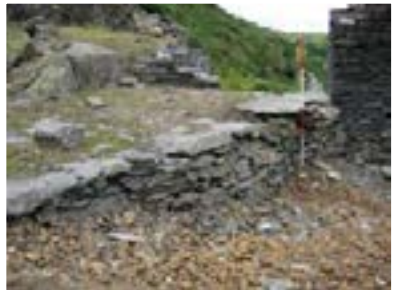
417	Dry stone retaining wall between ramps (414) and (416). N end butts against retaining wall (418).	<b>High</b> – of considerable evidential value because of its role as important structural element within the site as a whole.	Crusher house (400) Wall (407) Ramp (414) Ramp (416) Wall (418)	High High High High High	c. 1860

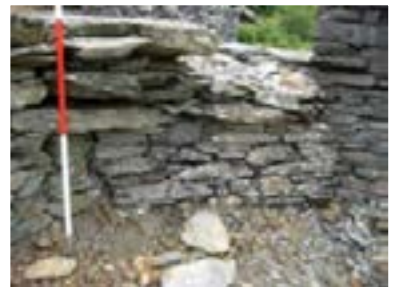
418	Short length of dry stone retaining wall between N end of wall (417) and crusher house wall (407). Probably designed to allow widening of ramp (416) above.	<b>High</b> – of considerable evidential value because of its role as important structural element within the site as a whole. Also demonstrates structural detail.	Crusher house (400 G) Wall (407) Wall (417) Ramp (416)	High High High High	c. 1860

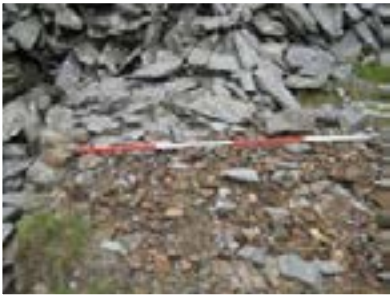
Context No.	Description	Significance	Associated with	Contribution to Significance	Date	Photo
419	Short length of retaining wall above ramp (416). Its continuation to the SW is obscured by slate tip (813). Above the wall is an oval area of crushed mineralised rock, 1.9m x 2.3m.	<b>High</b> – of considerable evidential because of its role as important structural element within the site as a whole. It may also be one of the few surviving features relating to primary ore breaking and selection.	Ramp (416) Tip (813)	High High	c.1860

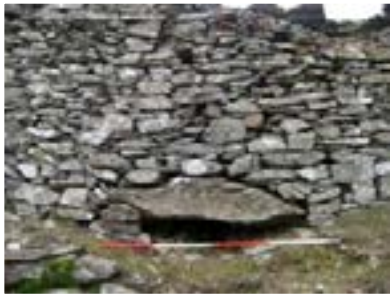
420	Entrance to culvert, 0.9m wide x 0.4m high, at base of retaining wall (415). Massive lintel supported by packed stone side walls. Probably constructed to drain the terrace above, it may have culverted a pre-existing stream.	<b>High</b> – of high evidential evidence as one of the few surviving features on site relating to the control of natural drainage.	Wall (415)	High	c. 1860

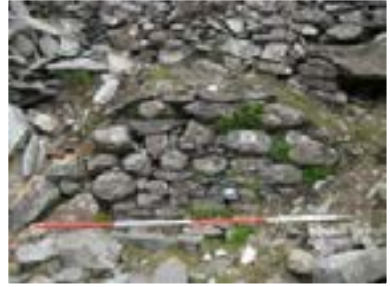
421	Pack wall. A short length of dry stone retaining wall, possibly forming part of a channel associated with drainage from culvert (420). Surrounding area obscured by spoil and recent storm damage.	<b>High</b> – of considerable evidential because of its role as important structural element within the site as a whole.	Entrance to culvert (420)	High	c. 1860

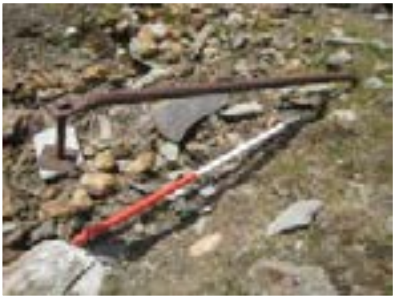
Context No.	Description	Significance	Associated with	Contribution to Significance	Date	Photo
422	Wrought iron bar, 1.62m long x (1 ½ inch) diameter set in rubble/spoil. At one end is a (9 inches) long hand forged bolt attached to a 0.10m x 0.10m (4in x 4in) iron plate. The bar presumably held or supported a timber element and may have formed part of a larger timber structure.	<b>High</b> – considerable evidential value as one of the few surviving pieces on site of structural metalwork. Potential for further research and interpretation.	Possibly crusher house (400)	High	c. 1860

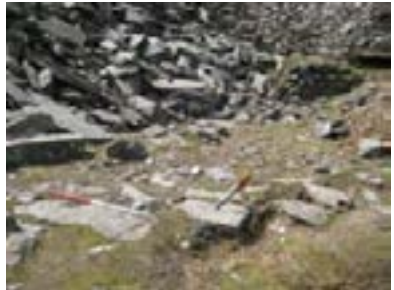
423	Paved area composed of large rectangular stone slabs. Obscured to W and S by slate spoil tip (813). Function unknown but may be the interior of a timber sided structure; alternatively a slabbed surface for some form of ore breaking.	<b>High</b> – considerable evidential value as may provide archaeological evidence for additional structures and/or activities associated with ore treatment. Potential survival of archaeological features and deposits.			c. 1860

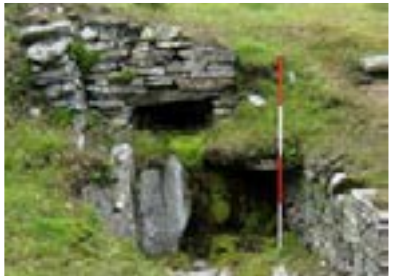
424	Culvert opening. S opening of culvert between wheel pit (300) and tank (425). Slab roof construction supporting N wall of (425).	<b>High</b> – of high evidential value in demonstrating the use and control of water on site.	Outflow tank (304) Tank/holding pond (425)	High High	c. 1860

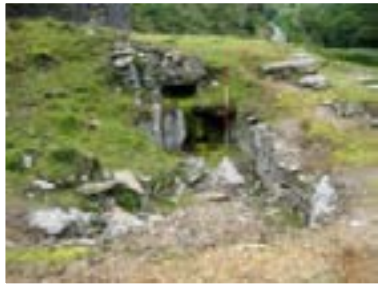
Context No.	Description	Significance	Associated with	Contribution to Significance	Date	Photo
425	Rectangular , sunken stone walled tank associated with culverts (424) and (426). The W wall has been partly destroyed. The tank may have served as a small holding pond for a waterwheel powering machinery within dressing mill (500).	<b>High</b> – as above	Culvert (424)	High	c. 1860

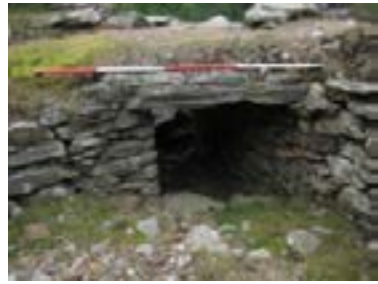
426	Short length of stone roofed culvert at SE corner of tank (425). Led water to external face of dressing mill wall (507).	<b>High</b> – of high evidential value in demonstrating the use and control of water on site.	Tank/holding pond (425) Wall (507)	High High	c. 1860

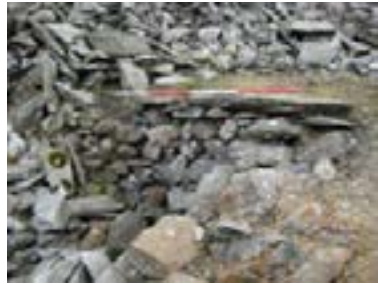
427	Length of dry stone retaining wall joining with wall (428) to N. S extent obscured by slate tip (831). Forms E edge of slabbed-floor area (423).	<b>High</b> – of considerable evidential value because of its role as an important structural element within the site as a whole.	Wall (428) Floor (423)	High High	c. 1860

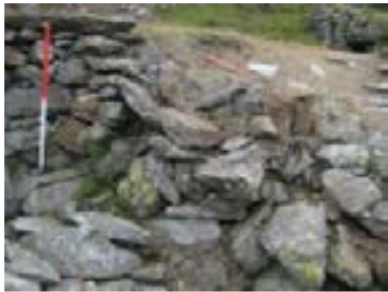
Context No.	Description	Significance	Associated with	Contribution to Significance	Date	Photo
428	Semi-collapsed length of dry stone retaining wall joined to W with wall (427)	<b>High</b> – as above.	Wall (427)	High	c. 1860

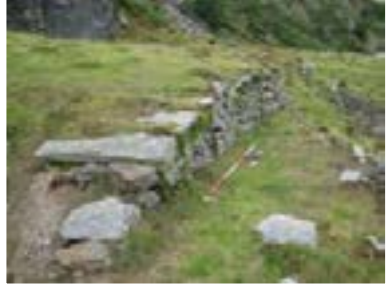
429	Length of low retaining wall E of tank (425). Continuation to N disturbed by possible landslip. May be a single feature with wall (431).	<b>High</b> – good evidential value for the construction and use of terraced features as part of the integrated design of the site.	Wall (431)?	High	c. 1860

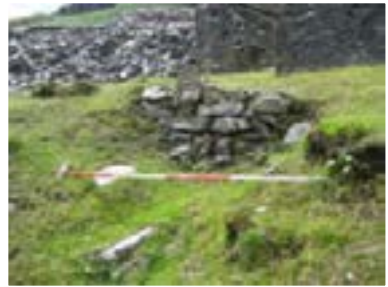
430	Dry stone retaining wall in front and E of wheel pit (300). May be associated with construction and structural support of culverts (306) and (424). Alternatively, it may have been constructed after failure of retaining wall (429/431).	<b>High</b> – good evidential value because of its role as an important structural element of the site as a whole.	Culvert (306)? Culvert (424)?	High High	c. 1860

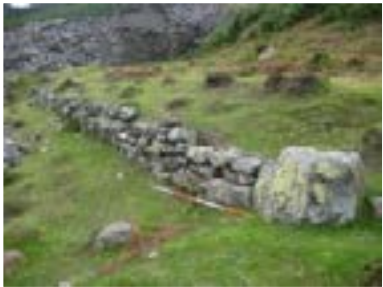
Context No.	Description	Significance	Associated with	Contribution to Significance	Date	Photo
431	Low stone retaining wall built against slope to W. Terrace above used by access track (432).	<b>High</b> – good evidential value for the construction and use of terraced features as part of the integrated design of the site.	Track (432)	High	c. 1860

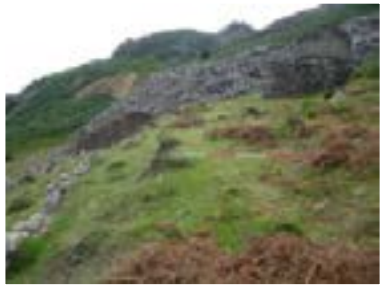
432	Probable access track to crusher house (400 G). Follows partly artificial terrace above and parallel to retaining wall (431).	<b>High</b> – as above.	Wall (431)	High	c. 1860

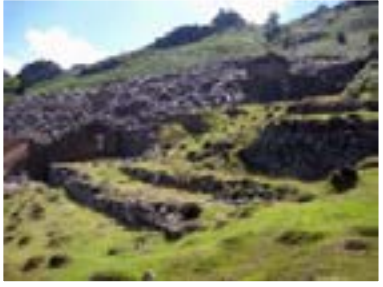
500 Group	Building and related structures associated with ore dressing and processing. Includes a probable mill building (501-515) and an area of settling ponds (516-522). The mill, open sided to the E, probably housed a set of jigs powered by a waterwheel located against the external S wall. The settling ponds were not enclosed.	<b>High</b> – considerable historical and evidential value as a well preserved and regionally/nationally important copper dressing mill with associated settling ponds. Good potential for survival of archaeological features associated with ore dressing machinery such as jigs.	Mill features (501-515) Settling pond features (516-522)	High High	c. 1860

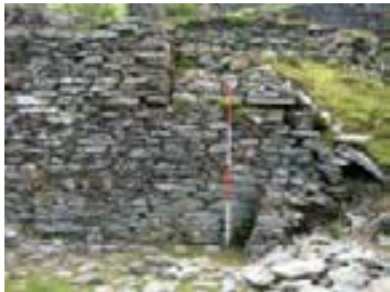
Context No.	Description	Significance	Associated with	Contribution to Significance	Date	Photo
501	Coursed random rubble retaining wall forming the W side of the mill building. Built against the natural slope, it incorporates two ore chutes or hoppers (504-05).	<b>High</b> – good evidential value as part of structural layout of dressing mill.	Mill (500) Ore hoppers (504-505) Launder support (503)?	High High High	c. 1860

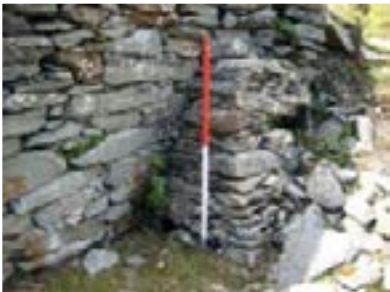
502	Buttress built against N end of mill wall (501). Feature (503) is incorporated within the buttress. Both the buttress and wall (501) have been destroyed to the N.	<b>High</b> – good evidential value as part of structural layout of dressing mill.	Mill (500) Wall (501) Launder support (503)?	High High High	c. 1860

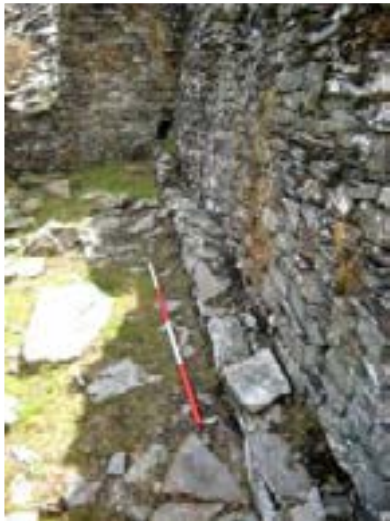
Context No.	Description	Significance	Associated with	Contribution to Significance	Date	Photo
503	Shallow stone rubble plinth at the base of wall (501) and associated with opening (506) in wall (507) and the opening at the base of buttress (502). Function unknown, but may have supported a wooden launder supplying water to the mill.	<b>High</b> – good evidential value as demonstrates use and control of water supply within the mill. Further research needed, but potential to aid interpretation of ore dressing process.	Mill (500) Launder support (503)? Buttress (502) Wall (501) Wall (507) Opening (506)	High High High High High	c. 1860

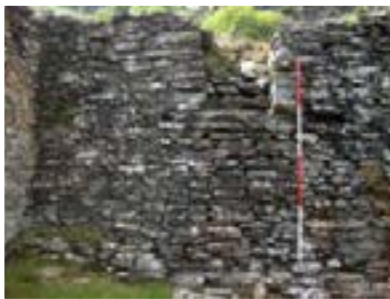
504	High-level rectangular opening with angled base/sill in S section of wall (501). Probable ore chute taking crushed material to the jigs.	<b>High</b> – good evidential value as one of only two ore hoppers on site and demonstrates process for delivering material between the crusher house and the mill.	Mill (500) Wall (501)	High High	c. 1860

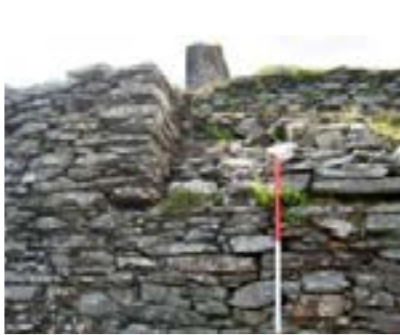
Context No.	Description	Significance	Associated with	Contribution to Significance	Date	Photo
505	High-level rectangular opening with angled base/sill in N section of wall (501). Probable ore chute taking crushed material to the jigs.	<b>High</b> – as above.	Mill (500) Wall (501)	High High	c. 1860

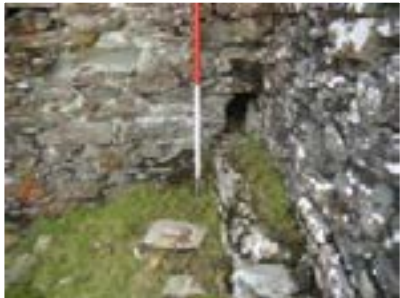
507	S wall of mill building. Coursed random rubble construction with rectangular opening (510) towards W section of wall. The profile of the wall shows a double roof line with a gable apex above opening (510) and a valley feature to the E. The E end of the wall is absent but there is a vertical face suggesting an E door or window; a later wall (515) butts against the E end of (507). At the E end wall (507) sits above a wider foundation or settling course (509).	<b>High</b> – good evidential value as part of structural layout of dressing mill. Also provides unique information on the constructional form and detail of the mill roof.	Mill (500) Wall (509) Wall (515) Opening (510)	High High High High	c. 1860

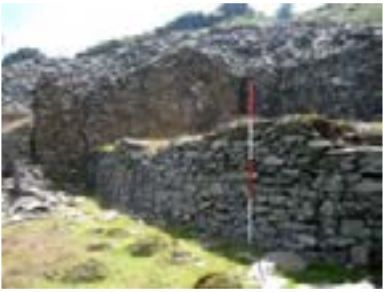
Context No.	Description	Significance	Associated with	Contribution to Significance	Date	Photo
508	Stone retaining wall, 1.7m high, within the main mill building. To the S it is abutted by wall (509) and overlain by mill wall (507). To the N the wall butts against settling pond retaining wall (516).	<b>High</b> – good evidential value for the construction and use of terraced features as part of the integrated design of the site.	Wall (507) Wall (509) Wall (516)	High High High	c. 1860

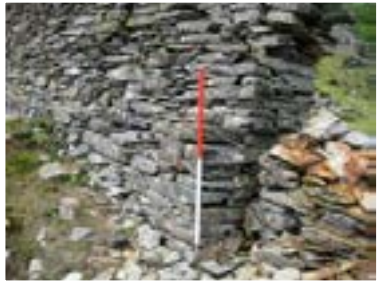
510	Rectangular opening, 0.9m wide by 1.46m high, in mill wall (507). Stone and timber lintels. The dimensions of the opening suggest a doorway but it may have been used to take drive equipment powered by a putative waterwheel housed against the external wall of (507).	<b>High</b> – good evidential value through association with putative second waterwheel and the operation of machinery within the mill building. Further research may aid understanding and interpretation.	Mill (500) Wall (507)	High High	c. 1860

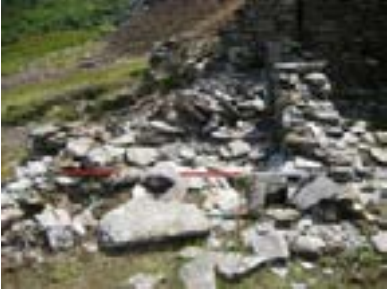
Context No.	Description	Significance	Associated with	Contribution to Significance	Date	Photo
511	Collapsed wall, approx. 0.55m wide, constructed from randomly coursed slate rubble. Runs parallel to wall (512) and the two may have formed the outer sides of a single rectangular structure.	<b>High</b> – good evidential value as demonstrates a second phase of construction within the mill complex.	Mill (500) Wall (512) Wall (515)	High High High	Second phase construction – post-1860

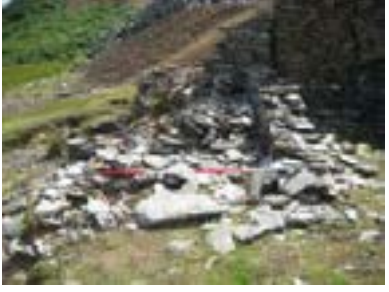
512	Collapsed wall, approx. 0.6m wide, constructed from randomly coursed slate rubble. Runs parallel to wall (511) and the two may have formed the outer sides of a single rectangular structure. To the S butts against and may be contemporary with wall (515).	<b>High</b> – as above.	Mill (500) Wall (511) Wall (515)	High High High	Second phase construction – post-1860

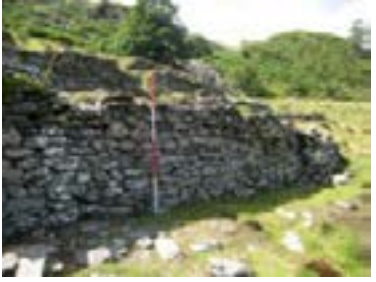
513	Retaining wall, 1.7m high, forming the E side of the mill building. Collapsed towards S end and to N abuts buttress (514). Overlain to S by wall (511)	<b>High</b> – good evidential value for the construction and use of terraced features as part of the integrated design of the site.	Mill (500) Wall (511) Wall (512) Wall (514) Wall (515)	High High High High High	c. 1860

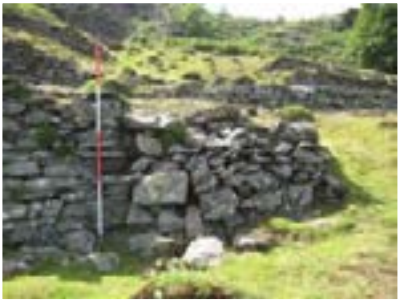
Context No.	Description	Significance	Associated with	Contribution to Significance	Date	Photo
514	Rubble buttress forming a short continuation of retaining wall (513).	<b>High</b> – good evidential value for the construction and use of terraced features as part of the integrated design of the site.	Mill (500) Wall (513)	High High	c. 1860

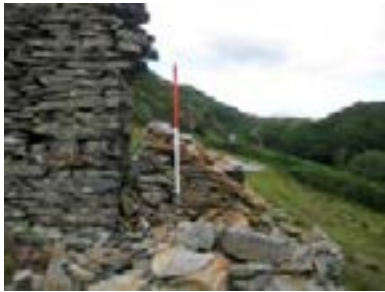
515	Poorly constructed slate rubble wall, partly collapsed. May form S end of structure with walls (511) and (512). Butts against E end of mill wall (507) and may infill possible door feature in that wall.	<b>High</b> – good evidential value as demonstrates a second phase of construction within the mill complex.	Mill (500) Wall(511) Wall(512) Wall (513)	High High High High	Second phase construction – post-1860

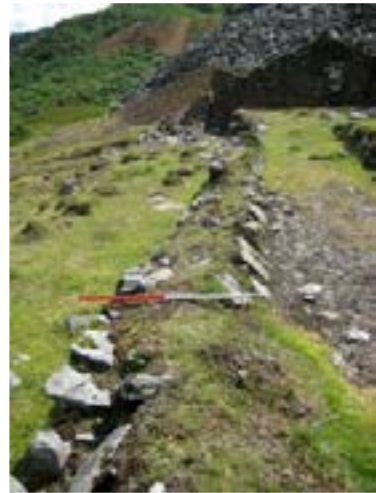
Context No.	Description	Significance	Associated with	Contribution to Significance	Date	Photo
516	Stone-faced bank, forming E edge of settling pond (521). Inner or W face is 0.4m high incorporates angled slabs. The outer face forms a 0.95m high retaining wall and is parallel to access track/terrace (538).	<b>High</b> – good evidential value as forms an integral part of the settling pond structure. The ponds are in good condition, form an important group association with the mill building to the S. Good condition and relative rarity suggests regional and possibly national significance.	Settling pond (517-522) Track (538)	High High	c. 1860

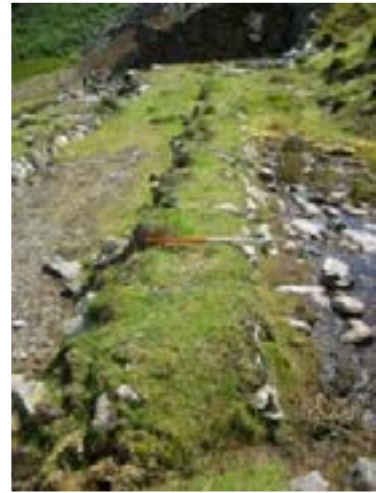
517	Stone-faced bank, 1.2m wide x 0.75m high, forming E edge of settling pond (520). Drain feature (522) at N end. S end obscured by tumbled masonry/landslip.	<b>High</b> – as above	Settling pond (516), (518-522)	High	c. 1860

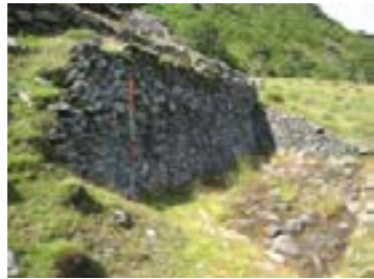
Context No.	Description	Significance	Associated with	Contribution to Significance	Date	Photo
518	Retaining wall built against slope and forming the W wall of the settling tank area. Joins with wall (519) to the N. Collapsed to S.	<b>High</b> – as above	Settling pond (516-517, 519-522)	High	c. 1860

A photograph showing a dark, stone retaining wall built against a grassy slope. The wall is partially collapsed at the base. A red surveying pole is visible in the background.
519	Retaining wall built against slope and forming the N edge of settling tank (520). Profile of the wall follows the slope profile.	<b>High</b> – as above	Settling pond (516-518, 520-522)	High	c. 1860

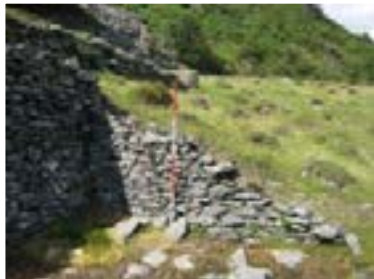
A photograph showing a dark, stone retaining wall built against a grassy slope. The wall follows the profile of the slope. A red surveying pole is visible in the background.
520	Rectangular settling pond. Defined to W and N by walls (518) and (519) and separated from pond (521) by bank (517). Obscured to S by collapsed material.	<b>High</b> – as above	Settling pond (516-519, 521-522)	High	c. 1860

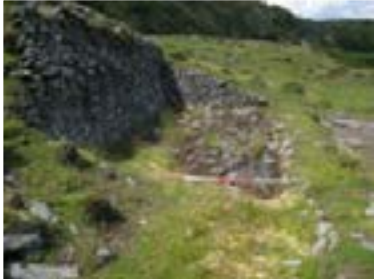
A photograph showing a rectangular settling pond. The pond is defined by walls (518) and (519) to the west and north. The pond is obscured to the south by collapsed material. A red surveying pole is visible in the background.

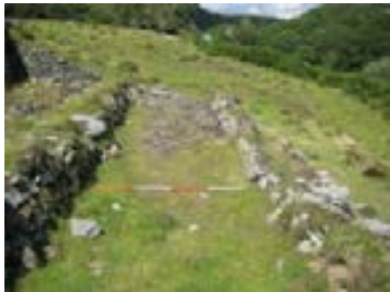
Context No.	Description	Significance	Associated with	Contribution to Significance	Date	Photo
521	Rectangular settling pond. Defined to W and E by walls (517) and (516). Pond (521) is slightly lower than pond (520).	<b>High</b> – as above	Settling pond (516-520, 521)	High	c. 1860

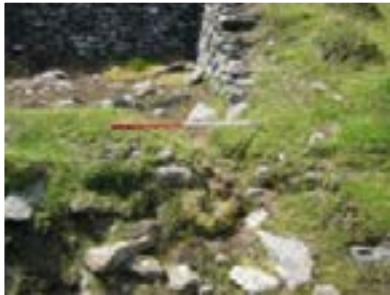
522	Channel, 0.6 m wide, between settling ponds (520) and (521). Probably operated by a simple paddle sluice the channel allowed water and sands to drain from pond (520) to pond (521).	<b>High</b> – as above	Settling pond (516-521)	High	c. 1860

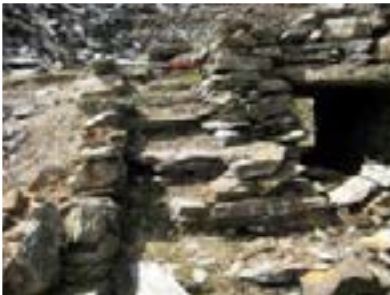
523	Support wall for top of steps (524). Built over culvert (426) and incorporating the external corners of mill walls (503) and (507).	<b>High</b> – good evidential value as forms an integral part of the mill complex.	Culvert (426) Mill (500) Steps (524) Wall (525) Wall (503) Wall (507)	High High High High High High	c. 1860

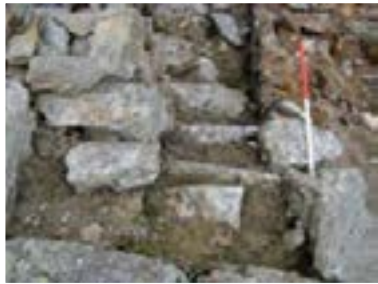
Context No.	Description	Significance	Associated with	Contribution to Significance	Date	Photo
524	Angled flight of stone steps accessing the area immediately S of mill wall (507). Built against wall (523) and defined to the S by wall (525).	<b>High</b> – as above.	Mill (500) Wall (523) Wall (525)	High High High	c. 1860

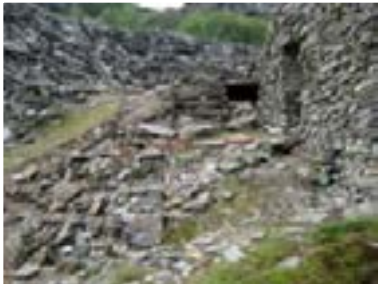
525	Wall line surviving as tumbled foundation course. Forms E edge of a rectangular space or structure defined to the N by mill wall (507) and accessed to the SW by steps (524). Possible location for waterwheel powering the mill machinery.	<b>High</b> – as above. Also of potential significance as location of putative second waterwheel; further research required.	Mill (500) Wall (524)	High High	c. 1860

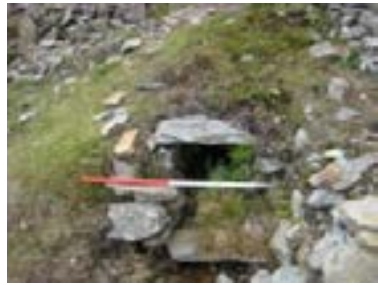
526	Culvert. Exit for stone-slabbed drain associated with culvert (426) to the W. May have served as the outflow channel for a putative waterwheel housed between mill wall (507) and wall (525).	<b>High</b> – good evidential value as forms an integral part of the mill complex and also of importance in understanding water control and use at the site.	Mill (500)	High	c. 1860

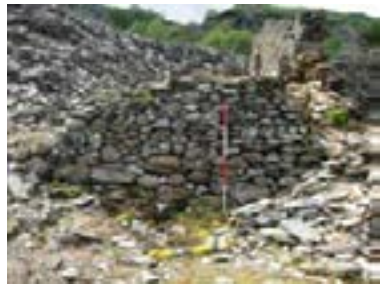
Context No.	Description	Significance	Associated with	Contribution to Significance	Date	Photo
527	Retaining wall built against slope to W. Random water rolled boulder construction on boulder plinth. Collapsed to N. On same line as retaining wall (513).	<b>High</b> – good evidential value because of its role as an important structural element of the site as a whole.	Mill (500)	High	c. 1860

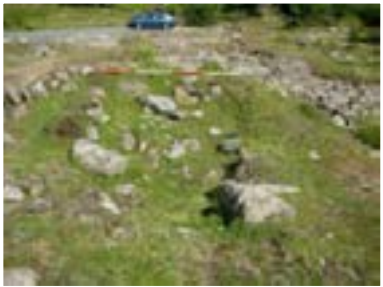
528	Rectangular buddle, 1.6m x 2.9m, retained to E by wall (529). Forms a group with buddles (530), (531).	<b>High</b> – good evidential value as one of only three buddles at the site and because of the information it provides on the relative level of technology in use.	Wall (529) Buddle (530) Buddle (531)	High High High	c. 1860

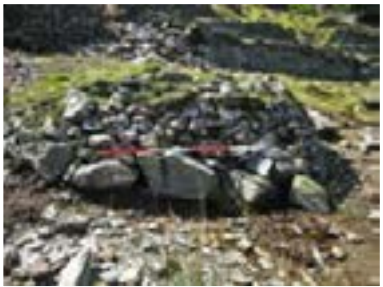
529	Curved retaining wall, 1.6m high, to E of buddle (528). Battered rubble face on boulder plinth.	<b>High</b> – good evidential value because of structural association with a buddle.	Buddle (528)	High	c. 1860
