PENNY RIGG COPPER MILL,

ARCHAEOLOGICAL  
COMMUNITY LANDSCAPE  
AND BUILDING SURVEY

PENNY RIGG COPPER MILL,  
TILBERTHWAITE, CONISTON,  
CUMBRIA

NAA 16/145  
November 2016  
(Issued January 2017)

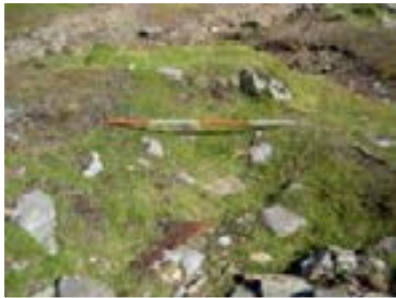
Context No.	Description	Significance	Associated with	Contribution to Significance	Date	Photo
530	Rectangular buddle, 1.4m x 3.2m, with subsurface drain at E end. Forms a group with buddles 528 and (531). Buddle waste and sand exposed in stream cut to S.	<b>High</b> – good evidential value as one of only three buddles at the site and because of the information it provides on the relative level of technology in use.	Buddle (528) Buddle (531)	High High	c. 1860

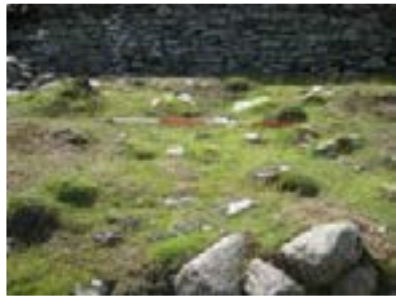
531	Rectangular buddle, 1.1m x 3.3m. Forms a group with buddles (528) and (530).	<b>High</b> – as above.	Buddle (528) Buddle (530)	High High	c. 1860

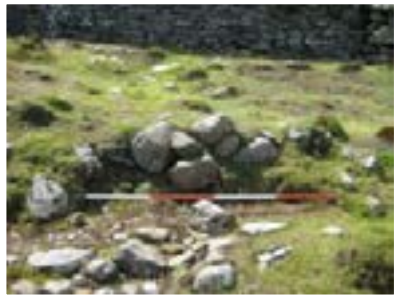
532	Low retaining wall, boulder construction, built against slope to W. Possibly constructed to retain the ground surrounding buddles (530) and (531).	<b>High</b> – of good evidential value because of its role as a structural element associated with two of the three buddles.	Buddle (530) Buddle (531)	High High	c. 1860

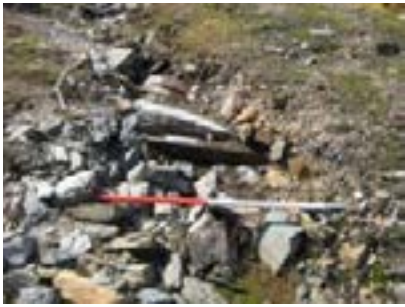
Context No.	Description	Significance	Associated with	Contribution to Significance	Date	Photo
533	Short length of low retaining wall. Possibly associated with buddle (530).	<b>Medium</b> – of value as a structural element of the site but importance lessened because of function unknown.	Buddle (530)	Medium	c. 1860

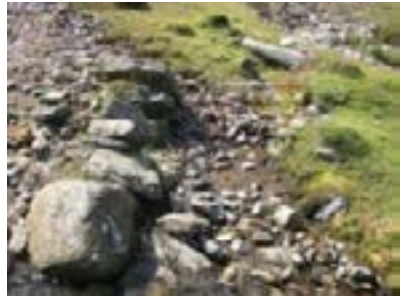
534	Culvert and drain. Short section of culvert with slabbed roof, partly destroyed by stream action. Probably associated with drainage from mill and the putative second waterwheel. Continues as drain (535).	<b>Medium</b> – of value in providing information on water control but significance lessened because of damaged state.	Culvert (535)	Medium	c. 1860	
535	Truncated section of drain/culvert. Survives to W as channel. A continuation of culvert (534).	<b>Medium</b> – as above.	Culvert (534)	Moderate	c. 1860

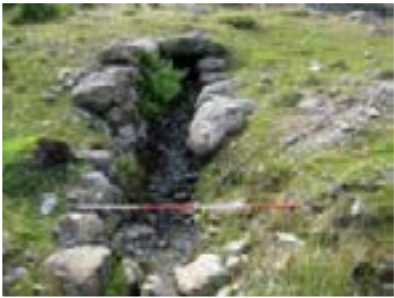
Context No.	Description	Significance	Associated with	Contribution to Significance	Date	Photo
536	Culvert. Section of well-constructed boulder wall and slab roof culvert under mine track (705). Continues S to modern road as open, stone walled channel. A continuation of culvert/watercourse (535).	<b>High</b> – of good evidential value, despite its truncated state, because of association with track and fine structural condition.	Track (705) Culvert (535)	High High	c. 1860

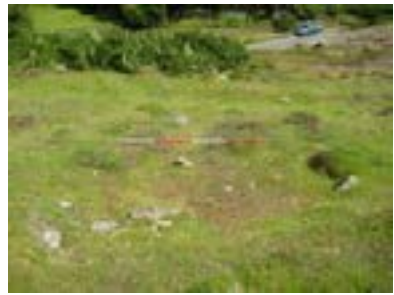
537	L-shaped depression between N end of wall (516) and mine track (705). Possibly associated with drainage between settling pond (521) and buddles (528), (530) and (531).	<b>Medium</b> – current level of significance relates to uncertainty over function. Future research may establish an association with the other mill features.	Settling pond (521)? Buddle (528)? Buddle (530)? Buddle (531)?	High High High High	c. 1860

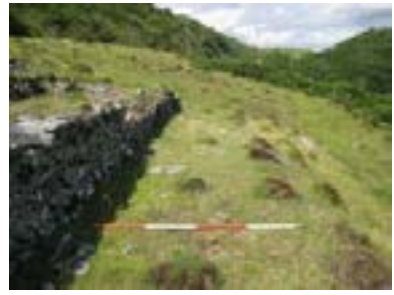
538	Possible access track to SE corner of mill complex. On natural (?) terrace parallel to retaining wall (516).	<b>High</b> – good evidential value for the construction and use of terraced features as part of the integrated design of the site.	Wall (516)	Medium	c. 1860

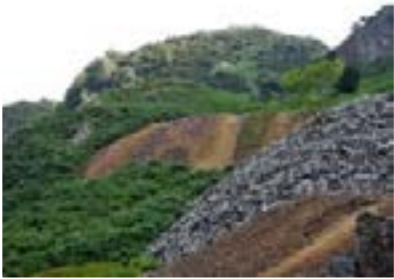
Context No.	Description	Significance	Associated with	Contribution to Significance	Date	Photo
539	Mine tips with distinctive orange-brown colour of copper mineralisation. Top of tips at same height as crusher house (400) suggesting the tips are waste from crushing process. Probably connected to crusher house by tramway or barrow run but this area now covered by waste from slate spoil tip (813).	<b>High</b> – good evidential and spatial evidence for dumping of secondary waste material. The only surviving example on the site of spoil from the crusher house. Provides interesting chronological and visual contrast with overlying slate tips. Distinctive colour is of aesthetic significance.	Crusher (400) Slate tip (813)	High High	c. 1860

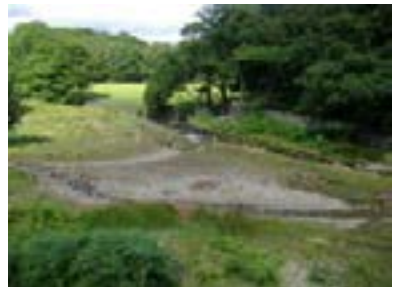
600	One or possibly two slime or tailings ponds below modern road and W side of Yewdale Bank. Defined by a series of banks enclosing an area with fine, laminated sands typical of mine tailings. S section badly damaged by recent floods.	<b>High</b> – good example of closely dated and well preserved tailings ponds with distinctive banked divisions and early use of levée-like safety banks to prevent discharge of waste into beck. Of regional significance.	Associated pond features (601-607)	High	c. 1860

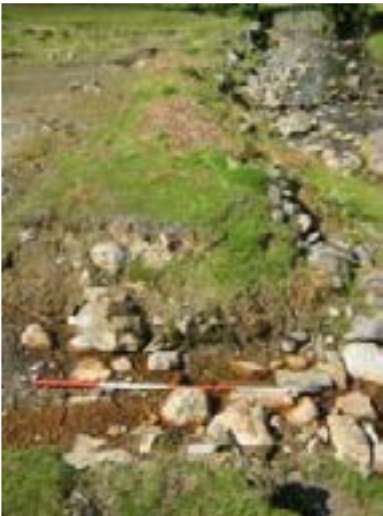
Context No.	Description	Significance	Associated with	Contribution to Significance	Date	Photo
601	Large beck side bank, 2.75m wide x 0.95m high. Turf and earth core with single stone face to W and discontinuous double stone face to E. To S terminates at natural outcrop with possible overflow channel (606) beyond.	<b>High</b> – good evidential value as forms an integral part of the tailings ponds feature group.	Associated pond features (602-607)	High	c. 1860

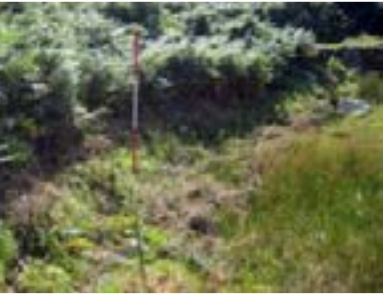
602	Low, discontinuous retaining wall against SW bank and forming curved S section of tailings pond.	<b>High</b> – as above	Associated pond features (601, 603-607)	High	c. 1860

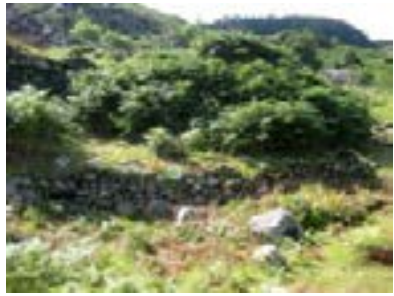
Context No.	Description	Significance	Associated with	Contribution to Significance	Date	Photo
603	Low retaining wall below (E) modern road. Forms SW perimeter of tailings pond.	<b>High</b> – as above	Associated pond features (601-602, 604-607)	High	c. 1860

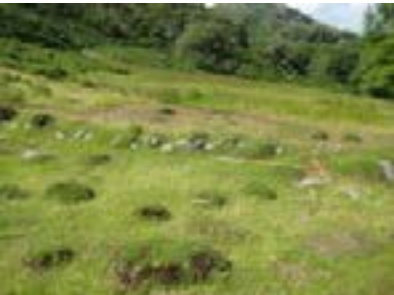
604	Stone faced bank running W from beck side bank (601) to base of slope. Gap or sluice (607) at E end	<b>High</b> – as above	Associated pond features (601-3, 606-07)	High	c. 1860

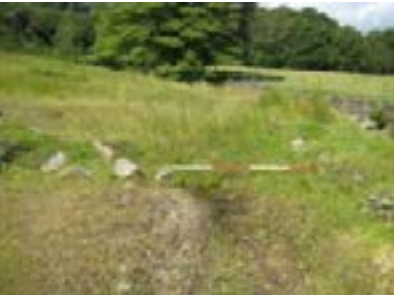
605	Area N of bank (604) and defined to E by beck side bank (601). Possibly a secondary tailings pond taking accidental discharge of waste from N section of mill complex.	<b>High</b> – as above	Associated pond features (601-604, 606-07)	High	c. 1860

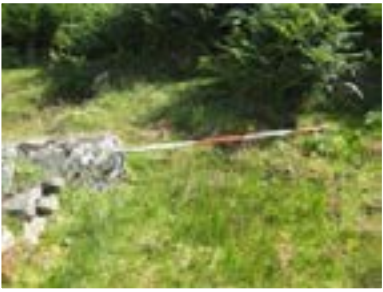
Context No.	Description	Significance	Associated with	Contribution to Significance	Date	Photo
606	Channel, 1.4m wide, at S end of bank (601). Probable overflow channel allowing water but not tailings to enter Yewdale Beck.	<b>High</b> – as above	Associated pond features (601-605, 607)	High	c. 1860

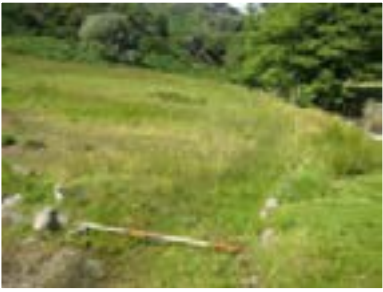
607	Gap at E end of bank (604), possible sluice or overflow between main tailings pond and putative pond (605).	<b>High</b> – as above	Associated pond features (601-606)	High	c. 1860

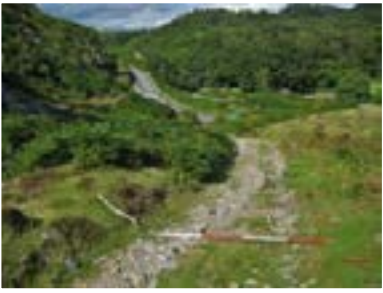
700	Track between modern road and Horse Crag quarry. Shown on Third Edition Ordnance Survey map of 1915, but not earlier editions. Cuts across route of track (705).	<b>High</b> – of good evidential value because of chronological and cartographical relationship to other tracks on site.	Track (705) Leat (309)	High High	Post 1898

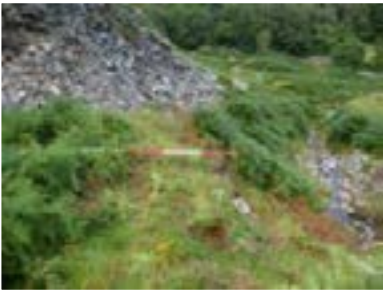
Context No.	Description	Significance	Associated with	Contribution to Significance	Date	Photo
701	Original track to mine and quarry from the NW. Constructed against NW slope and partly revetted to SE. Survives as terraced trackway between modern road and track (700) but overlain in central section by slate tip (814). Shown on First Edition Ordnance Survey map of 1850.	<b>High</b> – as above. Also of significance because of chronological and functional association with later slate tip.	Culvert (702) Spoil tip (814)	High High	Before 1850

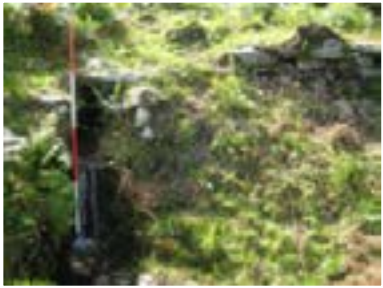
702	Culvert, stone slab roof and stone sides carrying outflow water from leat (317) under track (701). Probably contemporary with (701).	<b>High</b> – good evidential value as relates to use and control of water and its functional association with the track system.	Leat overflow (318) Track (701)	High High	Before 1850

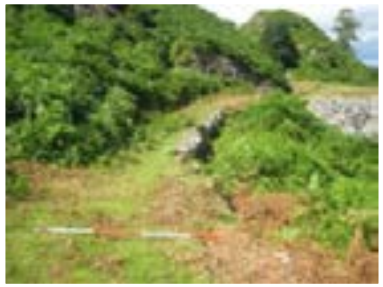
703	Track constructed against W slope with discontinuous stone revetment to E. Runs between smithy (201) and slate riving shed (800). Not shown on First Edition Ordnance Survey map.	<b>High</b> – of good evidential value because of chronological and cartographical relationship to other tracks on site. Also of significance because of chronological association with later slate workings.	Slate tip (814) Riving shed (800)	High High	Post 1850.

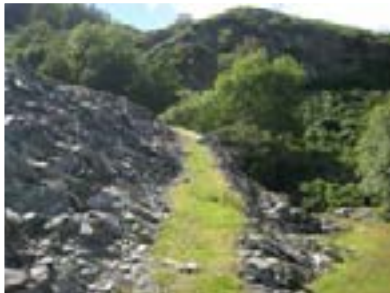
Context No.	Description	Significance	Associated with	Contribution to Significance	Date	Photo
704	Inclined track from Horse Crag quarry on NE side of slate spoil tip (811).	<b>High</b> – of good evidential value because of chronological and cartographical relationship to other tracks on site. Also of significance because of direct association with post-copper mill slate quarrying.	Tip (811)	High	Late 19th century

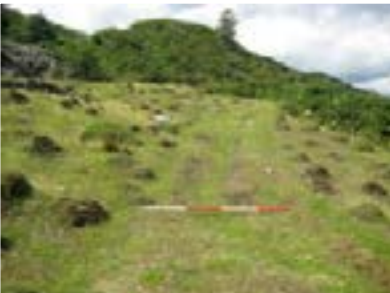
705	Track running NW from the modern road to the mine. Incorporates culvert (536), cuts leats (308) and (309) and is overlain by track (700). Not shown on First Edition Ordnance Survey map. Probably became the main access route for the mine and mill but may have continued in use when the site was re-worked for slate in the later 19th century.	<b>High</b> – of good evidential value because of chronological and cartographical relationship to other tracks on site.	Leat (308) Leat (309) Culvert (536) Track (700)	High High High High	Probably c. 1860

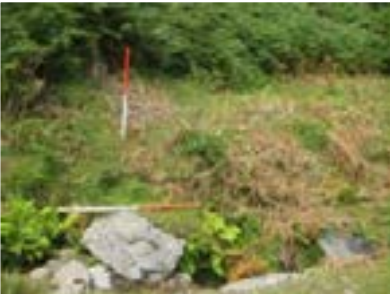
706	A 20m length of trackway, 1.4m wide, terraced into slope to W and truncated by track (700) and the modern road. Probably a section of the original dale road.	<b>Medium-low</b> – some evidential value as relates to part of pre-tarmac road along alley. Not directly relevant to history and archaeology of Penny Rigg mill.	Track (700)	High	Mid-19th century or earlier

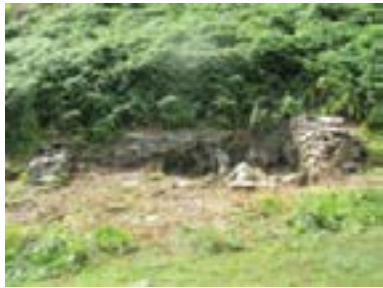
Context No.	Description	Significance	Associated with	Contribution to Significance	Date	Photo
800 Group	Riving Shed associated with nearby level opening. Appears to have been open-fronted.	<b>High</b> – good evidential value because of its chronological relationship with slate tip (814) plus physical, historical and narrative links with Penny Rigg quarry and the local slate quarrying industry.	Spoil tip (814) Track (703) Rock cutting (815)	High High	19th century

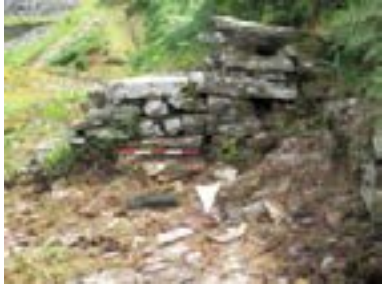
801	South wall of riving shed. Not much survives. Random coursed slate.	<b>High</b> – as above.	Spoil tip (814) Platform (805) Wall (802) Track (703)	High High High High	19th century

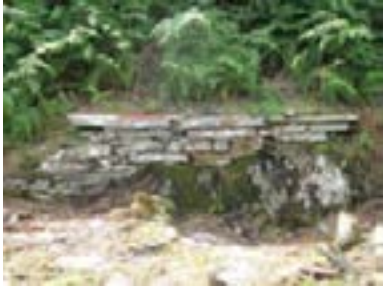
802	West wall of riving shed. Random coursed slate built over and around the exposed bedrock.	<b>High</b> – as above.	Spoil tip (814) Platform (805) Wall (802) Wall (803)	High High High High	19th century

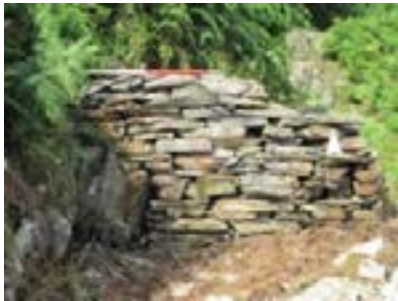
Context No.	Description	Significance	Associated with	Contribution to Significance	Date	Photo
803	N wall of riving shed. Random coursed slate built over and around the exposed bedrock.	<b>High</b> – as above.	Spoil tip (814) Wall (802) Track (703) Rock cutting (815)	High High High	19th century

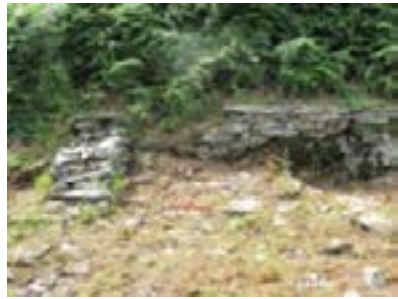
805	Platform within the SW corner of the riving shed	<b>High</b> – as above.	Spoil tip (814) Wall (801) Wall (802)	High High High	19th century

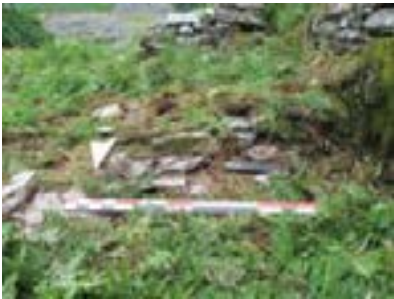
Context No.	Description	Significance	Associated with	Contribution to Significance	Date	Photo
806	Retaining wall within the riving shed forming the edge of platform (805)	<b>High</b> – as above.	Spoil tip (814) Platform (805) Wall (802)	High High High	19th century

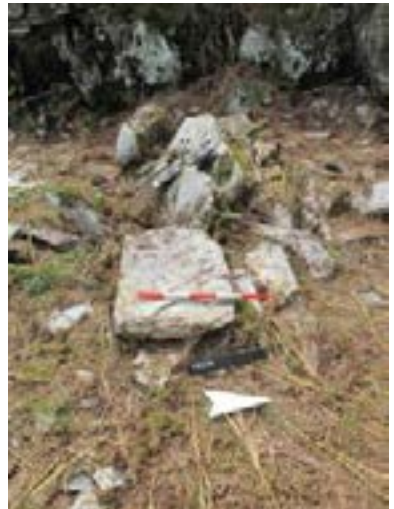
807	Stones that were originally placed end-on into the ground forming a partition within the riving shed.	<b>High</b> – as above.	Spoil tip (814)	High	19th century

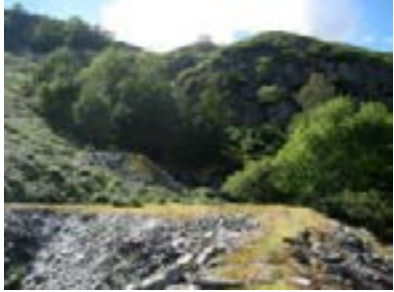
Context No.	Description	Significance	Associated with	Contribution to Significance	Date	Photo
811	Horse Crag quarry spoil tip. High-level slate tip.	<b>High</b> – good evidential value because of its chronological relationship with slate tip (814) plus physical, historical and narrative links with Penny Rigg quarry and the local slate quarrying industry.	Slate tip (813) Slate tip (814) Shed (812)	High High High	Later 19th century

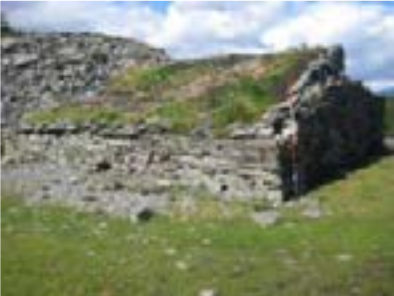
812	Much altered building, probably slate riving shed. Not shown on First Edition Ordnance Survey map. In use as a bothy	<b>High</b> – good evidential and historic value because of condition and associations with Penny Rigg quarry and the local slate quarrying industry. Some amenity value but not open for general public use.	Slate tip (813) Slate tip (814) Slate tip (811)	High High High	Later 19th century

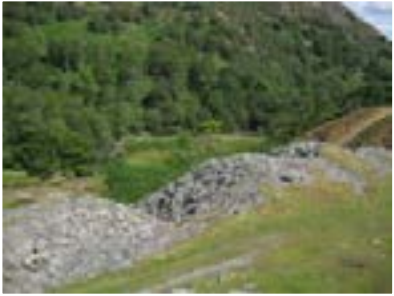
813	Slate tip. On same horizon as entrance to Horse Crag level and probably composed of waste from the closehead working in the level. Probably overlies a number of copper mine and mill features such as ore hoppers.	<b>High</b> – good evidential value because of its chronological relationship with development of Horse Crag Level and historical and narrative links with Penny Rigg quarry and the local slate quarrying industry.	Horse Crag Level (100) Shed (812) Slate tip (814) Slate tip (811)	High High High High	Later 19th century

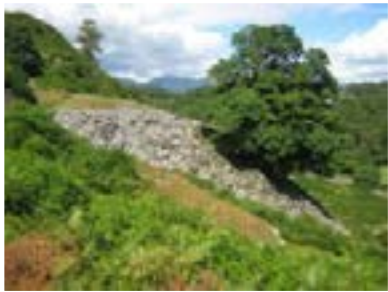
Context No.	Description	Significance	Associated with	Contribution to Significance	Date	Photo
814	Slate spoil tip. Composed of waste from the adjacent Penny Rigg quarry. Probably contemporary with riving shed (800). Overlies track (701) and leat (317) and contemporary with culvert (319).	<b>High</b> – of good historical and evidential value because of its chronological relationship with track (701) and the reuse of leat (317).	Level (815) Culvert (319) Leat (317)	High High High	Later 19th century

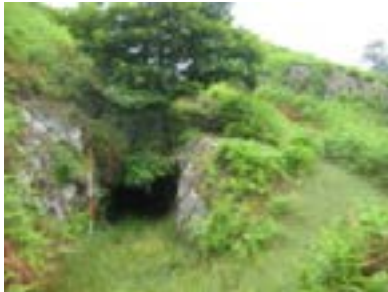
815	Rock cutting leading to open entrance to mine level known as Quarry Level. Level driven SW to Penny Rigg quarry. Originally drained water from quarry for use in Penny Rigg copper mill. Spoil tip (814) derives in part from the driving of the level.	<b>High</b> – good evidential value because of its chronological relationship with slate tip (814) plus physical, historical and narrative links with Penny Rigg quarry and the local slate quarrying industry.	Spoil tip (814)	High	1870s?
