Gazetteer Penny Rigg

APPENDIX 4 – CONDITIONS SUMMARY - PENNY RIGG

Conservation Management Plan – Penny Rigg Copper Mill, Cumbria – Appendix 4: Conditions Summary

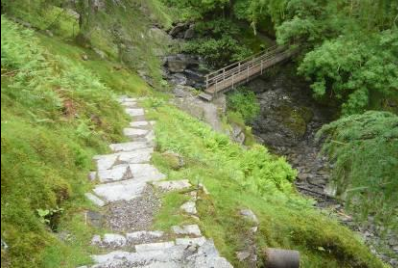
ID No	Type	NGR	Date	Source	Conditions Risks/Issues	Description	Image
						enclosure shown on third edition OS but now destroyed, this may have been a riving shed.	
2017	Bridge	330328, 500688	18th Century	First edition OS Site Survey	Good - Bridge modern replacement but abutments earlier	Bridge across Gill, originally provided access to woodland on north bank which provided pit props amongst other things.

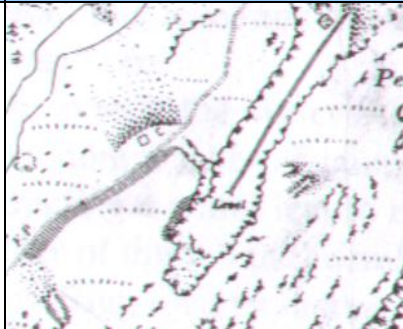
ID No	Type	NGR	Date	Source	Conditions Risks/Issues	Description	Image
2019	Quarry Cutting	330467, 500774	19th Century	Second edition OS Site Survey	Good	A third cutting providing access into the quarry and allowing slate to be transported to the riving sheds on this side and eventually out to the Tilberthwaite Road.

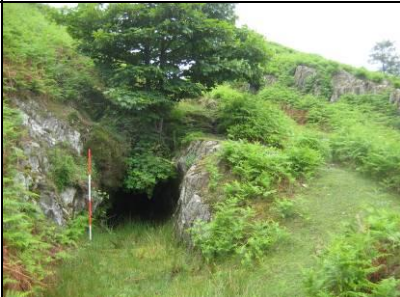
2023	Level	330608, 500809	19th Century	Second edition OS Site Survey	Good	Open level in rock cutting.

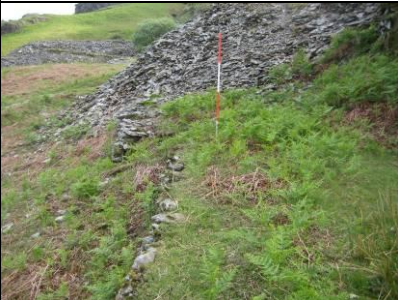
2027	Access Track	330662, 500824 330618, 500745	19 th century	Site Survey	Moderate	Track, embanked and revetted in places, running SW from road to Deep Level entrance and the area above the wheel pit and crushing house. Leat overflow (2025) is culverted beneath the track and the central section of the track is overlain by slate tip (2024).

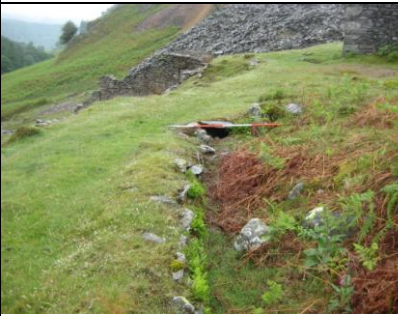
2028	Water Course	330655, 500774 330653, 500739.	19 th century	Site Survey	Moderate.	Short length of water course leading N-S from wheel pit. Southern section is culverted. Appears to run under a track (2029) but cannot be traced further to North. Presumably associated with water supply to/from the dressing floors.

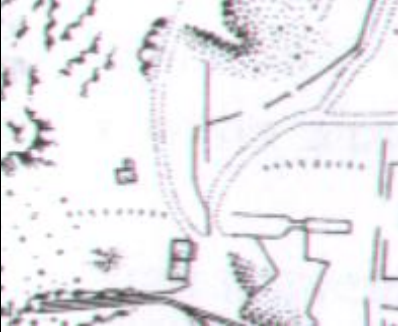
ID No	Type	NGR	Date	Source	Conditions Risks/Issues	Description	Image
2029	Access Track	330653, 500739 330637, 500753 330670, 500801 330614 500722	19 th century	Site Survey Third edition OS	Moderate - SE section cut and damaged by recent erosion gullies.	Grassed track running NW then W from road to area outside Deep Level entrance.

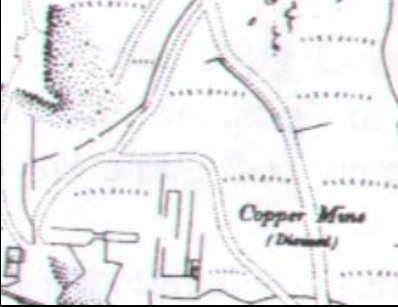
2030	Access Track	330608, 500786 330610, 500722	19 th century	Site Survey	Moderate	Track with stone revetment on east side running from smithy (2041) to level entrance (2023).

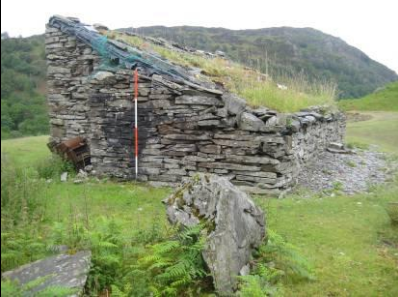
ID No	Type	NGR	Date	Source	Conditions Risks/Issues	Description	Image
						square feature in SW corner, probably a forge.	
2032	Building	330636, 500667	19 th century	Site Survey	Moderate - Window lintel cracked and stone work above slumping. Building has modern roof and is used as some form of temp. accommodation - chimney etc added to structure by recent occupants	Rectangular quarry building with angle pitched roof. Buttressed on SE face. Single door and window in NE face.

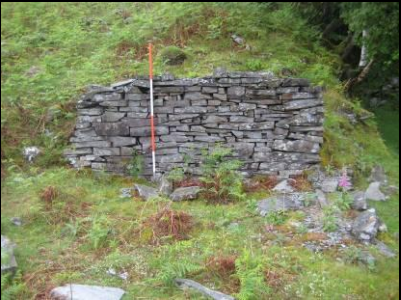
2036	Wall	330580, 500677	19 th century	Site Survey	Moderate	Two revetment walls in slate spoil either side of track to top workings in Horse Crag Quarry

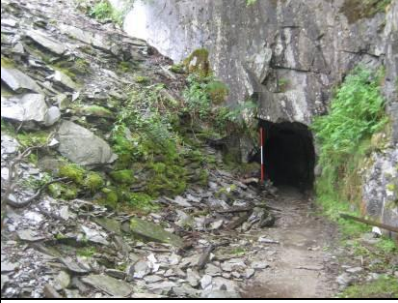
2039	Tilberthwaite Deep Adit or Horse Crag Level	330572, 500704	19 th Century	Site Survey	Good, Stable. Continuing research and recreational access use by CATMHS provides regular condition monitoring and ensures short term survival.	Rock cut portal of mine adit. Level open and accessible via slate closehead – underground slate working – to area of backfill and collapse which is currently being removed by members of CATMHS

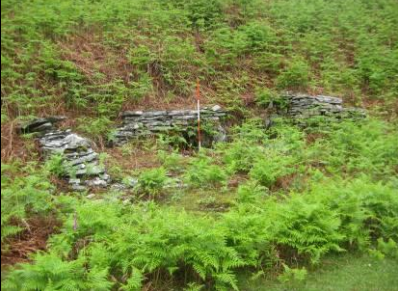
2043	Building	330611, 500790	19 th century	Site Survey	Poor - foundations only surviving. No direct risk.	Rectangular building, foundations only, with central division. Constructed on slate rid tip.

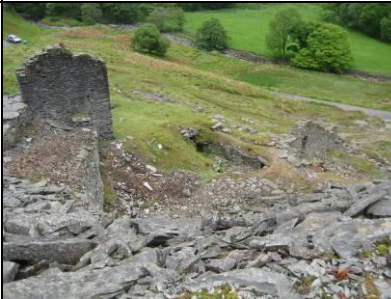
ID No	Type	NGR	Date	Source	Conditions Risks/Issues	Description	Image
						relates to a recessed floor line in the south wall and a line of joist holes in the west wall. The east end of the south wall comprises a free standing gable with a single partly blocked door.	
2047	Retaining walls south of Crushing House	330647, 500712	19 th century	Site Survey Second/Third Edition OS	Moderate. Risk of future flooding undercutting the base of the walls.	Two retaining walls built against the slope and joining with crushing house (2046). The west wall retains the access way, the wall top opening in (2046). The east wall is on the same alignment and retains the access way to the low level entrance in (2046). The top of the east wall is covered with copper spoil. Wall shown on earlier OS maps to continue South but now covered by Slate rid.

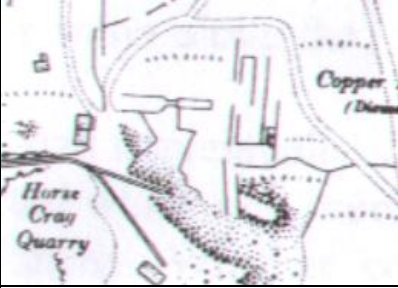
ID No	Type	NGR	Date	Source	Conditions Risks/Issues	Description	Image
2048	Retaining wall	330634, 500714	19 th century	Site Survey Second/Third Edition OS	Blocked - Hidden by spoil – no longer extant	Retaining wall similar to (2047) shown on third edition OS map but no longer extant.

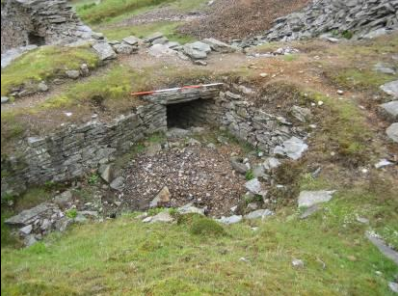
2049	Terrace walling	330634, 500714 330659, 500711	19 th century	Site Survey Second/Third Edition OS	Blocked - Hidden by spoil – no longer extant	Terrace walling above processing floors. Southern section, shown on third edition OS map, is concealed under spoil tip. Runs north to south.	As above
2050	Sunken Chamber	330658, 500712	19 th century	Site Survey Second/Third Edition OS	Moderate. Some risk of future flood damage with water running down slope from retaining walls (2047).	Open stone walled pit. The overflow culvert from wheelpit (2044) enters at the north end and resumes a culvert at the SE end. The area between this and retaining walls (2047) is paved.

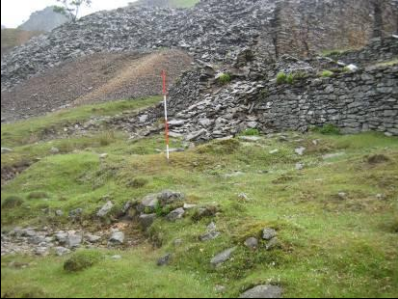
ID No	Type	NGR	Date	Source	Conditions Risks/Issues	Description	Image
						building.	
2052	Rectangular pits and terrace walling	330674, 500715	19 th century	Site Survey Second/Third Edition OS	Moderate condition. No direct threat.	Two conjoined rectangular pits, turfed walls, with low stone retaining bank to east. Possible settling or tailings ponds.

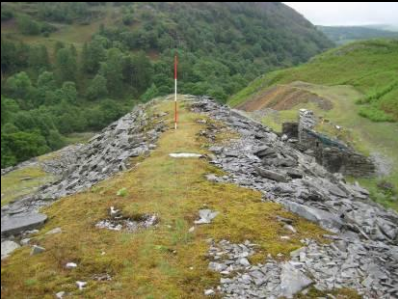
ID No	Type	NGR	Date	Source	Conditions Risks/Issues	Description	Image
		500694	century	Second/Third Edition OS		to west by slate tip (2056)	
2056	Slate Rid tips	330652, 500683.	19 th century	Site Survey	Moderate. Top of tip is turfed which aids stability.	Large slate tip with single flat topped spoil extension to east. Covers part of copper spoil tips (2054) and (2055) and southern range of the copper mill buildings

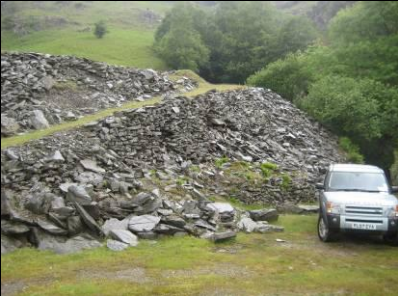
2057	Slate Rid tips	330619, 500688	19 th century	Site Survey	Moderate	Principal tip for Horse Crag Quarry.	
2058	Access Track	330631, 500690	19 th century	Site Survey	Moderate	Inclined track terraced into N side of slate tip (2057) Provides access from area outside Deep Level cutting to Horse Crag Quarry

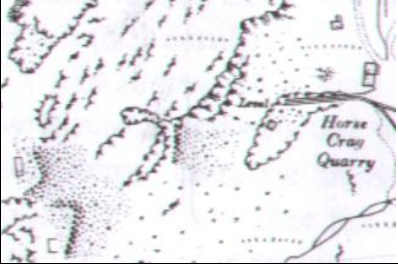
ID No	Type	NGR	Date	Source	Conditions Risks/Issues	Description	Image
2059	Quarry	330512, 500696	19 th century	Site Survey Third Edition OS	Moderate	Small quarry cutting above Deep Level

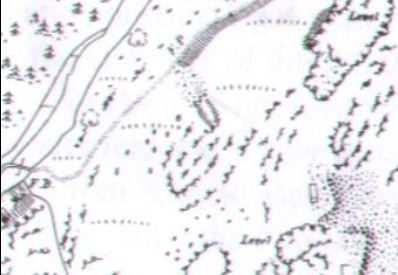
2063	Trail Quarry	330415, 500707	19 th century?	Site Survey OS Map Holland 1981	Not seen	Small area of trial quarrying

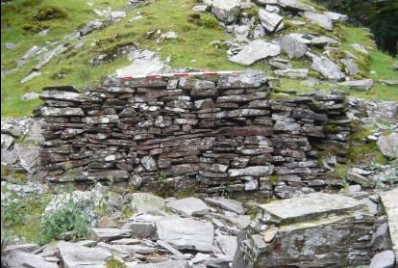
ID No	Type	NGR	Date	Source	Conditions Risks/Issues	Description	Image
						preparation of slates coming up from the closehead, via the rail track.	
2065	Quarry platform	330549, 500866	19th Century	Site Survey	Good/Moderate	Revetment wall running EW and extending west into quarry bank. Remains stand 1.40m high. Possibly a loading platform.

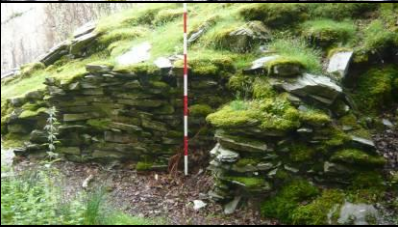
2066	Revetment wall	330545, 500869	19th century	Site Survey	Moderate - overgrown in places	Section of pack wall to the north, measuring 3m long and running SW-NE. May relate to platform (2065)

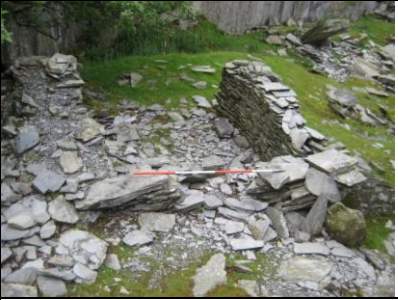
2067	Quarry building	330547, 500854	19th century	Site Survey	Good	Three-sided stone structure, within lower terrace of quarry. Measures 4.5 x 4.5m, with walls to 1.7m high. Slate splitting or riving shed

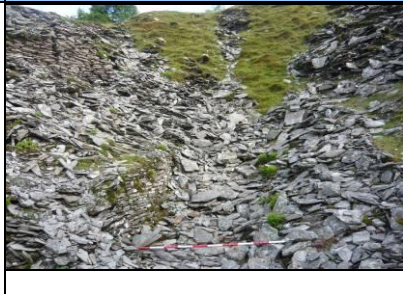
2068	Adit entrance?	330571, 500970	19th century?	Site Survey	Poor - Blocked by slate and debris	Possible blocked adit, maybe that shown on earlier OS maps but

ID No	Type	NGR	Date	Source	Conditions Risks/Issues	Description	Image
						<p>indicated further up hill (2012). Series of pack walls which seem to be at the right angle to suggest an adit cutting, but majority of structure covered by later slate rid. Series of related pack walls arranged up the slope.</p>

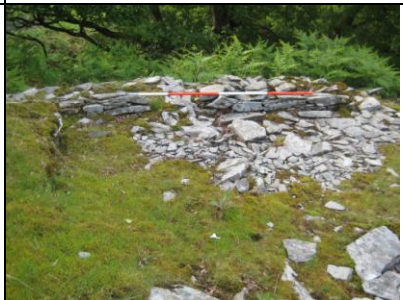
2069	Building?	330558, 500968	19 th century?		Moderate – grassed over in places	To north of quarry spoil tips, and on edge of slope dropping down to beck, are the foundations of a building measuring 5 x 4m. Only south and west walls survive.

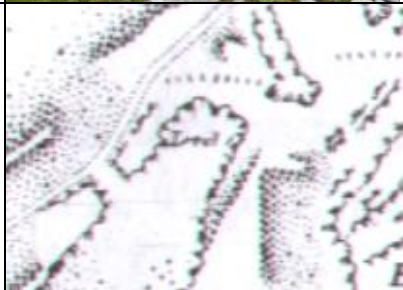
2070	Level (Closehead)	330557, 500864	19 th Century	Site Survey Third Edition Os	Destroyed	Level indicated on third edition OS but no longer visible. Quarry face undercut here and looks as if the level was opened out later for surface quarrying.
