APPENDIX 1 - GAZETTEER CONISTON

Conservation Management Plan – Coniston Copper Mine, Cumbria – Appendix 1: Site Gazetteer

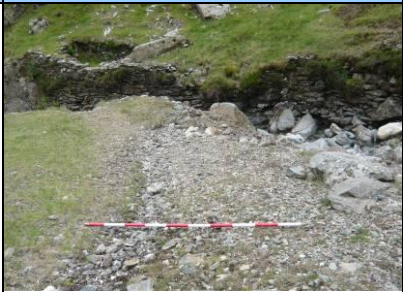
| ID No | Type | NGR | Date | Source | Conditions Risks/Issues | Description | Image |
|---|---|--|---|---|---|---|---|
| 1011 | Cobblers Dressing Floors | 328817 498941 | 17th century | Site Survey RCHME | Moderate- some minor flood damage but potentially at risk from erosion along the beck. | Series of dressing floors bounded by revetment pack walls. Feature believed to be 17th century in origin and associated with Low and White Works. | |

| ID No | Type | NGR | Date | Source | Conditions Risks/Issues | Description | Image |
|---|---|---|---|---|---|---|---|
| | | | | | | There is some suggestion (Peter Fleming pers.com) that there was a stamp mill in this location. This would be the mill referred to in the litigation between the Mines Royal and local tenants over the pollution of the beck (1620). However no extant evidence survives apart from the dressing floor. An alternative location for the 17th century mill is an earlier phase at Red Dell Mill (1060). | |

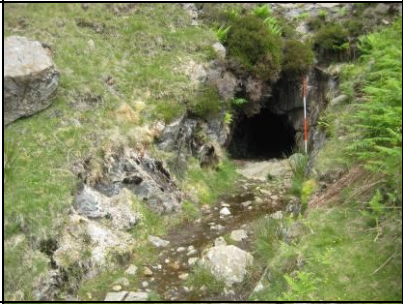
| ID No | Type | NGR | Date | Source | Conditions Risks/Issues | Description | Image |
|---|---|---|---|---|--|--|--|
| 1029 | Courtenays Cross Cut Level | 328342, 498851 | 19th Century | Site Survey RCHME Survey | Good. Level driven in competent rock. Underground access possible. | 19 th century level driven north east to reach South Vein with internal connection to Deep Level via South Shaft. | |

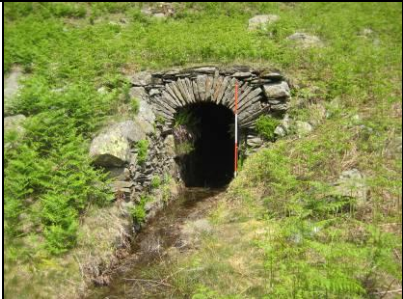
| ID No | Type | NGR | Date | Source | Conditions Risks/Issues | Description | Image |
|---|---|---|---|---|--|--|--|
| 1031 | Gaunts level | 328453, 498840 | 19th Century | Site Survey RCHME Survey | Good. Dry stone arched entrance with external cutting, revetted to east. Discharges water. No particular threat. | 19 th century level driven north under Kernal Crag. | |

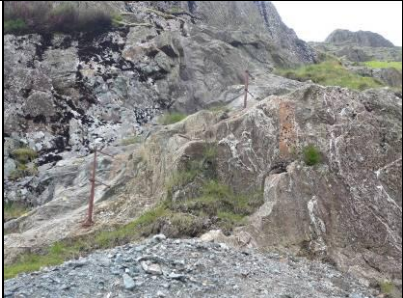
| ID No | Type | NGR | Date | Source | Conditions Risks/Issues | Description | Image |
|---|---|---|---|--|---|--|--|
| 1040 | Middle Level Hopper | 328210, 498910 | 19th Century | Site Survey RCHME Survey Holland 1981 | Good | Hopper associated with Paddy End Incline. Fittings and Iron rails above survive in-situ | |

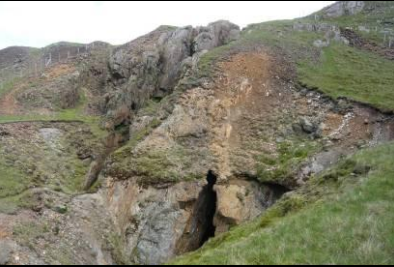
| ID No | Type | NGR | Date | Source | Conditions Risks/Issues | Description | Image |
|---|---|---|---|--|---|---|---|
| 1050 | The Back Strings | 328079, 499012 | 17th Century | Site Survey RCHME Survey Holland 1981 Flemming 2007 | Good – previously there was a problem with people throwing stones down the open stopes and dismantling the nearby structures to do so. This has largely been prevented by the fencing. However, location of the fencing does detract from the | Series of open and below ground workings known now as the Backstrings. Originally part of the 17th century mine and comprised a series of seven works each named after the head miner controlling the operation. Numerous shot holes in the area would indicate that the stopes were also widened and worked at a later date. | |

| ID No | Type | NGR | Date | Source | Conditions Risks/Issues | Description | Image |
|---|---|---|---|---|--|--|---|
| | | | | | <p>setting and is a risk to the below ground archaeology</p> | <p>Along the east side of the works are a series of structures and spoil tips, the latter being the yellow, ore rich tips associated with early mining. This would appear to be some form of processing area, with one stone built building (1046) and a number of smaller semi-circular shelters, approx. 1.5m in diameter (see photo) which provided some protection for workers who probably sat in the middle smashing and sorting ore before it was sent to the stamp mills for further processing. There are a number of other distinct features but no datable evidence beyond association with works themselves. There might even be pre-17th century evidence of mining here, some of the mortar stones being built into presumably later structures.</p> | |

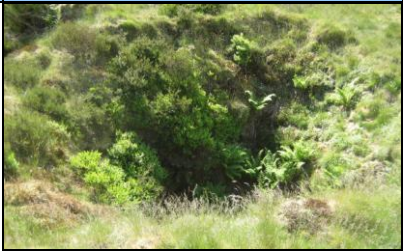
| ID No | Type | NGR | Date | Source | Conditions Risks/Issues | Description | Image |
|---|--|---|---|--|---|--|---|
| 1058 | Bonsor West Shaft (& New Engine Shaft) | 328655, 499088 | 18th Century | Site Survey RCHME Survey Holland 1981 | | Shaft opened by Charles Roe during the operation of the Macclesfield Copper Company. Shaft contiguous with the fenced off White Works. | |

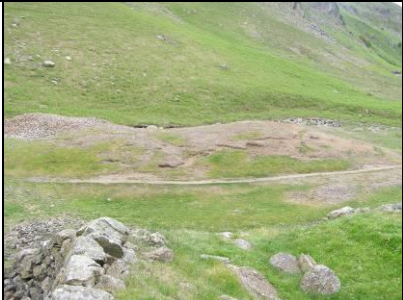
| ID No | Type | NGR | Date | Source | Conditions Risks/Issues | Description | Image |
|---|--|---|---|--|---|--|---|
| 1060 | Red Dell Dressing Floor | 328586, 499215. | 17th /18th Century? | Site Survey RCHME Survey Holland 1981 | Good. Complex of spoil tips relating to level driving, hand dressing and crushing. Low level erosion threat to east part of site from flooding | Multi period site possible dating to the 17th century, although the mill itself (1061) is probably later | |

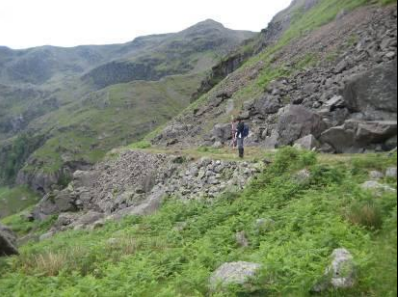
| ID No | Type | NGR | Date | Source | Conditions Risks/Issues | Description | Image |
|---|--|---|---|---|---|--|--|
| 1066 | Leat running from Levers Water to power Stamp Mill | 328187, 499032 328512, 498994 328563, 499105 328524, 499174 | 19th century | Site Survey RCHME Survey Holland 1981 | Good – moderate. Well preserved open channel. Stone revetting in places at western end and a massive support wall in central section. No obvious threat other than erosion through use as footpath. | In the 19th century the Red Dell Beck proved inadequate to drive the new wheel at Bonsor West and a new leat was constructed to bring water from Levers Water along the course of kernel Crag. The leat runs under the Thriddle incline where it passes under a stone bridge, recently restore by CATHMS | |

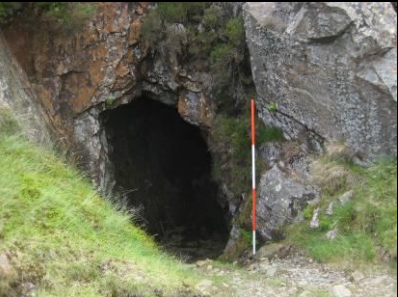
| ID No | Type | NGR | Date | Source | Conditions Risks/Issues | Description | Image |
|---|--|---|---|---|---|--|--|
| 1067 | Thriddle or Bouncy Shaft Balance Level | 328434, 499136 | 20th century (1907) | Site Survey RCHME Survey Holland 1981 | Good. Level driven in competent rock and the section by the internal shaft head has a safety gate. Potential threat of removal to some of the ironwork associated with the flat rod pumping system. | Primarily a tunnel to drain the deep workings below the Deep Level. Shaft entrance includes a Bob platform, with sections of the Balance bob still intact, and fittings associated with the pump rollers. Ore was not brought out of this level but instead via Fleming's and later Deep Level. The entrance to Bouncy mine proper lies above but is buried. | |

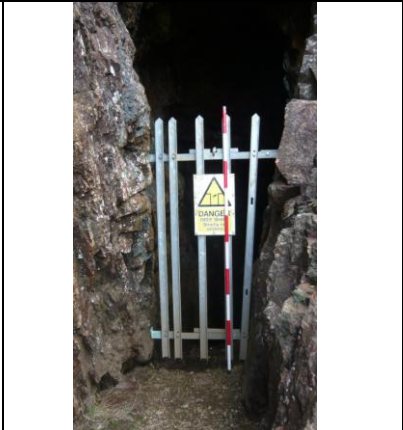
| ID No | Type | NGR | Date | Source | Conditions Risks/Issues | Description | Image |
|---|---|---|---|--|---|--|---|
| 1068 | Glory Hole | 328399, 499158 | 20th century (1907) | Site Survey RCHME Survey Holland 1981 | Good. Level driven in competent rock | A trial level, now protected by a gated entrance. | |

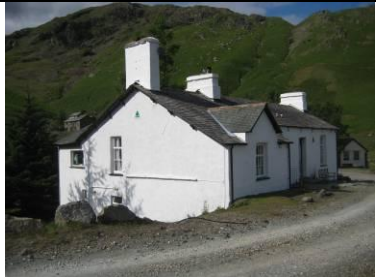
| ID No | Type | NGR | Date | Source | Conditions Risks/Issues | Description | Image |
|---|---|---|---|---|---|--|--|
| 1072 | Mine's Office | 328933, 498561 | 19th Century | Site Survey RCHME Survey | Good | Former mine's office and now a Youth Hostel | |

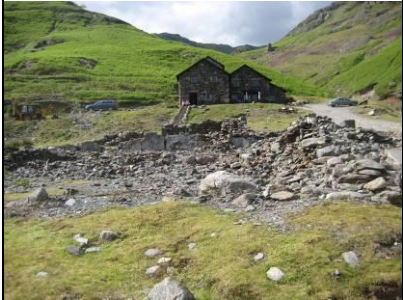
| ID No | Type | NGR | Date | Source | Conditions Risks/Issues | Description | Image |
|---|---|---|---|--|---|--|--|
| 1074 | Saw Mill | 328934, 498717 | 19th Century | Site Survey RCHME Survey | Good/Stable but converted and modified – full appraisal not undertaken. | Saw mill with adjacent wheel pit, later used for processing slate and powered by a Pelton wheel fed by a pipeline coming down from the top of the fell. The wheel powered a compressor delivering air to the slate quarries. The Saw mill has been recently converted into holiday cottages. Later became the generating and electro-precipitation house for the French 'Coniston Electrolytic Copper Company' until 1914. | |
