LOW BONSOR DRESSING MILL

ARCHAEOLOGICAL
COMMUNITY LANDSCAPE
AND BUILDING SURVEY

LOW BONSOR DRESSING MILL,
CONISTON, CUMBRIA

NAA 18/03
February 2018

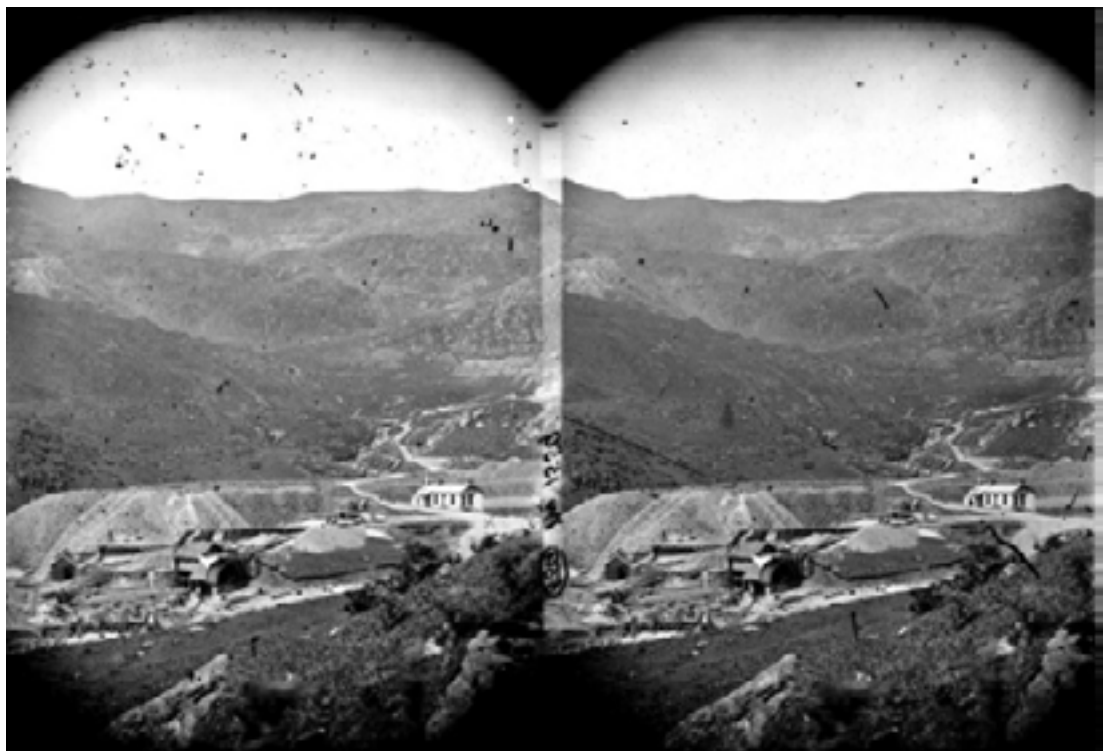
Plate 5: historic photograph 1: Old Man from above the mines. © University of Aberdeen.

- 5.2 At the centre left are two wooden buildings (see Plate 6), probably the sheds for the double stamps described by Gibson and also shown on the 1850 OS map (Figs. 7 and 8). Behind the sheds is a masonry pier carrying the tramroad and leat to the stamps. The water wheel, which sat between the two sheds, has been removed, indicating that the stamps were out of use when this photograph was taken.

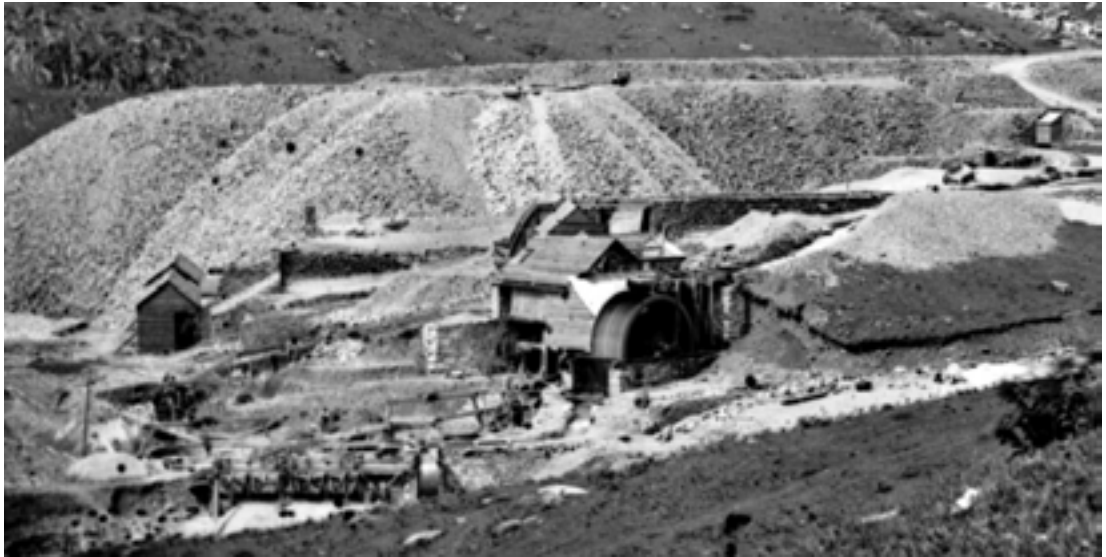
Plate 6: detail from P1 showing the Low Bonsor stamps and dressing floors. © University of Aberdeen.

- 5.3 In the centre foreground of the photograph is a water wheel with a wooden launder operating machinery in a wooden building (under construction?) to the left; this is a new set of stamps. And behind the building is the gabled roof of another building attached to a water wheel with a masonry launder pier to the right; this is a second stamping mill. In the left foreground are a set of jigs and in the background, is the main waste tip from Deep Level and the upper mill.

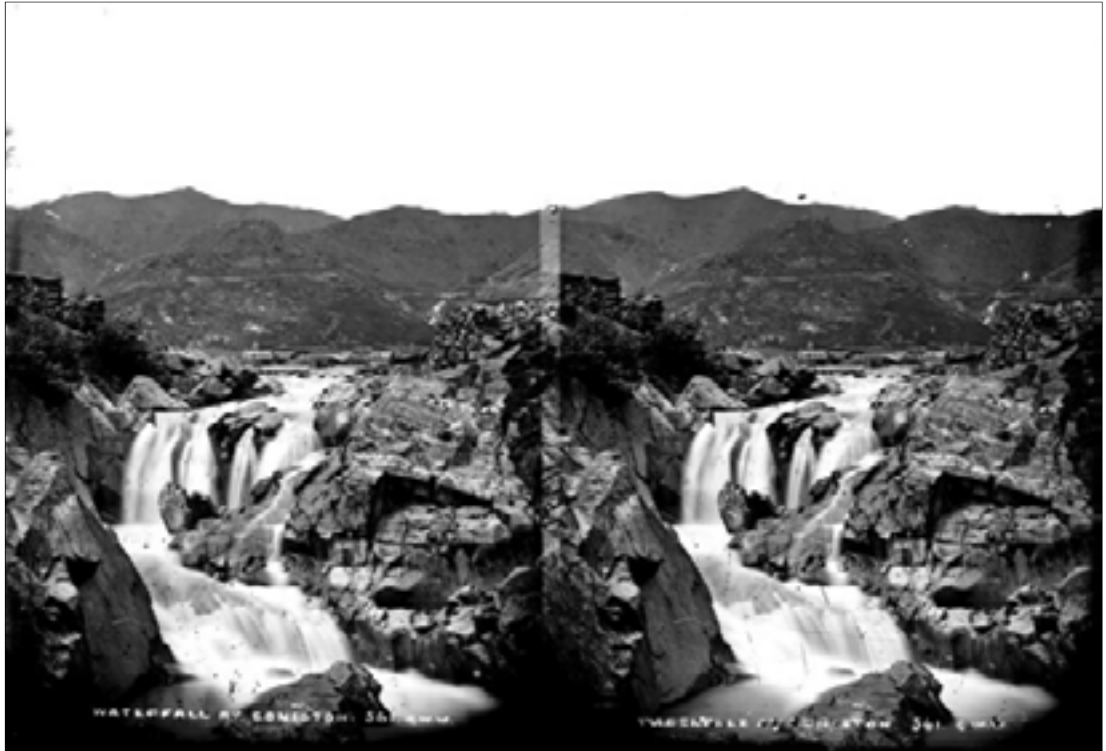
Plate 7: historic photograph 2: waterfall at Coniston. © University of Aberdeen.

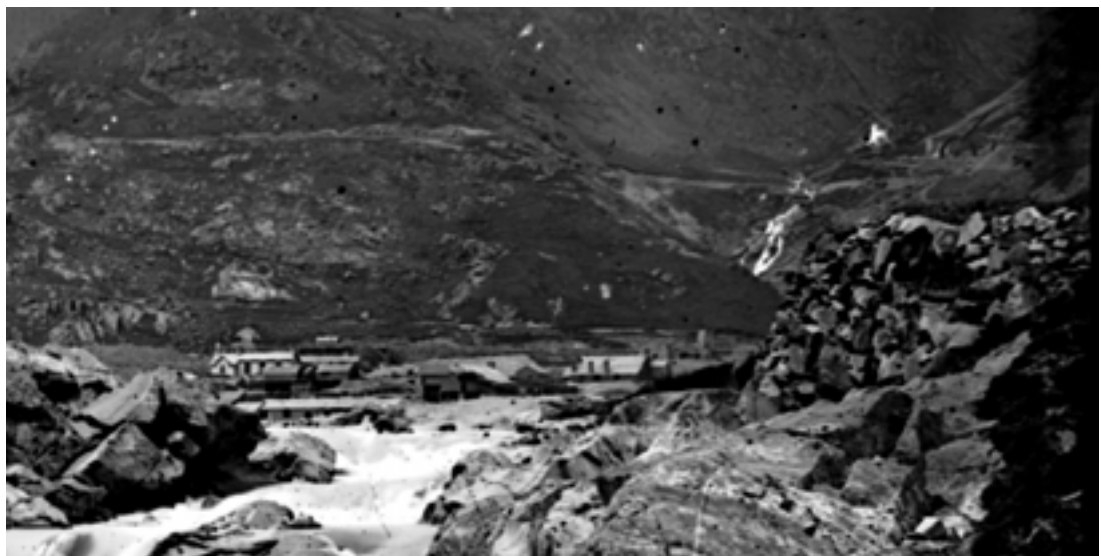
Plate 8: detail from P2 showing the showing the Bonsor mill complex from the south-east. © University of Aberdeen.

- 5.4 This image, also part of the George Washington Wilson Collection, shows the mine complex as viewed from the top of the waterfall on Levers Water Beck and is reminiscent of the “little town of sheds, offices, workshops, and water-wheels” described by A. C. Gibson in 1849. To the left is the mine office and in front are the sheds of the two new stamping mills seen in P1. In the centre foreground is a long single storey building with another building to the left; these structures appear on later photographs and maps and were probably sheds for buddles. At the right-hand side of the photograph are some of the buildings at the upper mill, including the large water wheel for the saw mill.

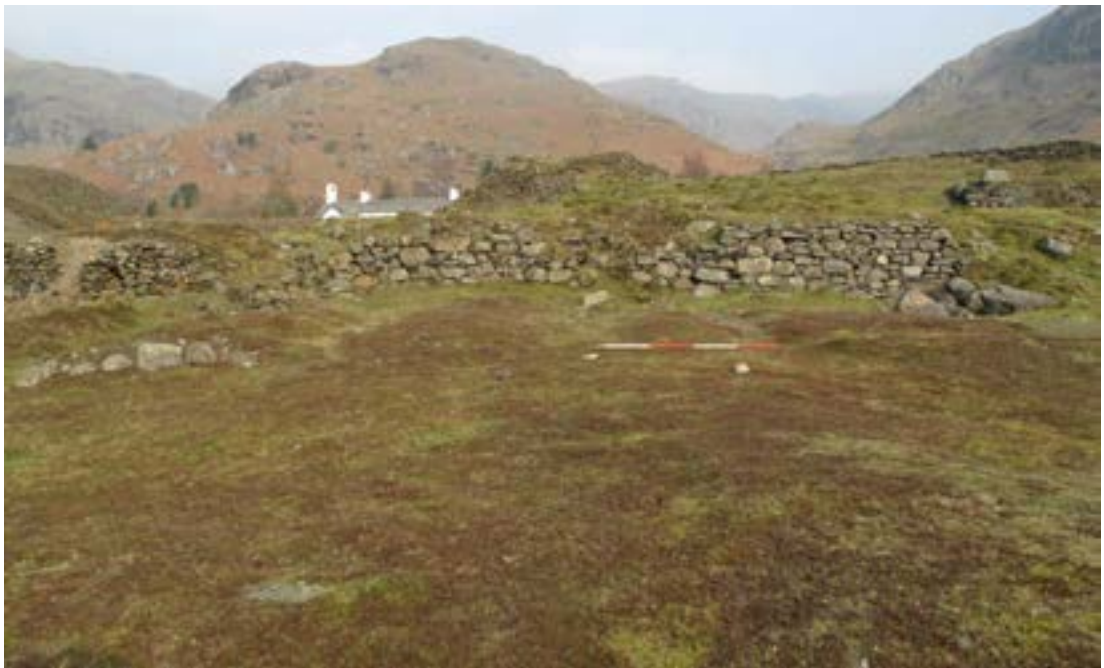
- 6.30 The principal evidence for jigging in Area 1b consists of a series of features associated with 410, a rectangular building platform defined to the north by retaining walls 400, 401 and possibly 405, and to the south by wall 416 and possibly 417 (Fig. 11). The water pipeline has destroyed the north-eastern end of the building platform and a flood gully has disturbed much of the south-western section, so the full extent of the building cannot be reconstructed. On the surface of the platform are a series of shallow, parallel gullies (411-414) aligned north-west to south-east, which appear to be associated with at least two high-level drains or culverts (402 and 403) in wall 400. One of the gullies, 413, is connected to a ground-level culvert (415 and 418) draining south-east towards the settling tanks. The most likely interpretation is that these gullies were drains positioned beneath a set of parallel jig tanks; the two culverts in wall 400 probably held small launders carrying pulp to the jigs from Stamping mill 1 and culvert 415/418 may have been one of a series of drains taking material—perhaps overflow waste—from the jigs to the settling tanks.⁴

- 6.31 No evidence survives for a water wheel pit at building platform 410 but linear feature 253 may well be a leat or water course. In addition, the timber structure at the gully's south-east end could be the remains of a sluice controlling a small water wheel positioned in the building's south-east section and aligned parallel to jig gully (411). Could this be the location of the 10ft diameter water wheel of 'unknown purpose' listed in the 1891 inventory? Historic photographs P4 and P5 (Plates 10-12) clearly show a substantial timber building with a gabled roof on building platform 410 but no internal details can be seen, and the angle of the view is such that the putative water wheel is hidden.

Plate 28: jig house platform (410) looking north-west.

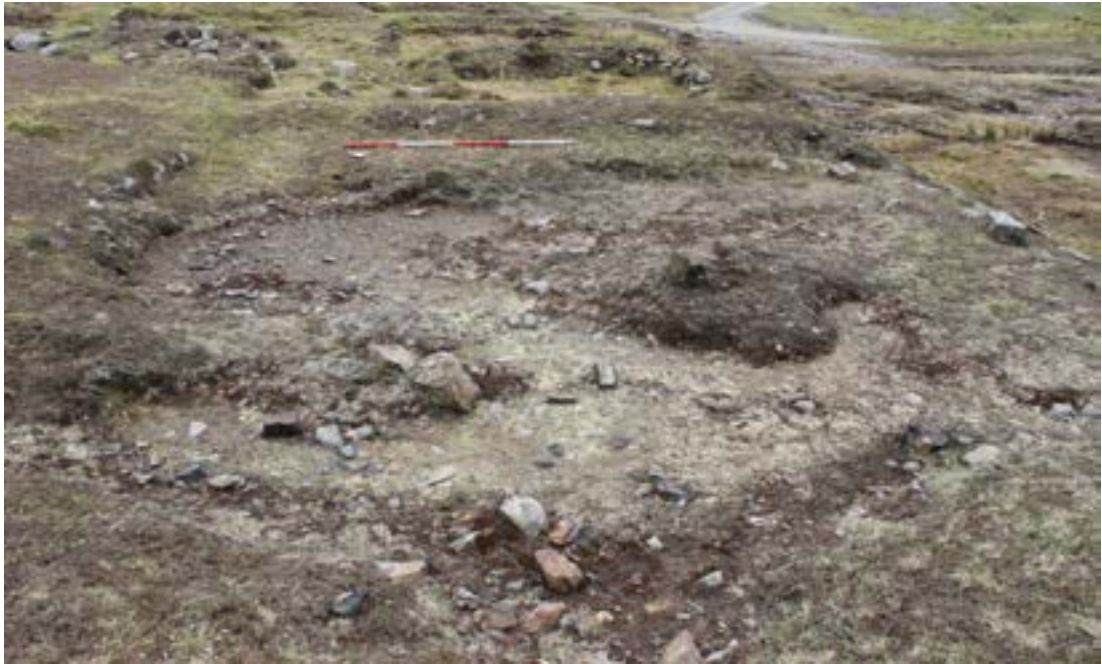
Plate 30: row of settling ponds in Area 1, looking east, with pond 448 in the foreground.

- 6.39 The other ponds are squarer in plan than ponds 442 and 444. They have been excavated into the terrace above Area 1c, share stone revetted earth bank dividing walls and are open along their southern edges. All have suffered from erosion but

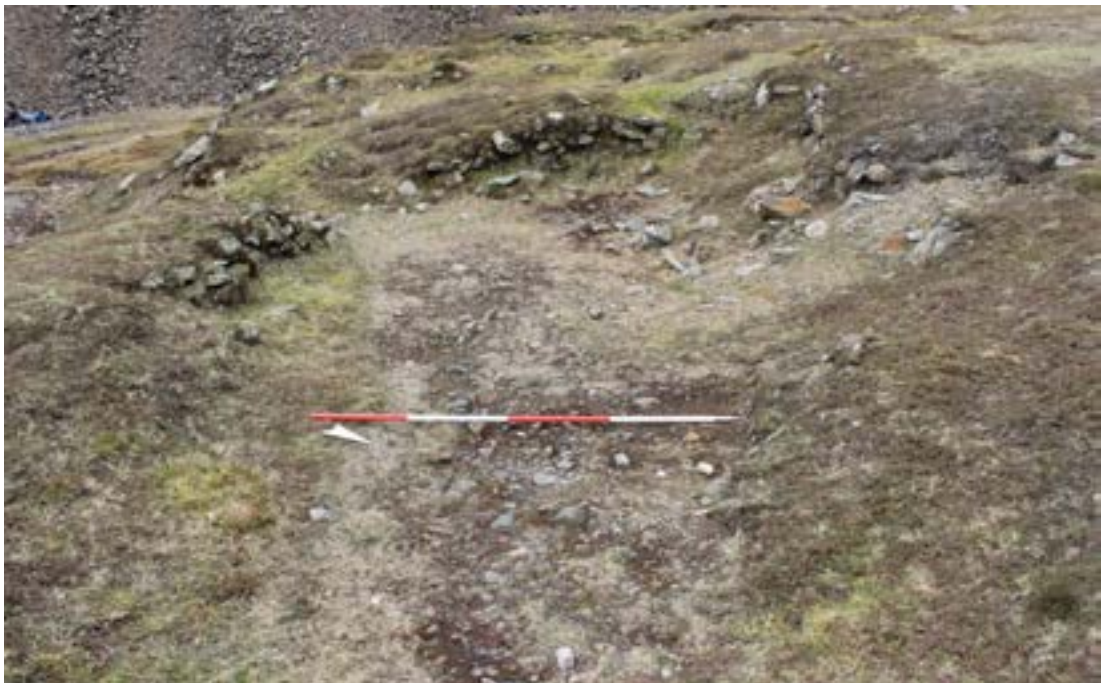
- 6.38 The best evidence for how the settling ponds operated is seen at pond 442 (Plate 31; Fig. 11). This received material from buddle 440 via culver 441 and had a drain at the south-west corner leading to buddle 505, located below the terrace bank in Area 1c. The pond immediately to the east (444) may have taken material from the buddles shown on the 1890 map that have now been lost and was probably linked with buddle 506. A shallow linear hollow and two timber uprights on the crest of the bank

between ponds 442 and 444 suggests there may have been a launder—perhaps an overflow channel—linking these two features.

Plate 31: settling pond 442, looking north-west.

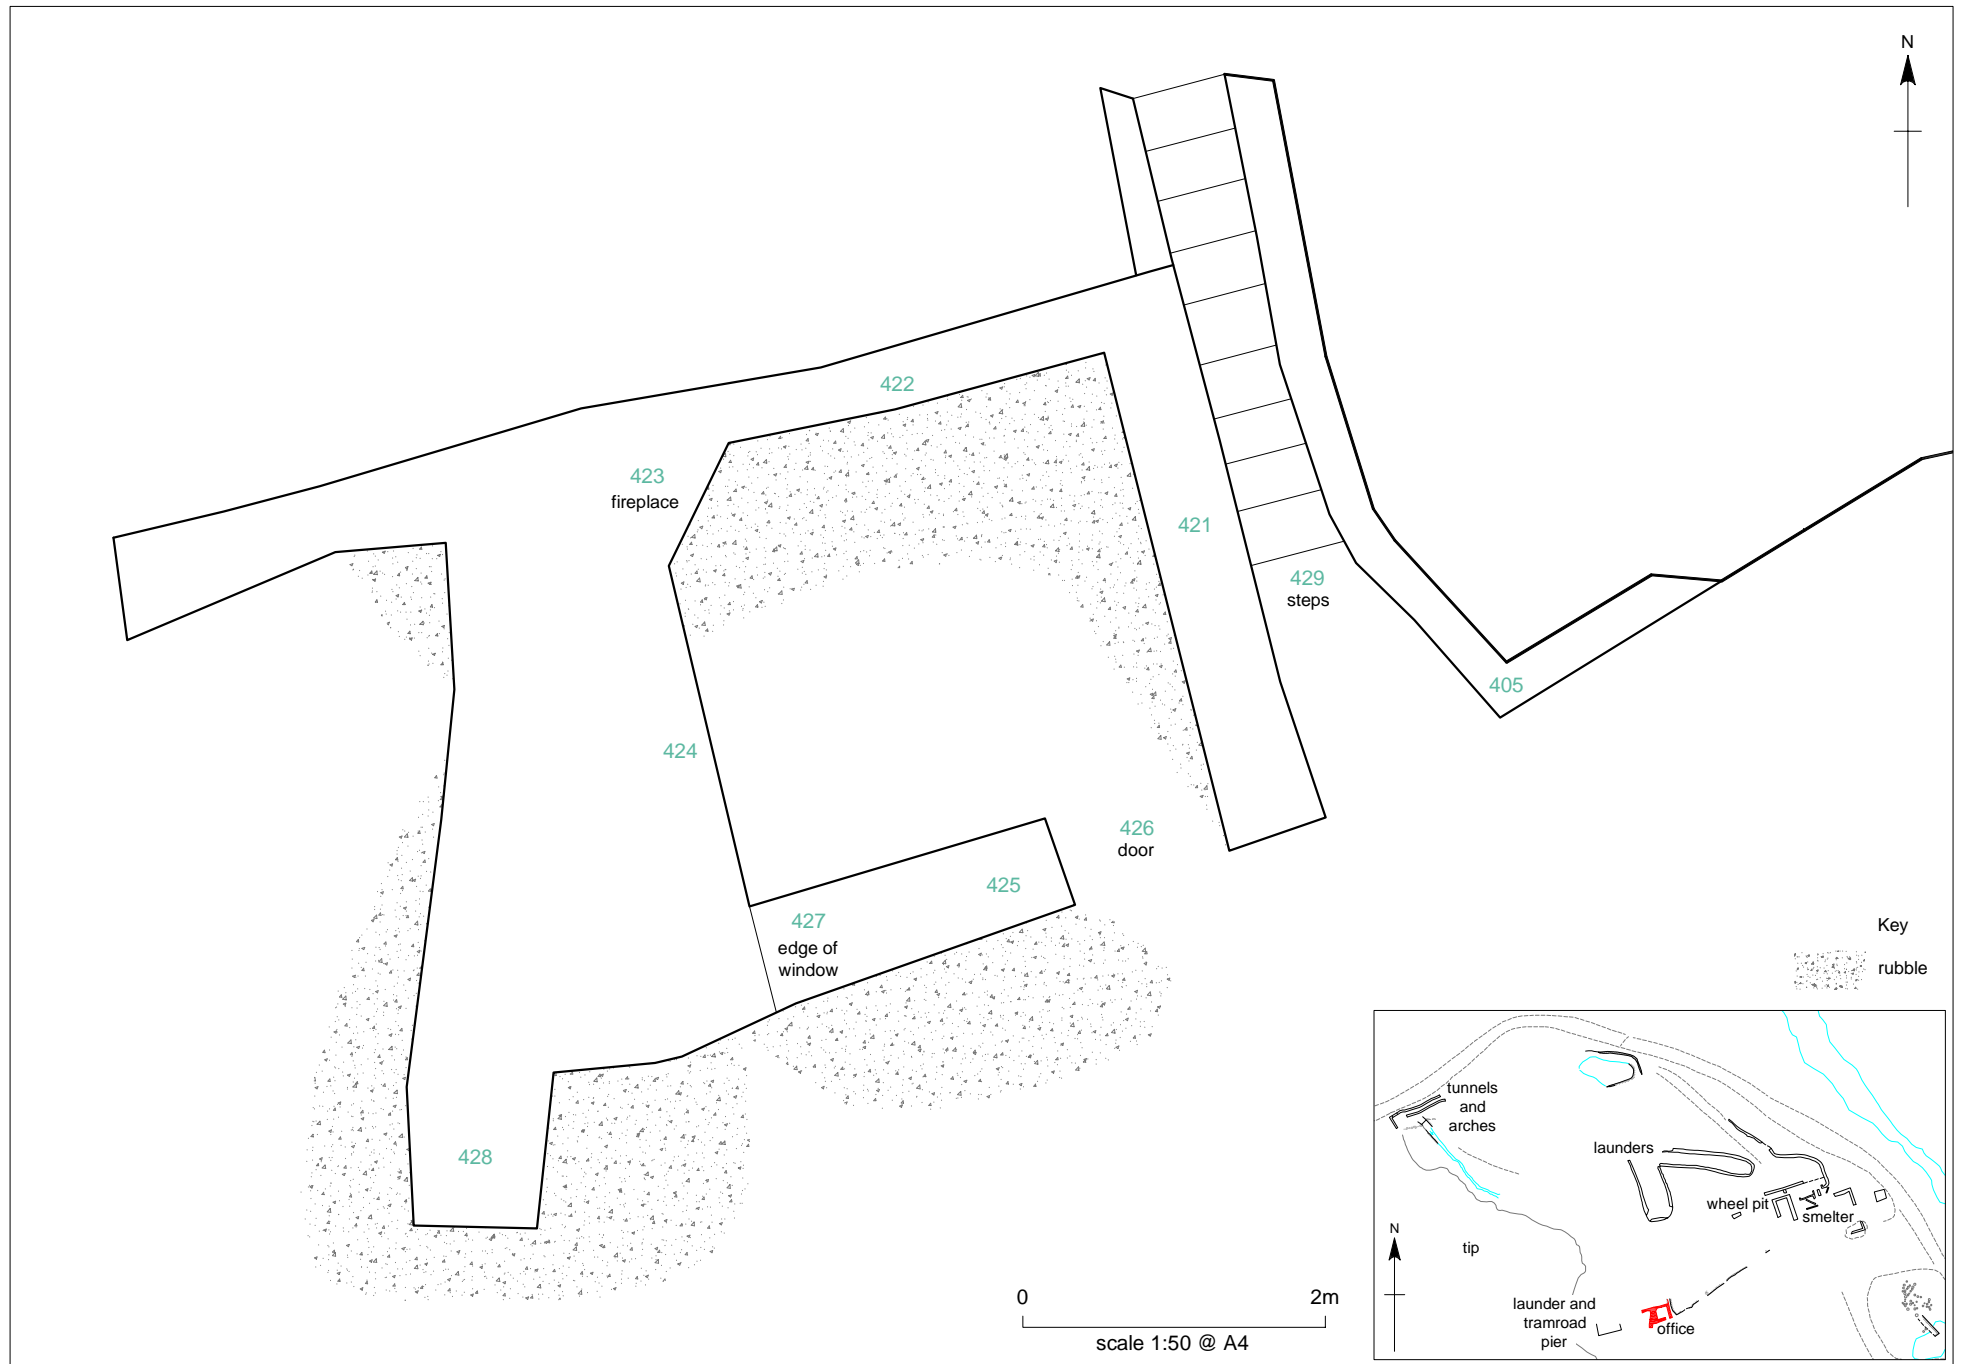
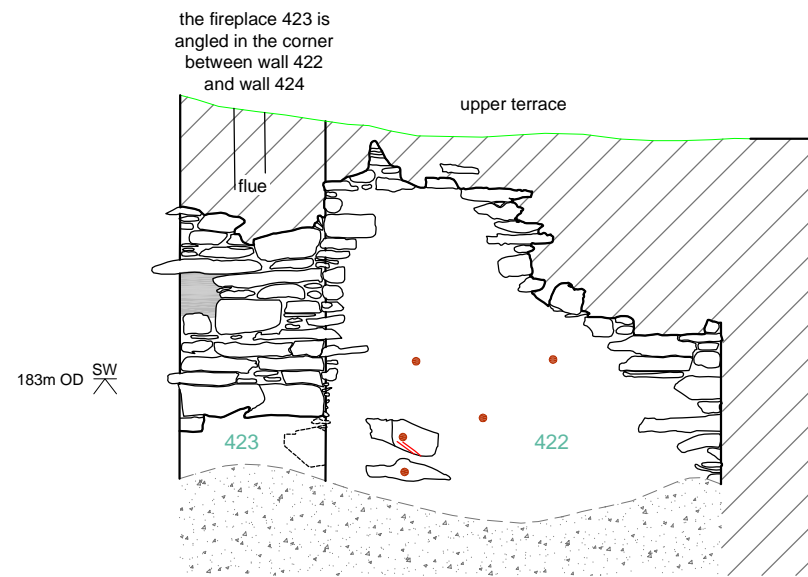
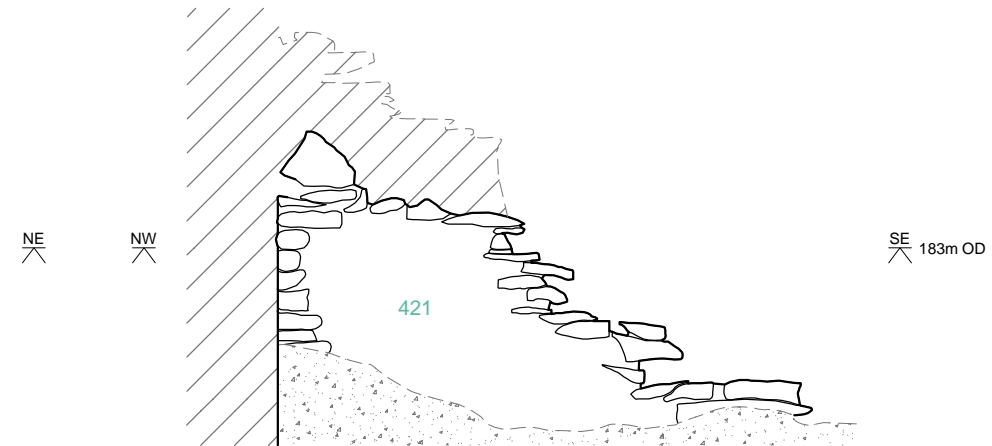
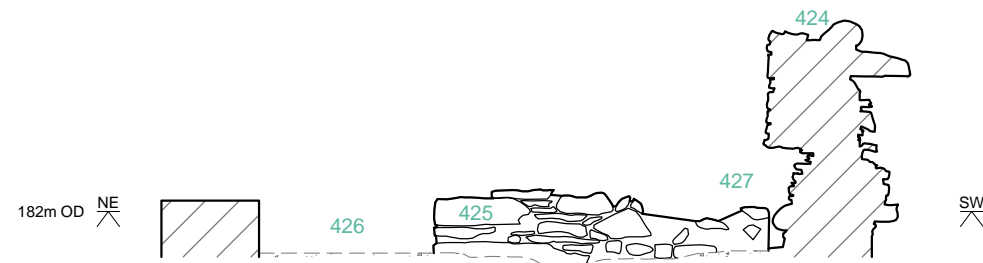
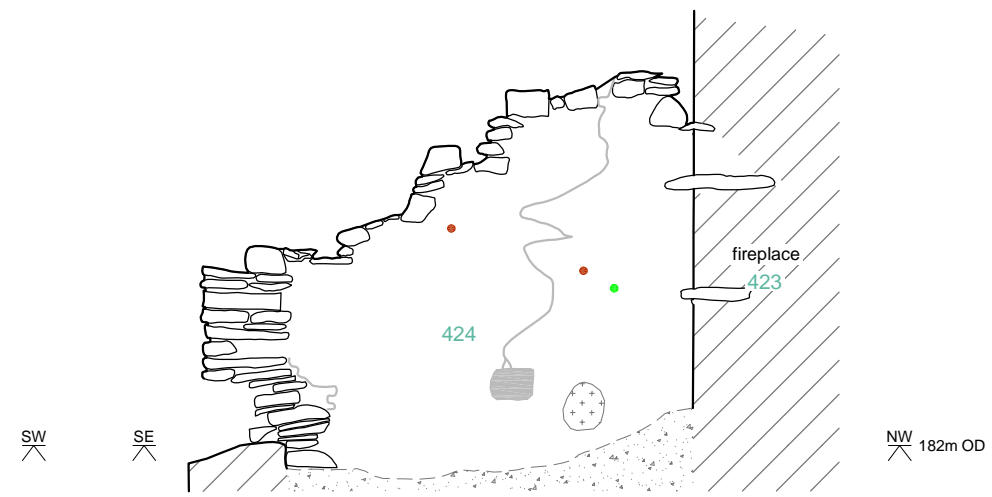
Office - interior elevations

- 6.42 The office (420) is of a single-phase construction. This can be surmised from the fact that all of the walls (421–428) are keyed into each other. This includes the extension to the west of the back wall beyond the end of the building, where it acts as an additional retaining wall, and the additional side wall (428), which again extends beyond the front of the building.

- 6.43 The whole structure is built into the slope of the site, helping to define the edge of the terrace bank of Area 1. The walls are constructed of coursed random rubble containing alternate layers of slate and river cobbles. The slate and cobbles vary in size, but the former was used to level the courses at fairly regular intervals.

the fireplace is angled in the corner between wall 422 and wall 424

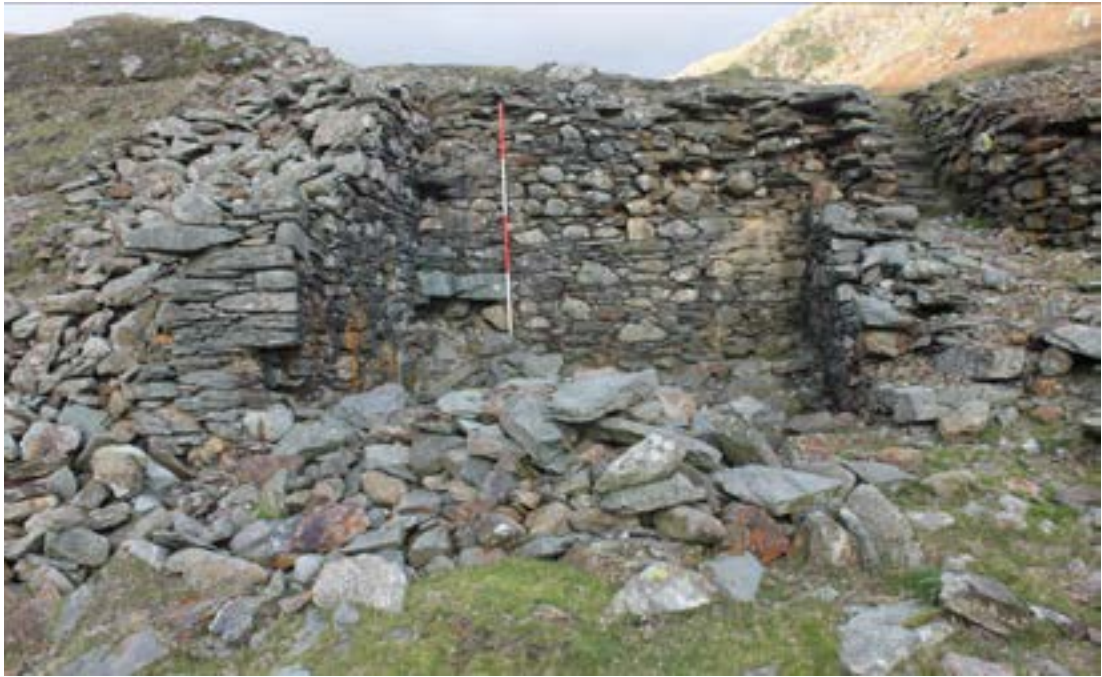
Plate 32: office building (420) looking north-west, steps visible to the left of the image.

- 6.44 The east (side) wall (421) of the building also forms the west wall for the external steps (429) and survives to c.2m in height internally and 0.85m externally. The wall is keyed into the north (back) wall (422), which is built into the slope of the site. Internally, 422 survives to a height of c.2.6m. At the back, it does not currently extend beyond ground level; however, historic photographs suggest that it was originally at least two courses higher than this (see P1 and P9). The back wall extends west beyond what could be considered the end of the building by 2–3m where it acts as a retaining wall.

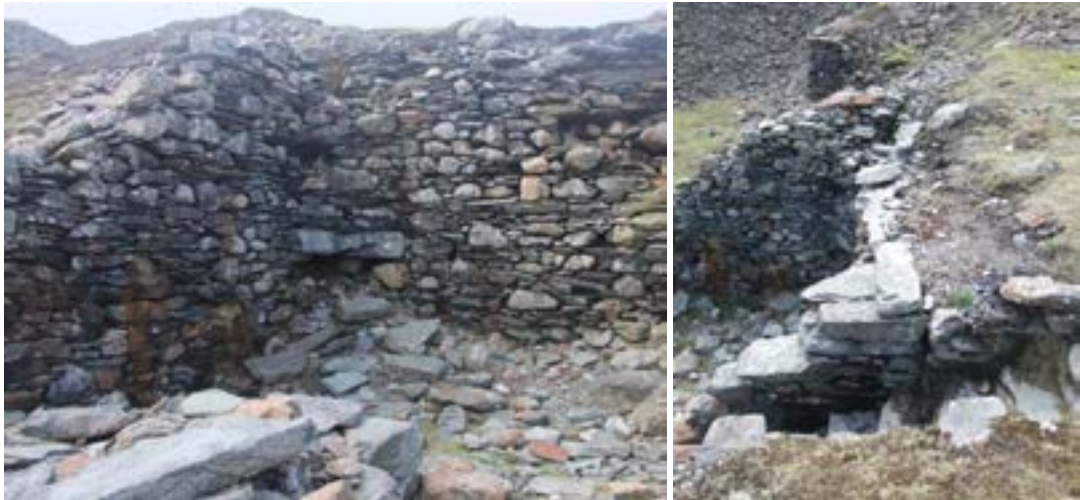
- 6.48 The west (side) wall (424) is keyed into the south (front) wall (425). The front wall survives to a height of c.0.5m, which is much lower than the other walls. Historic photographs of the structure (P1, P4, P5, P8) show that building had a sloped roof to the front; this means that the doorway (426) and a window (427) would not have had many courses of stonework above, accounting for the poorer preservation.

- 6.49 It is suggested that there was a window at the western end of the front wall, based on the relationship between the end of wall (424) and front wall (425). The bases of both walls are keyed in together and then higher up there is a straight joint which may have formed the west side of a window opening (427). However, it is not possible to deduce the size of the window because of the poor state of survival (the historic photos do not give any clues). The door (426) to the office was located at the eastern end of the front wall (425) and measured c.1m wide. It is not possible to estimate its

Plates 33 & 34: office west wall (424) and fireplace (423) (left) and view of structure looking west with steps (405) in the foreground.

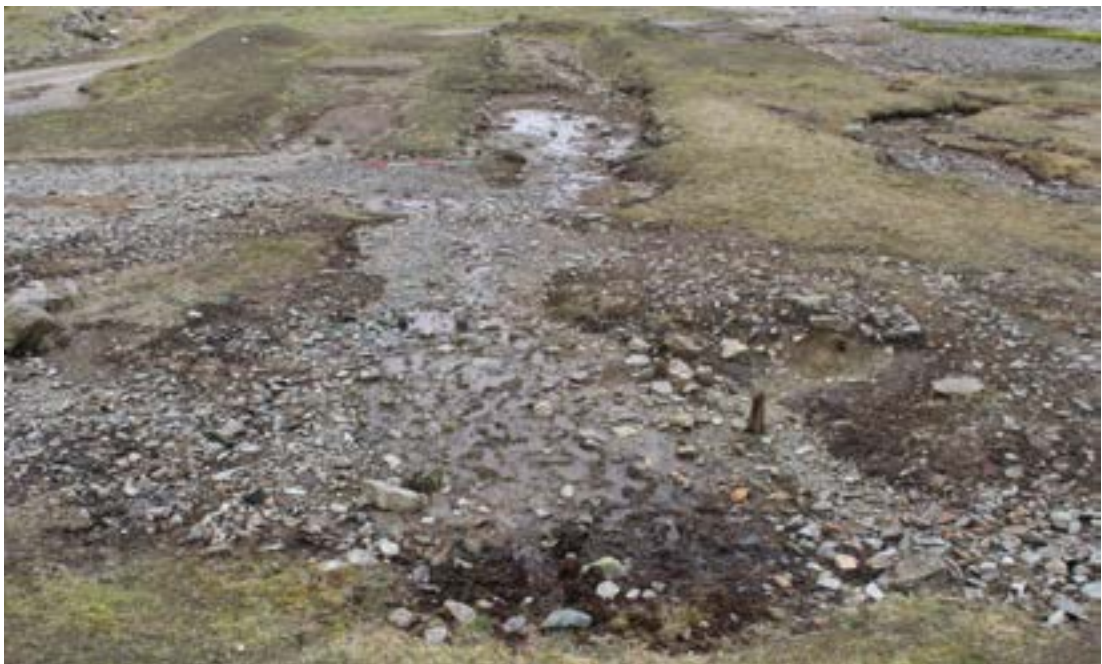
- 6.58 A comparatively well-preserved buddle (502) is situated at the base of terrace bank 506. Surviving timbers suggest that it had a diameter of approximately 5.2m with a stone-sided drain on the southern arc leading towards settling pond 517. Some 3m to the west an oval patch of bare ground marks the location of a second round buddle 505, which appears to have been supplied with material from settling pond 442 via drain 443, but little survives beyond a few displaced timber fragments and, to the south-west, a small heap of sand or buddle waste.

Plate 37: circular buddle (502) in Area 2c with settling ponds (517 and 518) visible in the background.

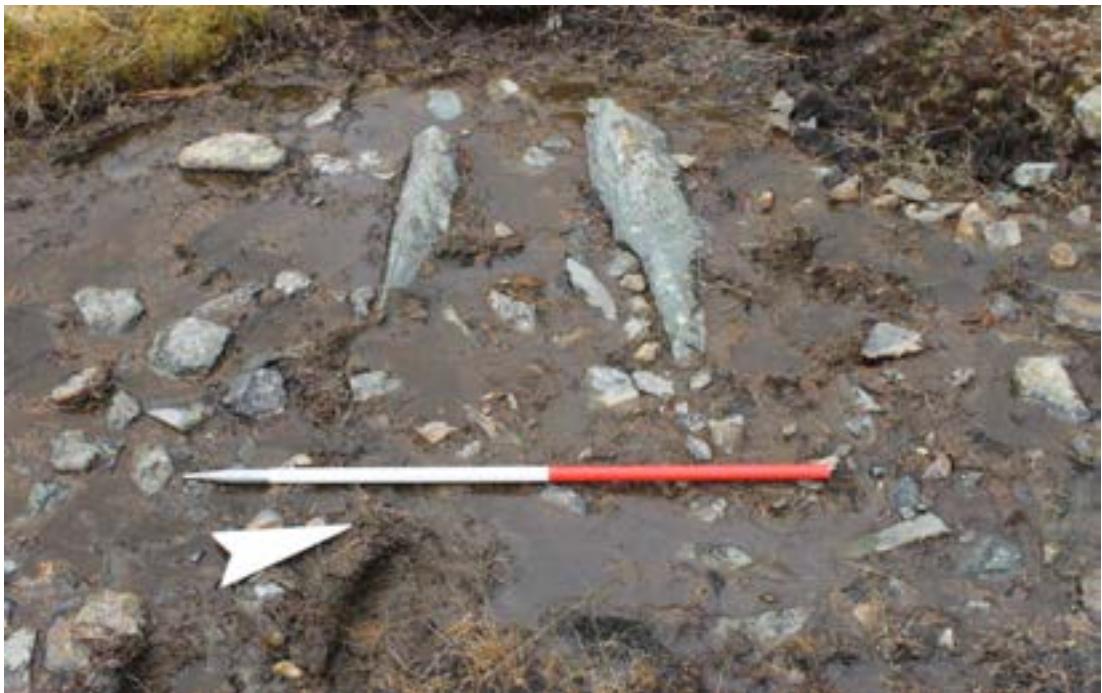
- 6.61 A number of isolated stone walls (515) and culverts (513) are visible in flood gullies immediately south of the Area 3 buddles but cannot be associated with any other features. They indicate, however, that processing took place in this section of the site and much of the ground between here and the buddles appears to have patches of a very degraded cobble surface.

Plate 38: stone lined culvert (513).

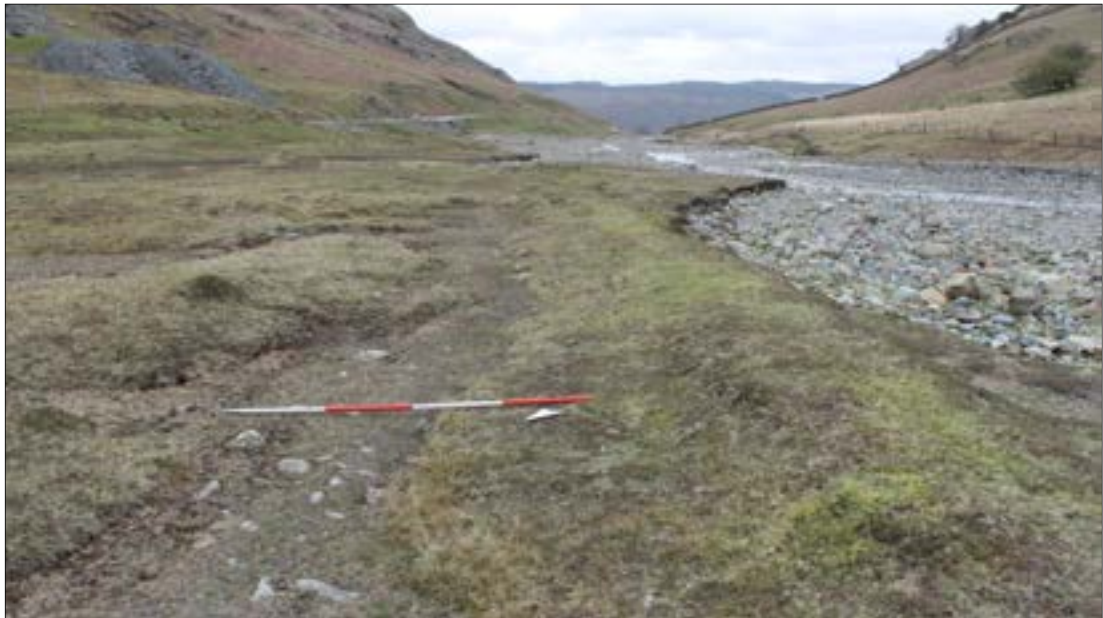
Plate 39: earth bank (521) on the east side of Levers Water Beck, possibly a pollution measure to prevent contaminated material entering the stream.

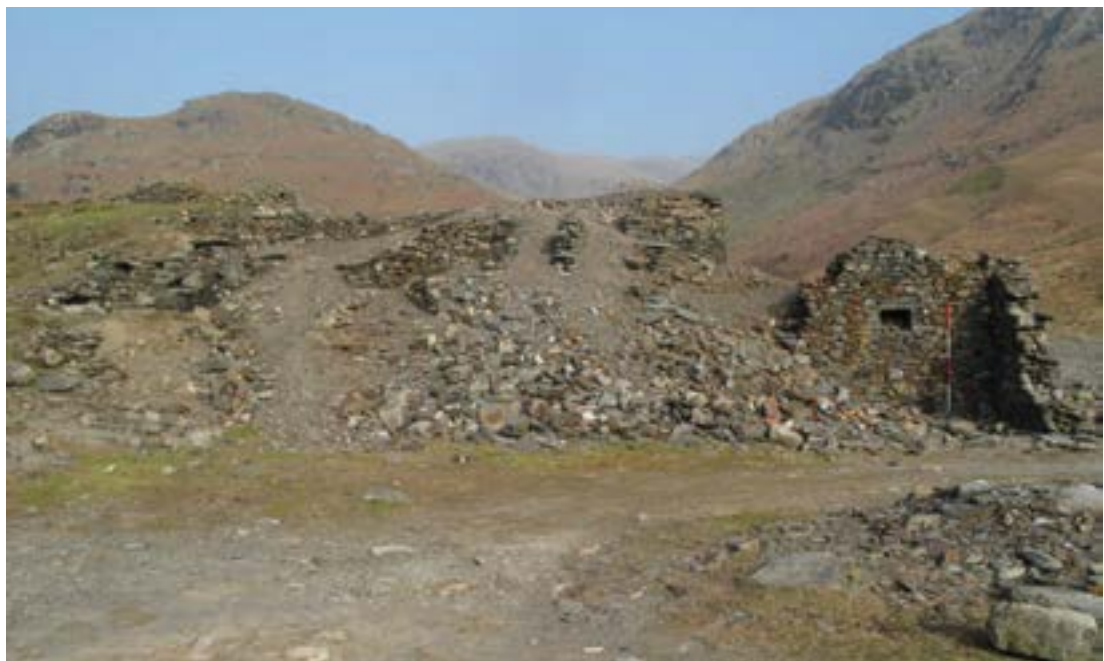
Plate 40: smelter site (300), looking north-west.

- 6.72 The smelter site is in a poor condition and it is hard to reconcile the surviving archaeological features with the structural details shown in P8 and P9. The north-east corner of the smelter building survives as standing masonry walls 301 and 303 and the building's probable south-east corner is marked by ground-level walls 304 and 305. Nothing survives of the remaining stretch of the south wall or any of the west wall. The rest of the north (back) wall has collapsed and any associated features are buried under tumbled masonry although there is an isolated stretch of battered stone wall (333) supporting a horizontal, recessed timber that is close to what may have been the building's north-west corner.

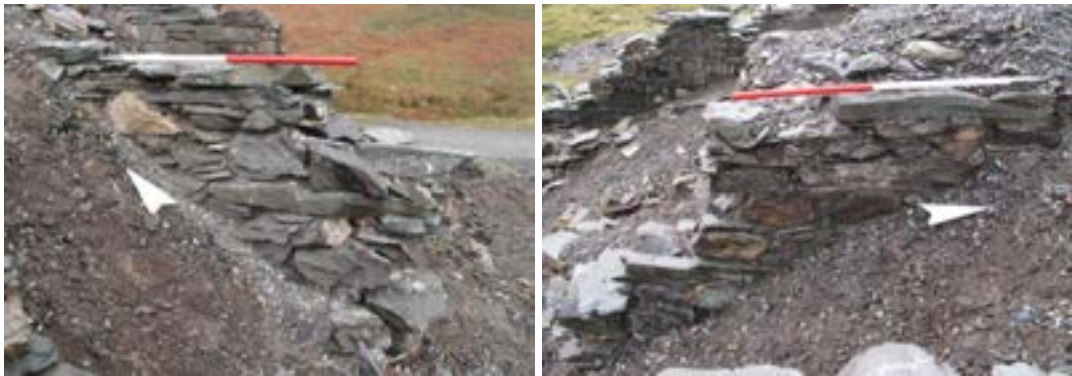
Plates 41 & 42: wall 324 (left) and 325 (right), which post-date the stamping mill and are probably associated with the copper smelter.

- 6.82 Possibly associated with the smelter building are a series of short wall-like features (324–330), which have been built into the backfilled area. It is thought that they may have held/helped support structures for the furnace or formed part of a recess for the furnace stack. It is unlikely that they formed part of a hopper system, as the furnace was charged from above and not at ground level.

- 6.83 The recess (326) created by walls 324 and 325 was approximately 1m wide and 1.6m deep. It could either have been used as a hopper or as a support for one of the furnace stacks. Walls 324 and 325 were identical in their construction and made up of alternating layers of slate and river cobbles. They were both built into the bank of waste material. Both walls are approximately 1m high and 2m long. The brick lined chute recorded by the RCHME in 1997 can no longer be discerned.

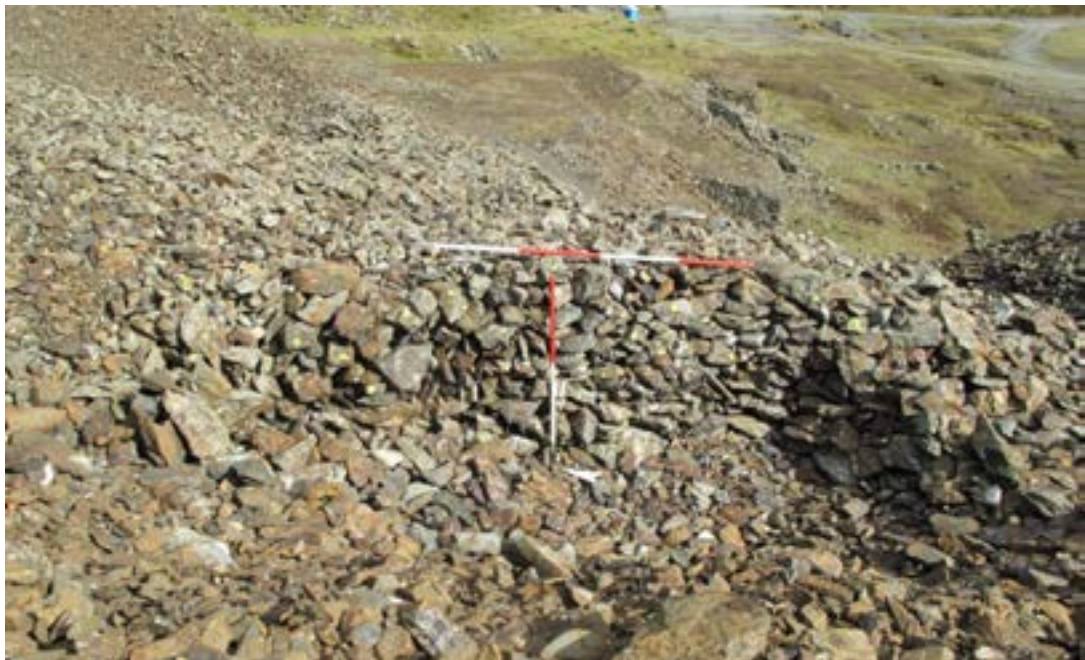
Plate 43: pack wall (122) in tip 102, looking east.

- 6.90 On the central, east-facing side, tip 101 overlies a smaller spoil dump (102). The difference between the two is not immediately apparent, but tip 101 is composed of regularly-sized, orange-stained rock with an average diameter of 20cm, while the material comprising tip 102 is more irregular in size and features grey-brown coloured rock. Tip 102 also contains a number of dry-stone revetment walls and associate linear

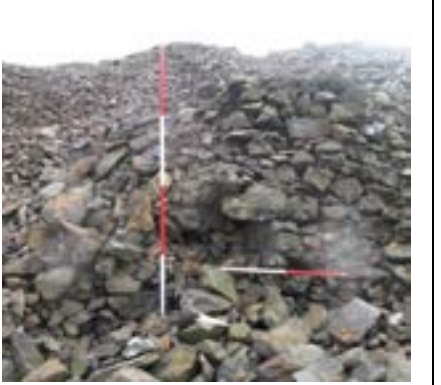
Context	Description	Significance	Assoc. with	Contribution to Significance	Date	Photo
122	Revetment wall - rough, random rubble dry-stone wall constructed from waste tip material. Roughly north-east facing. Maximum height in the middle 1.3m and 4.12m in length. Partially covered with rubble at each end. Opposite wall (123) across a flattened area, 1.5m wide, possibly a trackway.	Medium - as above	Tip (100) Wall (123)	Low Medium	Late 19th Century

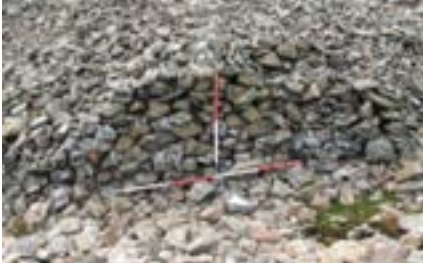
123	Revetment wall - rough, random rubble dry-stone wall constructed from waste tip material. Roughly south-west facing. Maximum height in the middle is 0.8m and 8.0m in length. Curves towards its northern end. Has not survived as well as (122), collapsed and demolished in certain places. Opposite wall (122) across a flattened area, 1.5m wide, possibly a trackway.	Medium - as above	Tip (100) Wall (122)	Low Medium	Late 19th Century

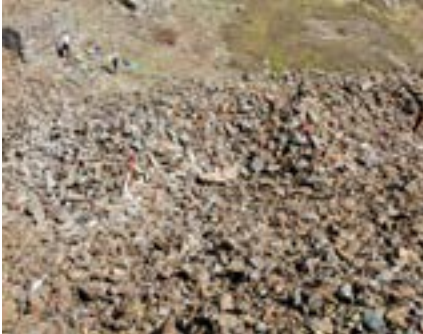
Context	Description	Significance	Assoc. with	Contribution to Significance	Date	Photo
133	<p>Depression - the area is dug out of the tip material and blocked with rubble at either end. Maximum length 1.2m and width 0.8m and roughly 0.5m in height.</p> <p>There is a narrow ridge running roughly north-west to south-east which is just about wide enough to walk along to the north-east of the depression.</p> <p>A tramway can be seen running up the tip on the 1888 OS map.</p>	Medium - as above	Tip (100) Depression (132) Depression (134)	Low Medium Medium	Late 19th Century

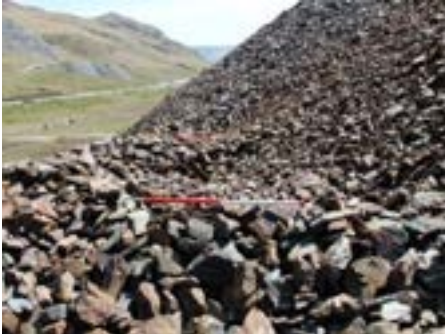
134	<p>Depression - the area is dug out of the tip material and blocked with rubble at either end. Maximum length 2m and width 1m and roughly 0.5m in height.</p> <p>There is a narrow ridge running roughly NW to SE which is just about wide enough to walk along to the north-east of the depression.</p>	Medium - as above	Tip (100) Depression (133) Depression (135)	Low Medium Medium	Late 19th Century

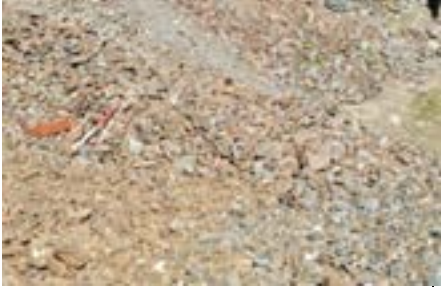
Context	Description	Significance	Assoc. with	Contribution to Significance	Date	Photo
135	<p>Depression - the area is dug out of the tip material and blocked with rubble at its north-western end. Maximum length 1.4m and width 0.7m and roughly 0.5m in height.</p> <p>There is a narrow ridge running roughly north-west to south-east which is just about wide enough to walk along to the north-east of the depression.</p>	Medium - as above	Tip (100) Depression (134)	Low Medium	Late 19th Century

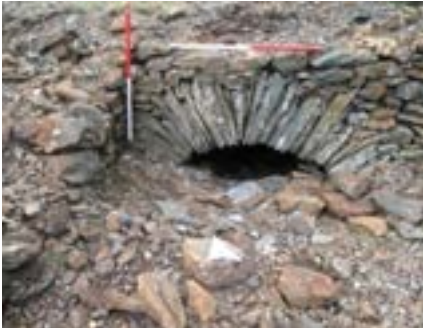
202	Arch - made up of random sized pieces of slate, which range in height from 0.45 to 0.8m. The arch is approx. 2m wide and 0.9m high. Key stones were observed. Material appears to have been backfilled against the arch. The arch forms a tunnel which allows the continuation of a leat (206) from the upper mill.	High - demonstrates the relationship between the upper mill and the lower mill and the movement of water down the site.	Retaining wall (201) Tunnel (203) Return wall (204) Retaining wall (205) Leat (206)	Medium High Medium Medium High	c. 1888-1912

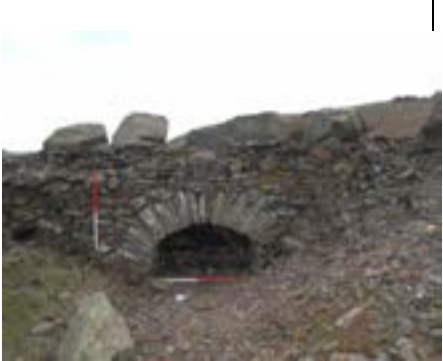
Context	Description	Significance	Assoc. with	Contribution to Significance	Date	Photo
203	Tunnel - the stone arch (202) forms the front face of a stone lined, arched tunnel, which is approx. 7.65m in length. The tunnel is approx. 1m high by 1.1-1.7m wide. The tunnel channels a leat (206) from the upper mill to the lower mill beneath the main trackway. The leat (206) collected water from a water wheel in the upper mill and transferred it to the Lower Mill where it supplied a further two water wheels.	High - as above	Retaining wall (201) Arch (202) Return wall (204) Retaining wall (205) Leat (206)	Medium High Medium Medium High	c. 1888-1912

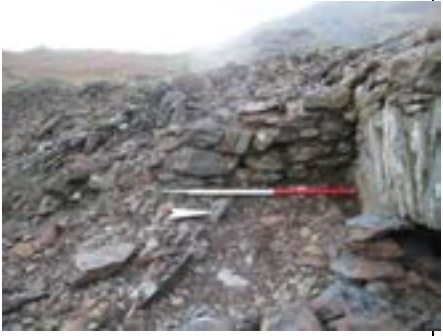
204	Return wall - short length of random rubble dry-stone wall constructed from waste tip material. The wall is at 90 degrees to the main retaining wall (201). It survives to a length of 2.2m and 0.62m high at its highest point. Wall (204) appears to butt up against wall (201). at its northern end it consists of 4 courses, at its southern end it has been reduced to a single course of stones.	Medium - as above	Retaining wall (201) Arch (202) Tunnel (203) Retaining wall (205) Leat (206)	Medium High High Medium High	c. 1888-1912

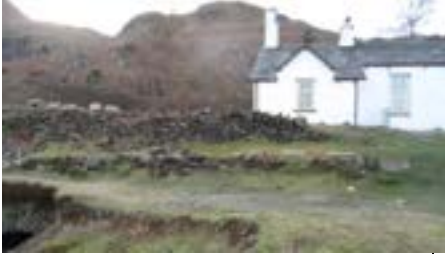
205	Retaining wall - random rubble dry-stone wall constructed from waste tip material. it survives to 3 courses high	Medium - as above	Retaining wall (201) Arch (202)	Medium High High	c. 1888-1912

Context	Description	Significance	Assoc. with	Contribution to Significance	Date	Photo
	in places. It is approx. 10m in length, but it is missing both ends. It is in a poor condition. This low retaining wall is 1.9m south of wall (201) forming the northern edge of leat (206) once it has left the tunnel.		Tunnel (203) Return wall (204) Leat (206)	Medium High High

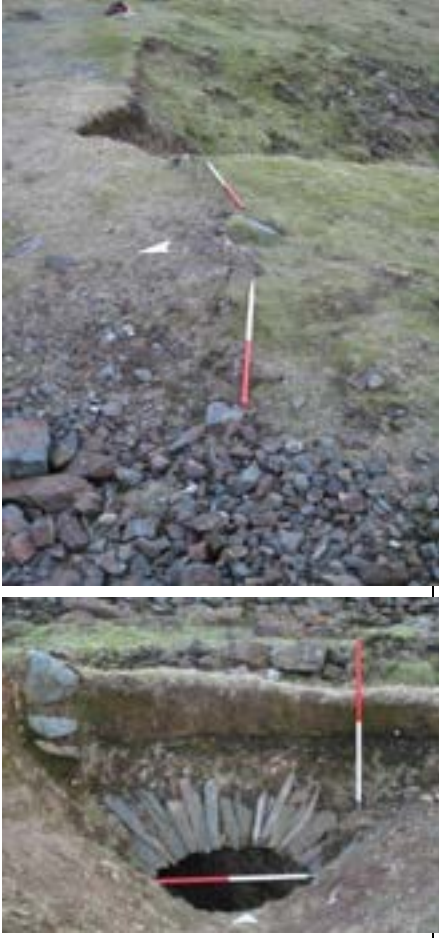
Context	Description	Significance	Assoc. with	Contribution to Significance	Date	Photo
207	<p>Retaining wall - remains of a retaining wall to the south of leat (206) approx. 4.6m long. It is in a very poor state of repair with stones only visible at the surface. Part of this wall can be seen in section just above arch (231).</p>	<p>High - demonstrates the relationship between the upper mill and the lower mill and the movement of water across the two sites.</p>	<p>Return wall (204) Leat (206) Arch (231)</p>	<p>High High High</p>	c. 1888-1912

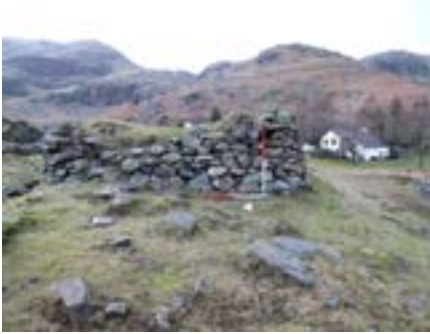
Context	Description	Significance	Assoc. with	Contribution to Significance	Date	Photo
212	Retaining wall - random rubble wall at E (end) section of launder pier (210). 4.7m wide x 1.5m high. Battered face, slightly convex in plan. Stonework has fallen away from bank behind to reveal leat channel in section.	High - as above	Launder pier (210)	High	Not shown on 1850 OS; shown on 1890 OS

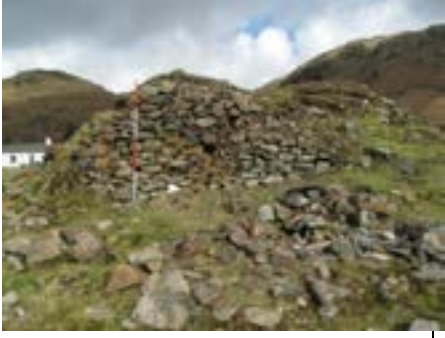
222	Wall - random rubble wall on S (end) side of launder pier (220). 4.8m wide x 1.9m high. Battered profile with a slight curve. In poor condition, E and W corners collapsed.	High - as above	Launder pier (220) – element of.	High	As above

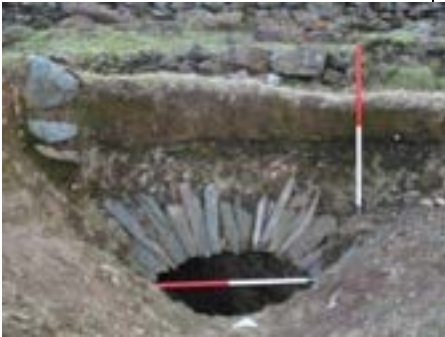
231	Arch - made up of random sized pieces of slate, which range in height from 0.45 to 0.8m. The arch is approx. 1.7m wide and 1.2m high. Key stones were observed. This arch has been exposed within an area where the land has collapsed. It therefore does not represent the front face of this arch. This can be seen from observing how the stones are not evenly aligned to create a smooth face. They are instead stepped in such a way that would allow further stones to be keyed in when the arch / tunnel (232)	High - as above	Tunnel (232) Retaining wall (233) Retaining wall (234) Wall (207)	High High Medium Medium	c. 1850-1888

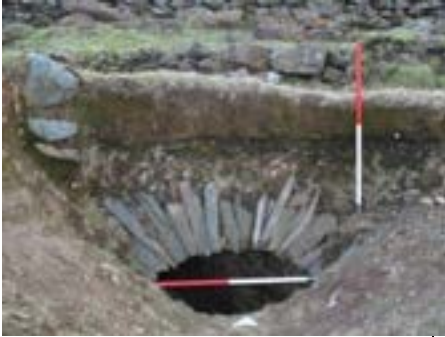
232	<p>Tunnel - the stone arch (231) forms part of a stone lined tunnel. This tunnel, like (203) also runs underneath the main trackway. It is approx. 10.5m in length and at this southern end the opening is approx. 1.2m wide and 1m high. The tunnel is nearly completely blocked at this end due to the land collapsing around it. This tunnel allows the continuation of a tramway from the upper mill to the lower mill.</p>	High - as above	<p>Arch (231)</p> <p>Retaining wall (233)</p> <p>Retaining wall (234)</p> <p>Wall (207)</p>	<p>High</p> <p>High</p> <p>Medium</p> <p>Medium</p>	c. 1850-1888

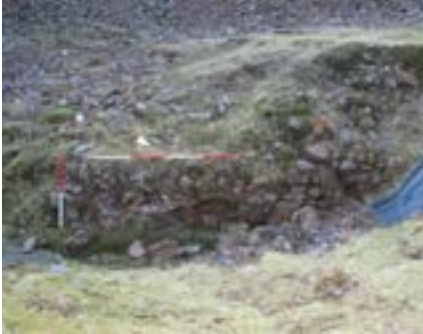
Context	Description	Significance	Assoc. with	Contribution to Significance	Date	Photo
233	Wall - random coursed rubble wall approx. 4.5m in length and 1m high at its highest point. This forms the western retaining wall for the tramway. The top of the wall is now very overgrown.	High - as above	Arch (231) Tunnel (232) Retaining wall (234) Wall (207)	High High Medium Medium	c. 1850-1888

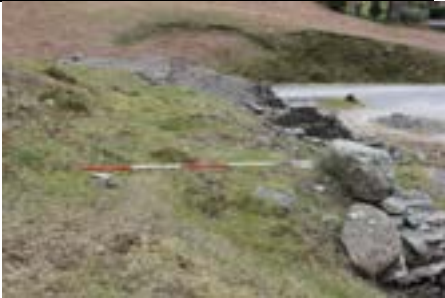
251	Tramway - Embanked terrace with partial stone revetment on steep SE face, marking line of tramway to BLM Stamping Mill 1; 14m long x 1.3m wide. Runs to SW end of wall (331). Truncated and destroyed to SW by modern water pipeline.	High – good evidential value for tramway and transport system and direct association with ore supply to east stamp mill.	Wall (331) Buttress (252)		Shown on 1890 OS
