LOW BONSOR DRESSING MILL

ARCHAEOLOGICAL
COMMUNITY LANDSCAPE
AND BUILDING SURVEY

LOW BONSOR DRESSING MILL,
CONISTON, CUMBRIA

NAA 18/03
February 2018

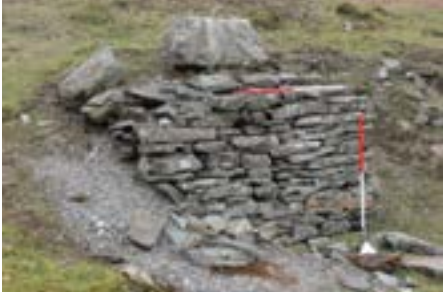
Context	Description	Significance	Assoc. with	Contribution to Significance	Date	Photo
252	<p>Buttress - random coursed rubble buttress. The front face contains stones with numerous drill holes in them demonstrating the re-use of this material.</p> <p>The buttress is built into a terrace. The front face is approx. 2.1m wide by 1.4m high at its highest point. The buttress helped to support the tramway (251) above.</p>	<p>High - helps to demonstrate the re-modelling of the terrace to support the re-direction of tramway (251) to serve the stamping mills.</p>	Tramway (251)	High	1850's OS map

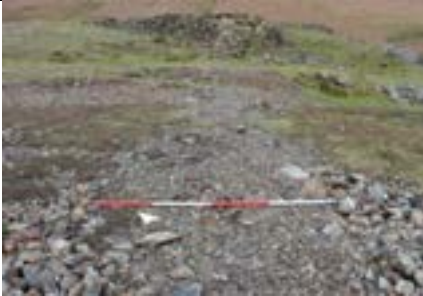
255	Tramway - linear feature, probable tramway, defined by gravel spread demarcated by stone side stones and spoil. Cut to NE by a flood gully and eroded on spoil dump to SE	High – good evidential value for tramway and transport system and the formation of the later spoil dumps.			Shown on 1890 OS

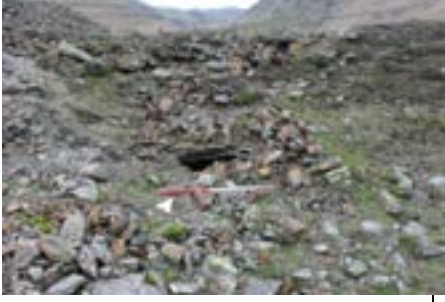
256	Culvert - slab roofed outfall for stone side culvert, 1.2m wide (possibly) x 0.3m high. The culvert, which may be part of culvert (254), is exposed in an erosion hollow 1.6m below the top of the bank. It has been destroyed to the S but may have been associated with	High - good evidential value as its function and date have yet to be established. Potential for further research, thus adding to interpretation and knowledge of site. It is likely that this is an early	Culvert (254), possibly; Structure (430), possibly	High	Unknown

Context	Description	Significance	Assoc. with	Contribution to Significance	Date	Photo
	structure (430).	feature, perhaps associated with the water systems shown on the 1850 OS map.

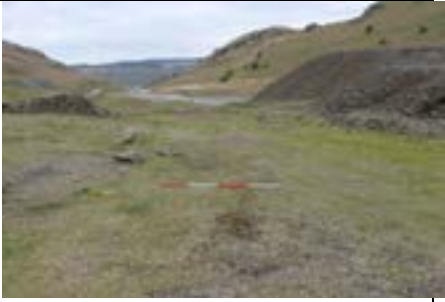
257	Track - faint outline of road or cart track running SE down slope from leat bridge (208). Terraced into slope on E side and built up to W. 25m long x 1.5 wide. Destroyed to SE by modern water pipeline.	High – good evidential value for transport system between upper mil and BLM.	Bridge(208)	High	Shown on 1850 OS (so predates leat (206)

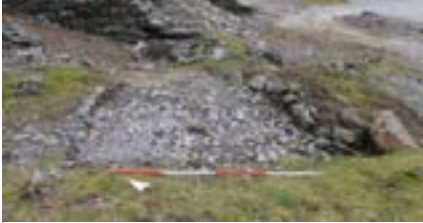
258	Catch pit? - oval, pit-like feature with curving stone face to N and straight face to S; 2m x 2.5m. Partially in-filled drain at SW. Interior filled with small angular stones and considerable amount of burnt limestone. Possibly a catch pit for Stamping Mill 3 but limestone suggests association with later copper smelter.	High – good potential evidential value for operation of the stamping mill and/or the copper smelter.		High	Possibly shown on 1890 OS map

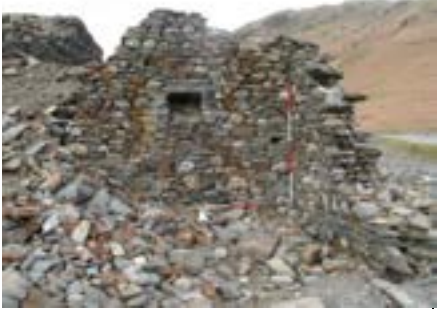
301	Northern wall of smelt building - coursed random rubble wall made up of layers of river cobbles and slate and occasional pieces of quartz. Evidence of mortar in places. Built into a bank of what appears to be waste material. Heavy mineral staining on the internal elevation. External elevation contains a stone with a drill hole in it and a brick. The north-east corner is well constructed with large quoins visible	High - as above	Aperture (302) Wall (303) Wall (304) Wall (305) Wall (324) Wall (325) Aperture (327) Wall (328)	Low High High High High High High High	Smelt building built 1893 and destroyed Dec. 1894

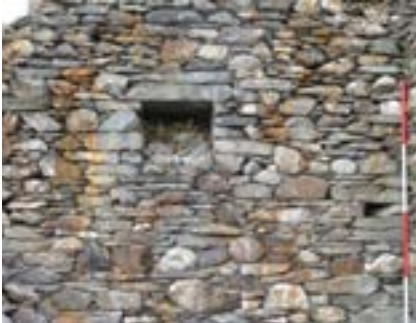
302	<p>Aperture - roughly square opening within wall (301), 0.58m wide by 0.54m high and 0.74m deep (the depth of the whole wall). It is approximately 1.4m above the ground, although the floor is covered in rubble. It has a substantial slate lintel but no sill. The base appears to slope down from outside to inside, although part of this slope may have been created by material falling in from outside. The aperture is blocked from the outside</p>	<p>Low - the exact function of this aperture is unclear.</p>	Wall (301)	High	Smelt building built 1893 and destroyed Dec. 1894

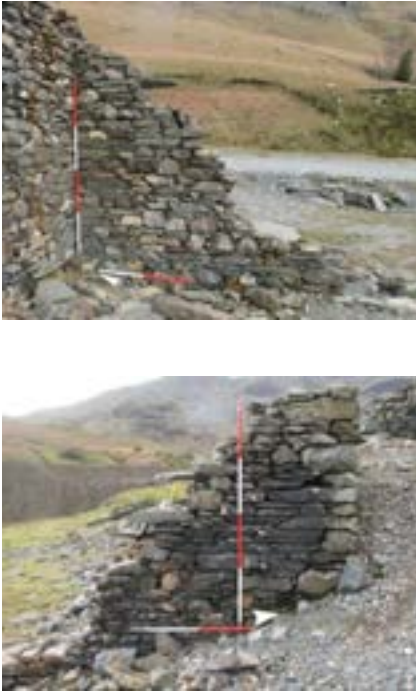
Context	Description	Significance	Assoc. with	Contribution to Significance	Date	Photo
	due to the amount of material that has been deliberately built up behind the building.					
303	<p>East wall - coursed random rubble wall made up of layers of river cobbles and slate and occasional pieces of quartz. Evidence of mortar in places. The north-east corner is well constructed with large quoins visible externally.</p> <p>Internal dimensions: Maximum height = 2.60m Maximum width = 3.10m</p> <p>External dimensions: Maximum height = 2.07m Maximum width = 4.20m Depth = 0.60m</p> <p>This wall is in line with wall (304), which may indicate the original length of the whole wall / building. The external length of the wall would be approximately 11.75m.</p>	High - demonstrates a very short lived (6 months), but apparently very productive period of the sites history.	Wall (301) Aperture (302) Wall (304) Wall (305)	High Low High High	Smelt building built 1893 and destroyed Dec. 1894

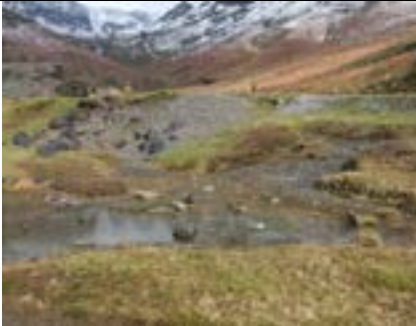
311	Pond - or flooded hollow, approximately 12.50m south-west to north-east by 7.10m north-west to south-east. The level of the pond goes up and down according to how much rain there has been. Possibly originally part of an outflow channel for wheel pit (340)	Medium - the exact function and purpose of this feature is uncertain and as such it may benefit from further research.	Smelt area G(300) Slag (310) Wall (312)	Medium Medium High	Unknown

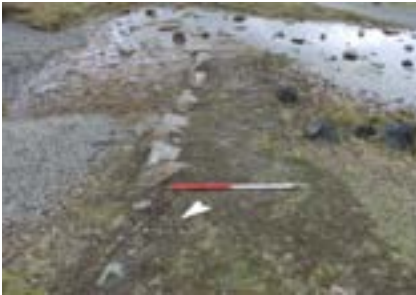
312	Pond wall - an earth covered wall which has stone revetting along its north-eastern edge. It survives for an approx. length of 6.45m running downhill from the pile of slag (310) and into the pond area (311). It survives to a maximum height of 0.50m. It is buried by the slag at its NW end and it is truncated at its SE	High - good evidential value as its function and date have yet to be established. Potential for further research, thus adding to interpretation and knowledge of site. It may in understanding of water supplies on site.	Slag (310) Pond (311)	High High	Unknown

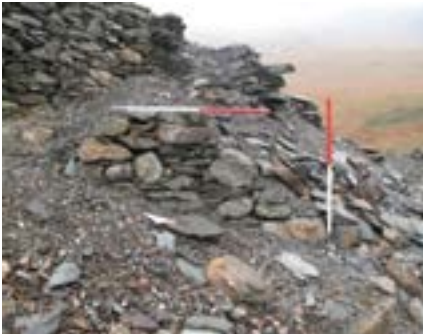
330	Angled wall - between retaining wall (328) and sloping wall (333). Coursed random rubble wall consisting of slate and river cobbles built into a bank / terrace of waste material. It is approx. 0.8m high and 2.2m long. It is in a very poor condition, but it may have once butted up against retaining wall (328). Its construction is different to (329). Its exact function is unclear, but it may have been a support of some kind for machinery related to the furnace.	Medium - as above	Retaining wall (328) Sloping wall (333)	Medium Low	Smelt building built 1893 and destroyed Dec. 1894

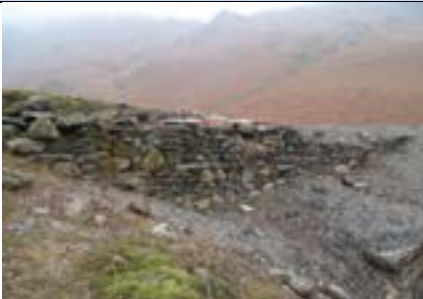
Context	Description	Significance	Assoc. with	Contribution to Significance	Date	Photo
331	Long retaining wall - consisting of coursed random rubble including large flat pieces of slate and large river cobbles. Approx. 10.56m in length survives as a visible retaining wall. It may continue behind collapsed material for approx. another 5.47m to the east. It defines part of the edge of tramway (251) and tramway (255). It is approx. 2m at its highest point.	High - shows how the site has been adapted and developed to accommodate the movement of material down it.	Tramway (251) Tramway (255)	High High	c. 1890

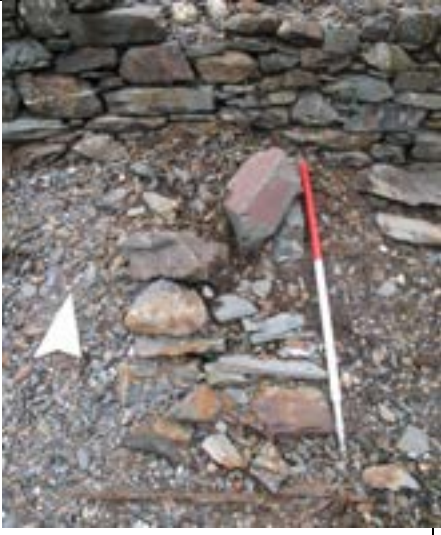
332	Buttress - remains of a buttress, surviving only at ground level. It appears to have butted up against the long retaining wall (331). It is approximately 1m long by 0.6m wide. It appears to be of a random rubble construction with some pieces of slate and river cobbles visible. A piece of poorly preserved timber defines its southern extent.	Low - date and purpose unknown	Retaining wall (331) Wheel pit (340)	High Medium	Unknown

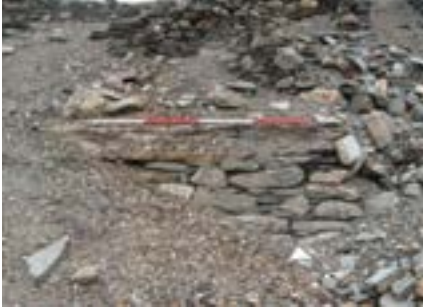
Context	Description	Significance	Assoc. with	Contribution to Significance	Date	Photo
333	Sloping wall with timber - possibly a retaining wall, but its exact function is not clear. It is on a similar alignment to the north gable wall of the smelt building (301). It occurs half way down the bank / terrace of waste material. It is approx. 2.25m wide and 0.77m at its highest point. It slopes backwards into the bank. There is a piece of timber set back slightly from the wall, but on the same alignment. It is a coursed random rubble wall.	Medium - exact function unknown but may contribute to our understanding of the layout of the smelt building and its machinery.	North wall smelt building (301)	Medium	Unknown

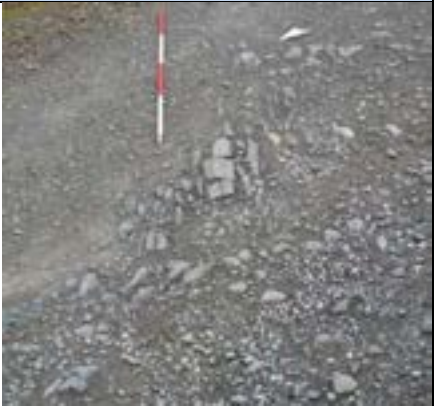
Context	Description	Significance	Assoc. with	Contribution to Significance	Date	Photo
335	Trackway culvert - the top stones of an arch probably for a culvert. Exposed on the surface of the road. Was observed running beneath the main track towards the river where its exit from beneath the track and into the river can be observed within the river bank. Probing through a void between some of the stones suggests a depth of 1.1m.	High - good evidential value as its function and date have yet to be established. Potential for further research, thus adding to interpretation and knowledge of site. It may aid understanding of water supplies on site	Culvert (336), possibly.	High	Unknown

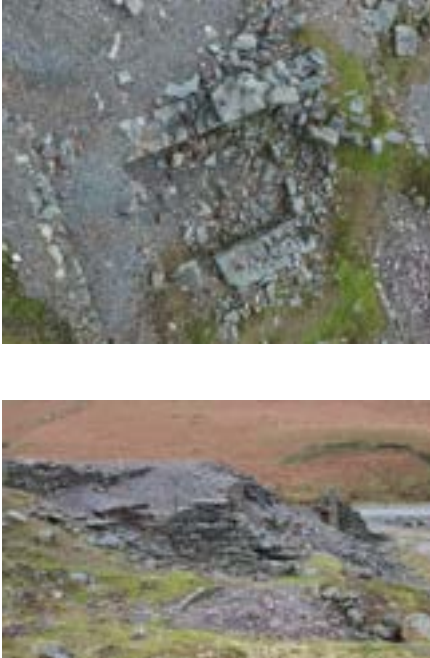
Context	Description	Significance	Assoc. with	Contribution to Significance	Date	Photo
340 Group	<p>Wheel-pit or wheel-housing. Raised rectangular structure consisting of coursed random rubble stone walls on at least 3 sides. Early images from c.1877 suggest that it may not have had a masonry front wall.</p> <p>The wheel was used to initially power the stamps in the wooden sheds either side of it. Later it was used to provide power for the smelt building (300).</p> <p>The internal dimensions of the pit are approx. 6.3m long by 3m wide.</p> <p>The pit itself now has a sloping base due to it being in filled with rubble and waste material from the terrace behind.</p> <p>The ground is also sloping outside the pit for the same reason.</p>	<p>High - well preserved and only surviving on-site example of a waterwheel pit. Value increased by its structural, group and visual association with associated features which allow interpretation of full process of water-powered ore processing.</p>	<p>Smelt group (300)</p> <p>West wall (341)</p> <p>North wall (342)</p> <p>East wall (343)</p> <p>Bolts (344)</p>	<p>High</p> <p>High</p> <p>High</p> <p>High</p> <p>High</p>	<p>1877 photo</p> <p>1890s photo</p>

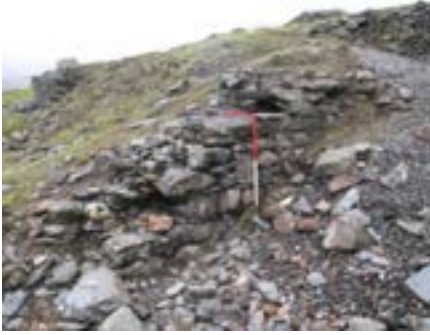
341	<p>West wall of wheel-pit - coursed random rubble wall consisting of slate blocks and river cobbles. Approx. 4.5m long and 1.9m high at its highest point. The wall is approx. 1m thick. The wall contains one bolt (344) which would have originally been centrally located. Well-constructed, but in a poor state as</p>	<p>High - reasonable well preserved and is the only one surviving within the lower mill. Value increased by its association with surrounding associated features.</p>	<p>Wheel pit (340)</p> <p>North wall (342)</p> <p>East wall (343)</p> <p>Bolts (344)</p>	<p>High</p> <p>High</p> <p>High</p> <p>High</p>	c. 1877-1888

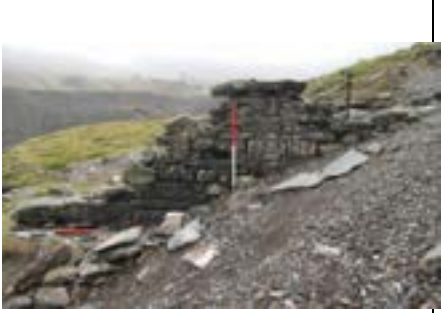
343	<p>East wall of wheel-pit - coursed random rubble wall consisting of slate blocks and river cobbles. Approx. 6.5m long by 2.1m high at its highest point. The wall is approx. 1m thick. The wall contains one bolt (344) which would have originally been centrally located.</p> <p>Both the interior and the exterior of this wall have gunk which has run down</p>	High - as above	Wheel pit (340) West wall (341) North wall (342) Bolts (344)	High High High High	c. 1877-1888

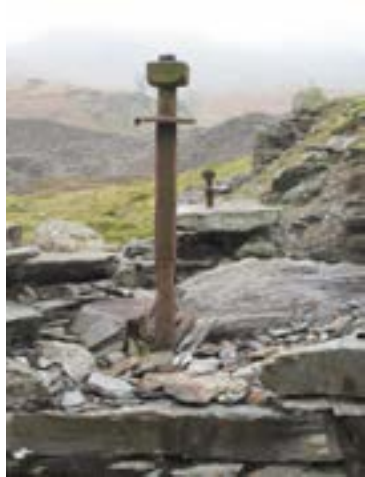
Context	Description	Significance	Assoc. with	Contribution to Significance	Date	Photo
344	Bolts - iron bolts on wall head of wheel pit (340). One bolt survives through wall (341) and one survives through wall (342). Originally held horizontal timber members supporting the waterwheel axle. Bolts are 50mm (2in) in diameter with screw thread and nut at top and square iron plate at base below.	High - as above	Wheel pit (340) West wall (341) North wall (342) East wall (343)	High High High High	c. 1877-1888

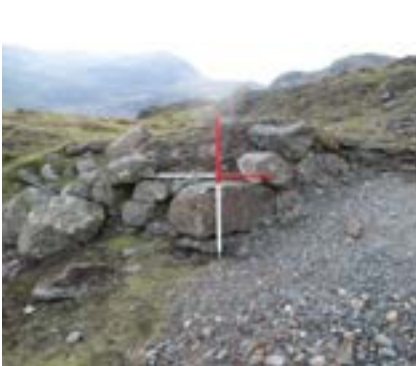
345	Retaining wall - or buttress located to the south of the wheel-pit (340). Coursed random rubble wall consisting of slate and large river cobbles / boulders. It is approx. 2.4m by 2.3m wide and 0.6m high. It is in a very poor state of repair. It can be seen on photos from the 1890s with a ladder lent up against it from the terrace below. It would appear that to the north of this buttress are the possible remains of a tailrace from the wheel-pit which diverted the water to the west.	Medium - due to its association with other features.	Wheel pit (340) Wall (400)	High Medium	1880s

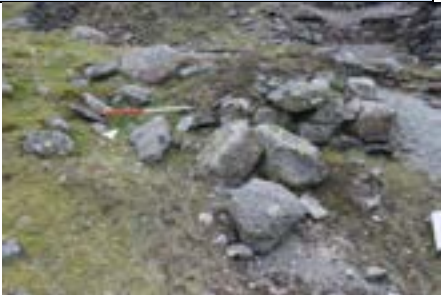
Context	Description	Significance	Assoc. with	Contribution to Significance	Date	Photo
400	Wall - corner of retaining wall, destroyed to NW and SW. Boulder construction. Length NE-SW: 2m; length NW-SE: 2.3m; height 0.55m. Probably a continuation of retaining wall (401).	Moderate/low – lacks context and poor relationship with other features.	Wall (401)?	Low	Shown on 1890 OS map

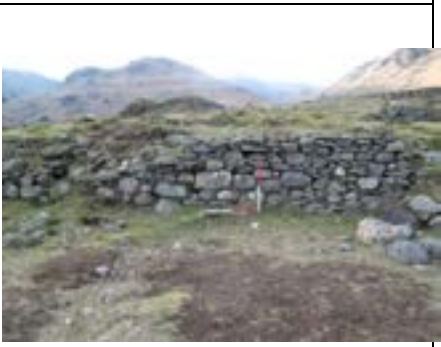
401	Wall - terrace retaining wall and back wall for structure (410). Random rubble construction, including boulders; no evidence for use of mine rock. Incorporates drains (402) and (403). 12.9m long x 1.5 high.	High – good evidential value as surviving example of typical terraced dressing floor retaining wall.	Wall (400)? Drains (402, 403) Building (410)	High	Shown on 1890 OS map

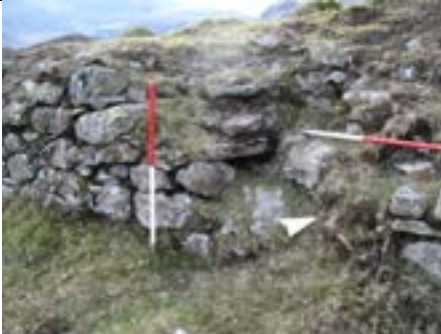
402	Drain - truncated outflow to drain or small culvert in wall (401). Stone slab roof on coursed stone sides. 0.5 wide x 0.2m high. Probably carried material between the now-lost west stamp mill and the jigging area.	High – good evidential value for movement of material from stamps to jigs.	Wall (401) Building (410)	High	Shown on 1890 OS map

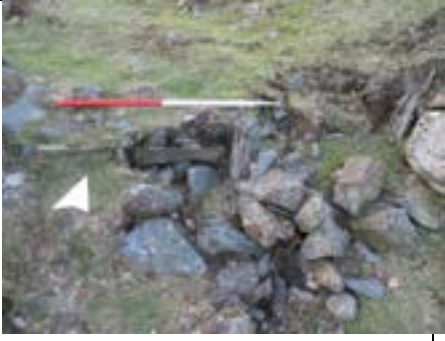
404	Timber structure - damaged timber structure exposed at SE end of gully (253) and spanning gap or break between walls (401) and (405). Two planks, 0.95m and 0.65m respectively, set on vertical timbers to S; planks 0.3m wide and uprights approx. 0.12m x 0.08m in section. Possible water management feature (remains of sluice gate?)	High – good evidential value for water control, possibly linked to putative water wheel at SW end of building (410)	Wall (401) Wall (405) Building (410) Gully/lead (253)	High	Shown on 1890 OS map

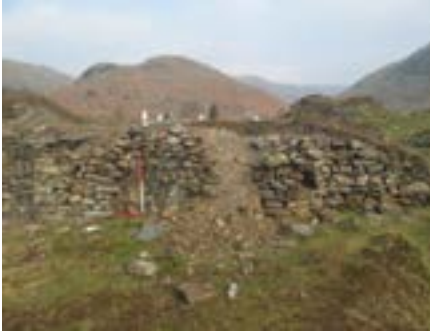
Context	Description	Significance	Assoc. with	Contribution to Significance	Date	Photo
405	Wall - low retaining wall, random rubble construction using mined rock. 7.2m long x 1.55m high. Corner at SW and short return parallel with steps (429). Damaged to NE.	High - good evidential value as surviving example of typical terraced dressing floor retaining wall. Value enhanced by use of mined rock as building material, something that might indicate phased construction.	Steps (429)	High	On 1888 OS map

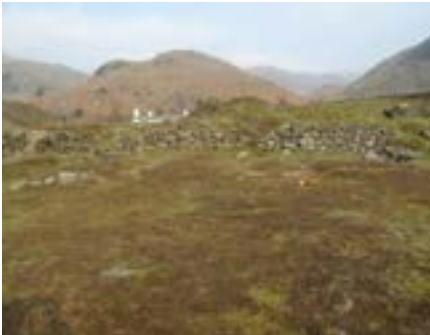
410 Group	Building platform - rectangular terrace defined to NW by walls (400) and (401) and to SW by wall (416) - damaged to W by flood gully. Series of linear gullies (411-414) within the building's interior. Interpreted as structure for jigs.	High - good evidential value as principal surviving example of jig house and therefore fundamental to understanding ore dressing process on site. Good potential for buried archaeology.	Wall (401) Wall (400) Wall (416) Gullies (411 - 414) Drain (418) Culverts 402 and 403)	High	On 1890 OS map

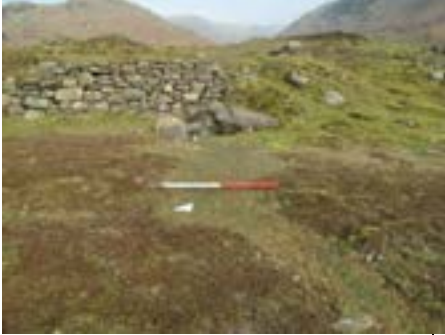
414	Jigg drain? - shallow linear hollow within building (410), badly eroded and probably disturbed to E by modern water pipeline. . 4.9m long; 0.8m wide and max. depth of 0.1m. Parallel to gullies (411-413).	High - as above	Building (410) Gullies (411-413)	High	1890 or earlier

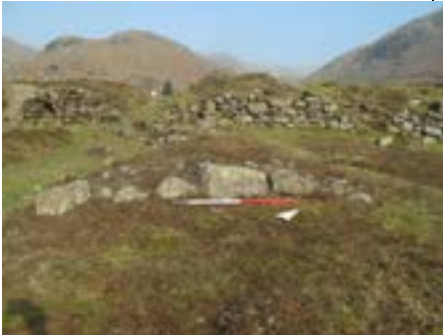
416	Wall - low wall, boulder construction, one course high. 3.2m long x 0.3m high. Truncated to SW by flood gully. Probably part of building (410) and may be a continuation of wall (417).	High - as above	Building (410) Wall (417), possibly	High	Shown on 1890 map

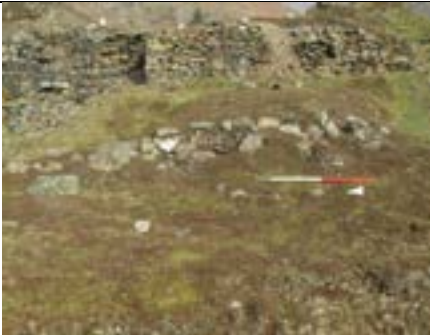
417	Wall - low wall, random rubble construction, retaining bank to N. 4.6m long x 0.9m wide x 0.3m high. Truncated to E by flood gully. Same alignment as wall (416) but different construction techniques.	High – good evidential value for structure associated with dressing process. Function of structure unknown so potential for future research.	Wall (416), possibly	High	?

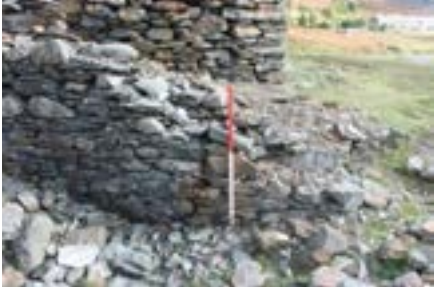
Context	Description	Significance	Assoc. with	Contribution to Significance	Date	Photo
421	<p>East wall - coursed random rubble wall consisting of alternate layers of slate and river cobbles. There is a large crack towards its southern end.</p> <p>Internal dimensions: Maximum height = 2m Maximum width = 3.8m</p> <p>External dimensions: Maximum height = 0.85m Maximum width = 4.6m</p> <p>The office is built into a slope which is why the external height is smaller than the internal height. The slope to the east of this wall has been utilised to create a flight of steps (429).</p>	High - as above	Wall (422) Fireplace (423) Wall (424) Wall (425) Door (426) Window (427) Steps (429)	High High High High High High	c. 1877

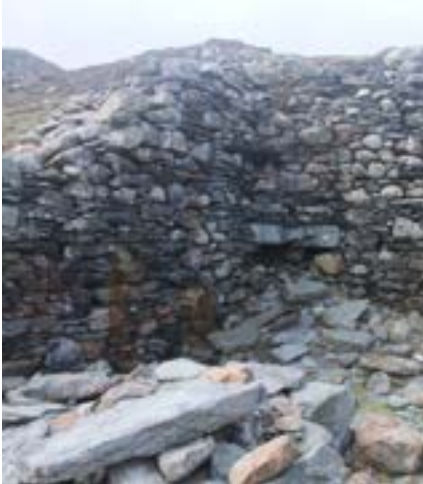
Context	Description	Significance	Assoc. with	Contribution to Significance	Date	Photo
424	<p>West wall - coursed random rubble wall consisting of alternate layers of slate and river cobbles. It contains several large cracks. There are no external measurements as the wall has been buttressed by a second external side wall (428). The two walls appear to have been keyed in together at their northern end forming a double thickness wall. At their southern end they appear to have been split, with (424) turning 90 degrees to become wall (425) and wall (428) continuing straight on for another 1m.</p> <p>Internal dimensions: Maximum height = 2.8m Maximum width = 2.7m</p>	High - as above	Wall (421) Wall (422) Fireplace (423) Wall (425) Door (426) Window (427) Side wall (428)	High High High High High High High	c. 1877

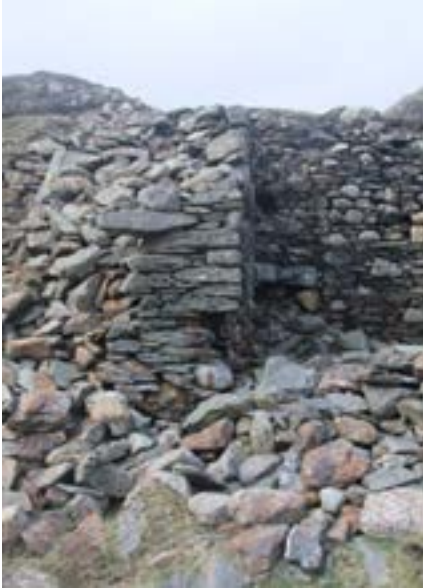
Context	Description	Significance	Assoc. with	Contribution to Significance	Date	Photo
427	Window - it is suggested that there was a window at the western end of the front wall. This is surmised from the relationship between the end of wall (424) and front wall (425). The bases of both walls are keyed in together and then higher up there is what could be described as a straight joint, which would have formed the west hand side of the window opening. It is not possible to suggest any measurements for the size of the window due to its poor state of survival and unfortunately the photos are not clear enough.	High - as above	Wall (421) Wall (422) Fireplace (423) Wall (424) Wall (425) Door (426)	High High High High High High	c. 1877

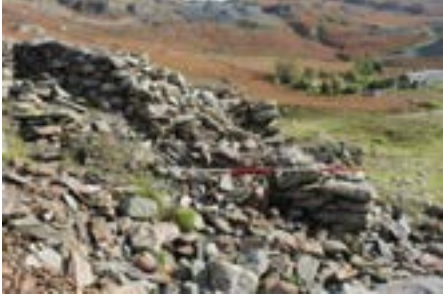
428	Side wall - coursed random rubble wall consisting of slate and river cobbles. The stones are considerably larger at the southern end of the wall. Approx. 2.5m long by 1m at its highest point. This wall can be seen protruding beyond the office in a photo from c.1894. It does not appear to relate to any other structure within the immediate vicinity, so it suggested that	High - demonstrates how the site was adapted over time.	Office (420) Fireplace (423) Wall (424) Structure (430)	High High High High	c. 1894

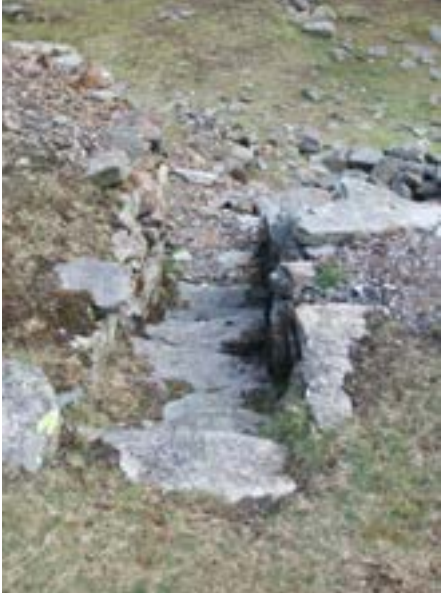
Context	Description	Significance	Assoc. with	Contribution to Significance	Date	Photo
429	<p>Steps - there is a narrow gap between the end of retaining wall (405) and the eastern wall of the office (421). This gap is occupied by a flight of steps made out of slate slabs. They are clearly marked on the 1888 OS map.</p> <p>The relationship between the retaining wall (405), the office (420) and the steps would suggest that they were probably all built around the same time.</p>	<p>High - this is the only flight of steps evident across the whole site and therefore suggests the relatively high status/importance of the office building/the people that worked in it as they were not expected to climb up and down a ladder as can be seen elsewhere on the site from photos.</p>	<p>Wall (405) Office (420) Wall (421)</p>	<p>High High High</p>	c. 1877-1888

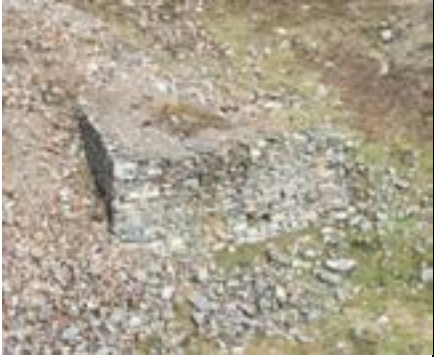
430 Group	<p>Structure - launder and tramroad pier - coursed random rubble walls consisting of large pieces of slate and large river cobbles. The size of the stones suggests that this needed to be structurally very strong. Approx. 2.6m high by 5.8m wide by 3m deep. It is built into a slope and the tip is encroaching on its western side.</p> <p>There is a photo from the 1860s - 1870s which suggests that this may</p>	<p>High - possible evidence for the management of waste/excess water.</p>	<p>Wall (431) Wall (432) Wall (433) Culvert (434)</p>	<p>High High High High</p>	1850s OS map

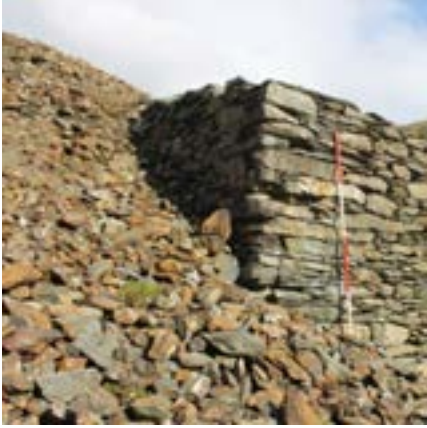
Context	Description	Significance	Assoc. with	Contribution to Significance	Date	Photo
432	West wall - coursed random rubble wall consisting of large pieces of slate and large river cobbles. The size of the stones suggests that this needed to be structurally very strong. The wall has been built into a sloping bank. Approx. 1.5m at its highest point by 3m wide.	High - as above	Wall (431) Wall (433) Culvert (434)	High High High	1850s OS map

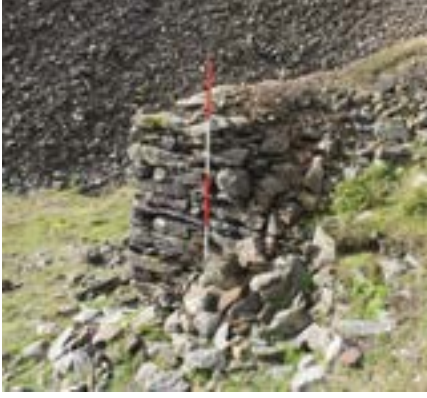
433	East wall - coursed random rubble wall consisting of large pieces of slate and large river cobbles. The size of the stones suggests that this needed to be structurally very strong. The wall has been built into a sloping bank. Approx. 2.1m at its highest point by 3m wide.	High - as above	Wall (431) Wall (432) Culvert (434)	High High High	1850s OS map

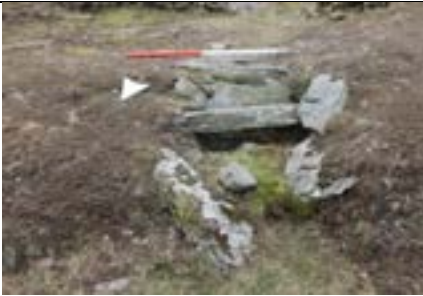
441	Drain - culverted drain with stone sides and stone-slab cap connecting buddle (440) with pond (442). Good condition, with slight disturbance at S end.	High – good evidential value for movement of materials in different stages of the ore dressing process.	Buddle (440) Pond (442)	High

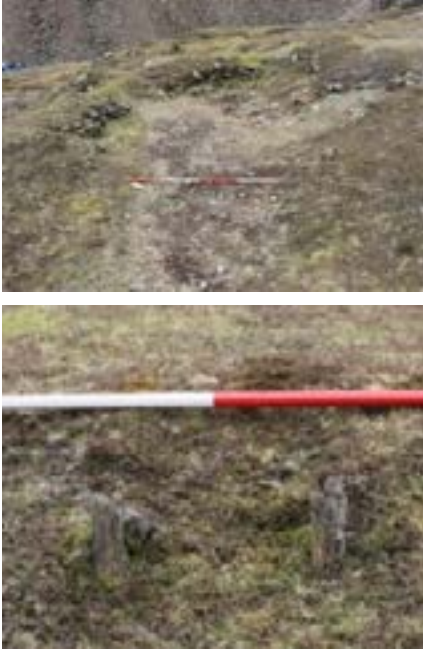
Context	Description	Significance	Assoc. with	Contribution to Significance	Date	Photo
442	Settling pond - rectangular pond or tank with internal stone revetment at W end. Drain (440) enters at centre north side and drain (443) cuts through terrace bank at SW corner. Two upright timbers set in bank at SE corner, possibly evidence for wooden superstructure or launder. ,	High – good evidential value relating to a specific part of the dressing process (settling). Survival of associated settling ponds adds to group value. Good historical value as feature can be identified on historical photograph.	Drain (441) Drain (443)	High	On 1890 OS map

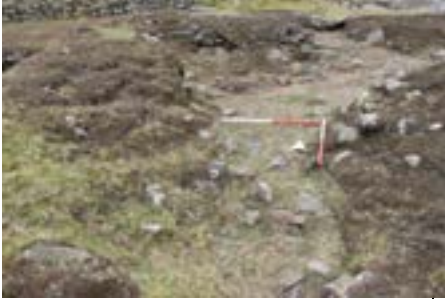
443	Drain - large open drain cut through terrace bank at SW corner of pond (442) and leading to buddles (502) and (505). V-shaped profile, 5.8m long and 0.8m wide. Some stone revetment survives on W side. V-shaped profile could be result of erosion.,	High - good evidential value for understanding of dressing process. Aids understanding of movement of material between settling tanks and secondary buddles.	Settling pond (442) Buddles (502) and (505) Terrace bank (506)

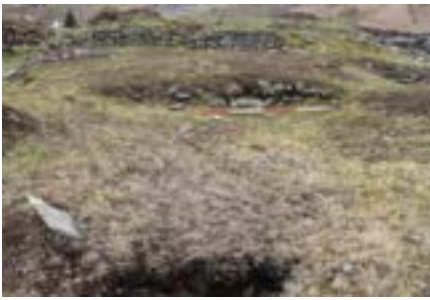
445	Settling pod - rectangular pond or tank separated from ponds (442) and (445) by grassed earth banks. No bank to S but this may have been lost to erosion. Length of edge-set timber in SW corner could be evidence for launder. Dimensions: 5.5m 3.5m x 0.5m deep.	High – good evidential value relating to a specific part of the dressing process (settling). Survival of associated settling ponds adds to group value.	Bank (507) Ponds (442) and (446)	High	On 1890 OS map

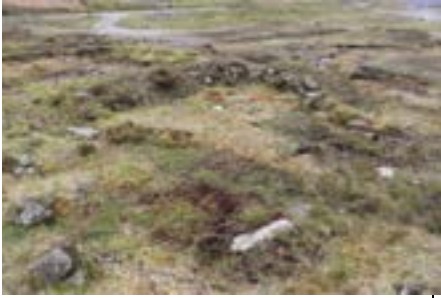
Context	Description	Significance	Assoc. with	Contribution to Significance	Date	Photo
447	Settling pond - rectangular pond or tank with stone revetments at NW corner. Badly damaged by erosion from flood gully. General dimensions: 5.9m x 5.1m x 0.8m deep.	High - as above.	Terrace bank (508) Terrace bank (509)	High	On 1890 OS map

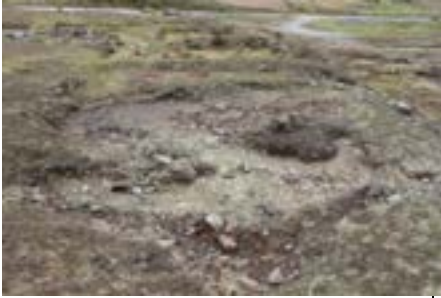
448	Settling pond - large rectangular pond or tank, most westerly in group. Evidence of central stone dividing wall, so may originally have been two conjoined tanks. Internal stone revetment. Possible drains at SW and NE corners and large rain at NW corner. General dimensions: 8.2m x 5.5m 0.4m deep.	High - as above.	Terrace bank (510) Drain (449)	High	On 1890 OS map

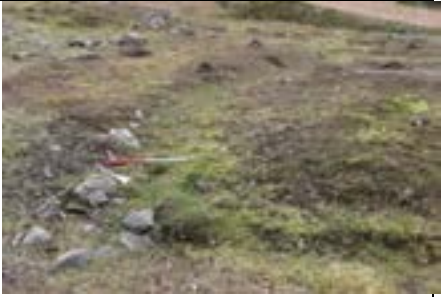
449	Drain - broad curving drain, stone revetment on N side, connecting NW corner of settling pond (448) with probable water channel at W side of terrace bank (510). 5.7m long x 1.1m wide x 0.2m deep.	High - good evidential value for understanding of dressing process.	Terrace bank (510)	High	On 1890 OS map

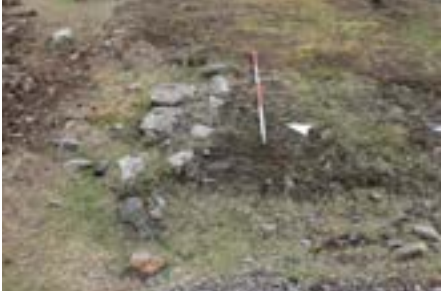
Context	Description	Significance	Assoc. with	Contribution to Significance	Date	Photo
450	Wall - slight foundations of stone wall. Damaged or destroyed to E and to W forms a corner with wall (451). Probably the SW section of a larger building. Central section accommodates or is cut by drain (452). 4.9m long x 0.3m wide. Possible catch-pit for Stamping Mill 1.	High – good evidential and historical value for early phase of dressing process and understanding chronological development of the mill.	Wall (451) Drain (452)	High	Unknown, but may relate to some of features shown on 1850 OS map.

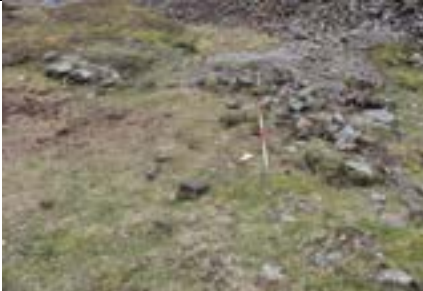
451	Wall - slight foundations of stone wall. Damaged or destroyed to N and to S forms a corner with wall (450). Probably the SW section of a larger building. Possible catch-pit for Stamping Mill 1	High - as above	Wall (450)	High	Unknown, but may relate to some of features shown on 1850 OS map.

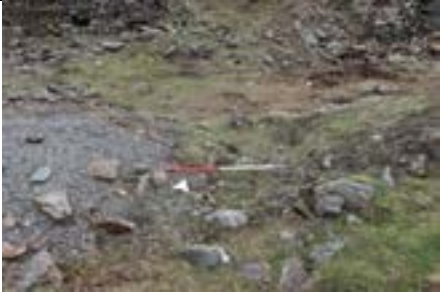
452	Drain - short length of drain running S from centre of wall 450 and possibly connecting with the base of drain (449). Fragment of timber upright at S end. Any continuation to S obscured by flood gully. Possible catch-pit for Stamping Mill 1.	Moderate – value reduced by lack of functional association with other features. This might be increased by archaeological investigation of surrounding area.	Wall (450) Drain (449)	Moderate	Unknown

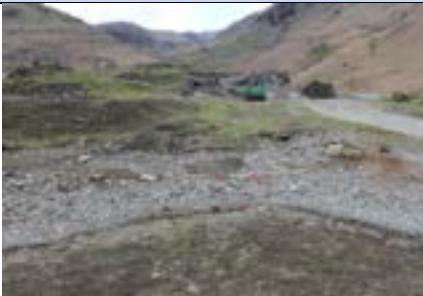
Context	Description	Significance	Assoc. with	Contribution to Significance	Date	Photo
501	Building - rectangular building, approx. 6m x 2.5m. Defined to SW and NE by foundations of 0.6m wide stone walls. To NE building space cut into shallow slope. The front or SE side of the building is undefined, but a series of stone blocks or slabs may be pad stones for timber supports. Out with the SE corner there is the stump of a free-standing timber post.	High – good evidential value for the type of building used on the lower part of the dressing floors. Good historical value as the building can be identified on historical photographs.		High	On 1890 OS map

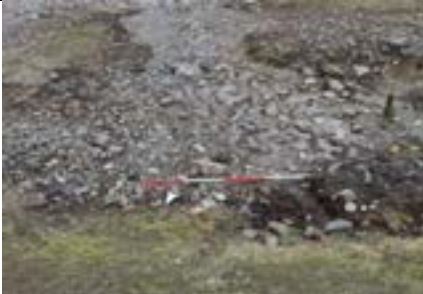
502	Round buddle - three vertical posts, largest 0.1m x 0.1m x 0.35 high delineate the circumference of a round buddle with a reconstructed diameter of 5.2m. The central timber post survives but the N section of the buddle is obscured by slumped material from bank (506). At the S edge of the buddle are two edge-set stones, probably an associated drain.	High – good evidential value as one of only three surviving round buddles on the site. Potential for below ground archaeology increases value of this feature.	Wall (503)	High	On 1890 OS map

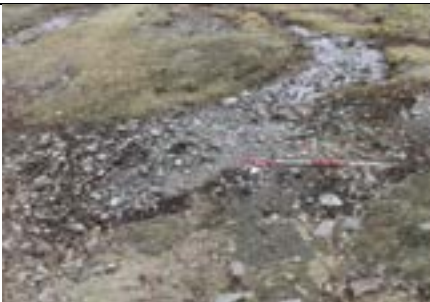
505	Round buddle - little remains of the buddle identified in the RCHME survey. It survives as an unvegetated area approx. 5m x 6m with some small displaced timber to the NE. To the SW is a concentration of fine sand, probably buddle waste.	Moderate - the poor condition of this feature reduces its evidential value. There is however potential for belowground archaeological survival and the feature as group value with the other buddles on site (440) and (502).		Moderate	Before 1890

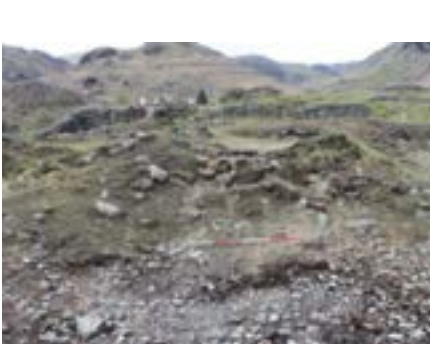
507	Terrace bank - very eroded, battered terrace bank with traces of stone revetment and possible drains/culverts. Forms division between settling ponds and lower buddles. 7m long x 1.9m high	Moderate/low - loss of retaining wall reduces evidential and visual value.		Moderate-low	Before 1890

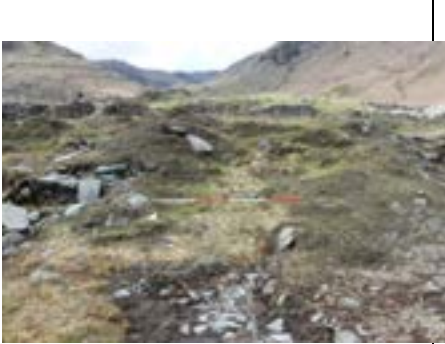
508	Wall - low retaining wall of slate block construction to W of bank (507). Possibly a terrace bank retaining wall.	Moderate/low - value reduced by feature's poor quality and un-associated nature.		Moderate-low	1890 or before

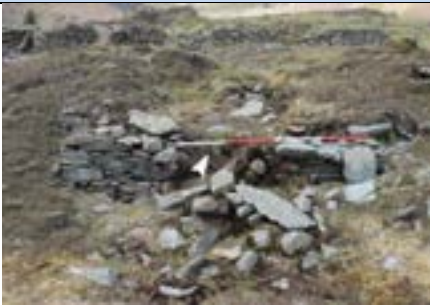
Context	Description	Significance	Assoc. with	Contribution to Significance	Date	Photo
509	Culvert - edge-set stones at base of bank (507) may be outfall to drain or culvert associated with settling ponds above.	Moderate/low - poor preservation and un-associated nature reduces value.		Moderate-low	1890 or before

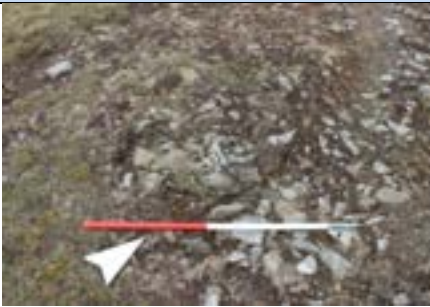
513	Culvert - two edge set stones (0.7m x 0.12m x 0.15m high and 0.7m x 0.16m x 0.15 high) set 0.4m apart. Exposed in flood gully, probably a truncated drain or culvert.	Moderate/ low - evidential value reduced because of fragmentary and un-associated nature of feature		Moderate-low	?

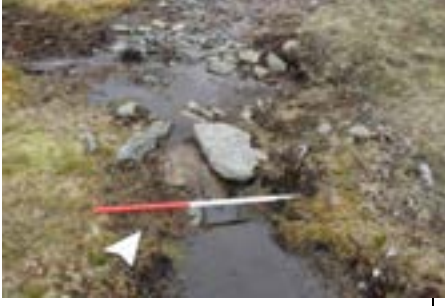
514	Stone setting - three large stone slabs exposed in flood gully. Possibly part of a covered drain or culvert.	Moderate/low - evidential value reduced because of fragmentary and un-associated nature of feature.		Moderate - low	?

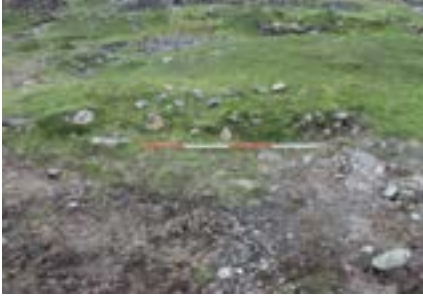
Context	Description	Significance	Assoc. with	Contribution to Significance	Date	Photo
515	Wall - low retaining wall, eroded to W by water course. Appears to continue W under main spoil tip. May form a structural unit with wall (516). Possibly part of an early settling or slimes pond. 5.1m long x 0,3m high.	High – good evidential value for early (pre-1850s) dressing floor layout.	Tip (100) Wall (516)	High	1850 or earlier?

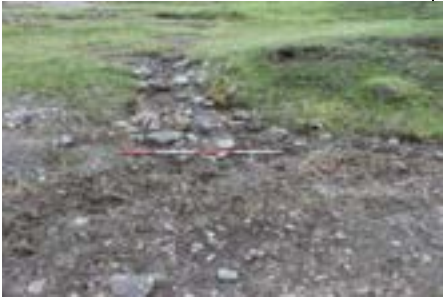
516	Wall - length of low retaining (?) wall exposed in and partly eroded by water course. May form structural unit with wall (515). Might continue SSE under main tip.	High – good evidential value for early (pre-1850s) dressing floor layout.	Tip (100) Wall (515)	High	1850 or earlier

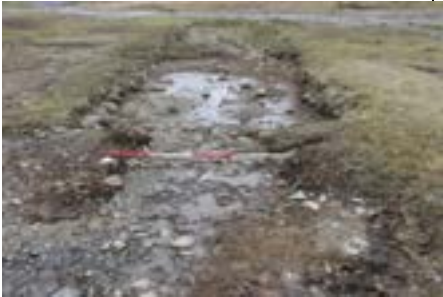
517	Settling pond - rectangular settling or slimes pond, 9.7m x 4m. Stone revetment along internal sides. N end in-turned with 1.5m gap between return walls. Channel/drain connection with pond 519 at SE corner. At S end it is separated from pond (519) by a revetted bank with a 0.7m wide gap .	High – good evidential value relating to form and operation of final part of ore dressing process. Good group value because of associated ponds.	Ponds (518) and (519)	High	On 1890 map

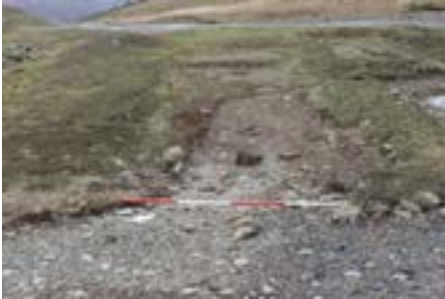
Context	Description	Significance	Assoc. with	Contribution to Significance	Date	Photo
518	Settling pond - settling pond. Rectangular settling or slimes pond, 17.4m x 3.4m, with earth banks (some stone revetment). Separated from pond (517) by flat-topped bank. Low, heather-covered spoil mound to SE may be piled waste from this and the other two ponds.	High - as above	Ponds(517) and (519)	High	On 1890 map

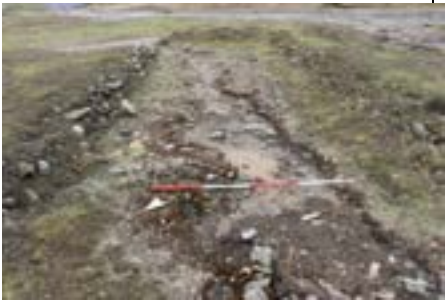
519	Settling pond - rectangular settling or slimes pond, 17.4mx 3.4m, forming the lowest or most southerly of a group with ponds (517) and (518). Internal sides are stone revetted. Break in bank at SW corner may be a deliberate drain. The pond appears to have been excavated into a pre-existing spread of sand and dressing waste, perhaps part of the original dressing floor. Rectangular hollows W and SW of the pond may be earlier dressing floor features.	High - as above	Ponds (517-518)	High	On 1890 map

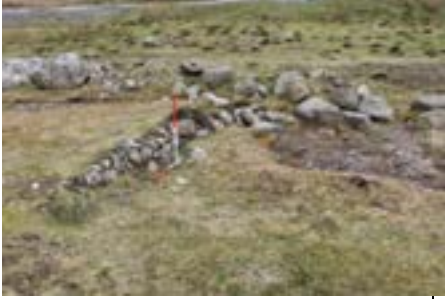
520	Dam - earth bank, 8.5m x1.10m, constructed across former course of Red Dell Beck. Stone revetment on	High – good evidential value relating to pollution control.		High	?

Context	Description	Significance	Assoc. with	Contribution to Significance	Date	Photo
	boulder base to S and some stone facing to N. Probably constructed to control/prevent release of slimes into Church Beck. Crescentic heap of fine sand (dressing waste) to SW.

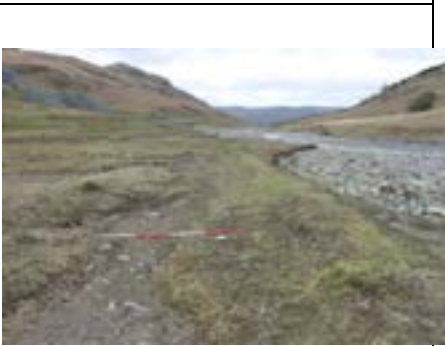
521	Dam - earth bank, 8.5m x1.10m, constructed across former course of Red Dell Beck. Stone revetment on boulder base to S and some stone facing to N. Probably constructed to control/prevent release of slimes into Church Beck. Crescentic heap of fine sand (dressing waste) to SW.	High – good evidential value relating to pollution control.		High	?
